Preowned Vehicle Inspection Report

Premium Inspection Analysis

Customer Name	: MERCEDES-BENZ MOBILITY (THAILAND) CO., LTD.	Inspection Date	: 2024-04-12
Tel.	: 0873663242	Lemon Inspection ID	: LEMON24040087
Inspector	: Natthapong Tong Suksing	Approved By	:

Brand	MERCEDES BENZ	Model year	2021
Model	A200	Engine Code - No.	28291430687714
Sub-model	AMG Dynamic	Registration year	2022-03-03
Registration No.	2๒๘9907	Chassis No.	W1K1771876L003762
Current Mileage(km.)	40171	Engine Capacity(cc.)	1300

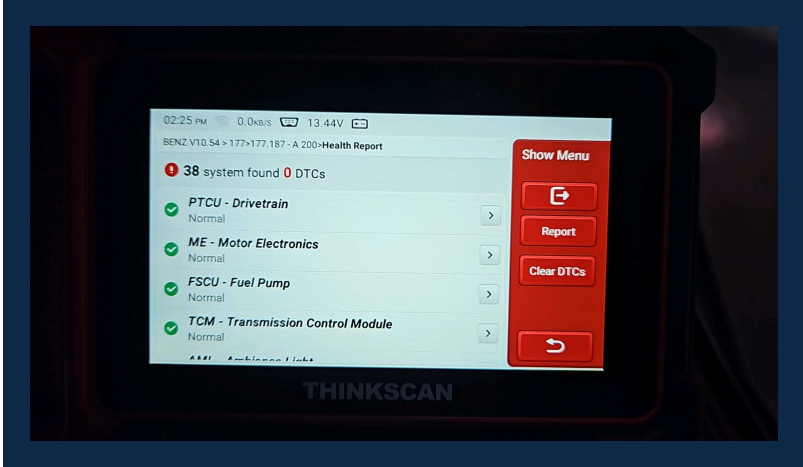
OBD Vehicle Health Analysis

Inspector : ***รุ่นย่อยรถยนต์ Mercedes-Benz A200 AMG Dynamic*** ภายนอก ตรวจสอบไม่พบหลักฐานการ
ทำสี สภาพดีสวยครับ มีรอยขีดข่วนบนแฉวเล็กน้อยจางๆสามารถขัดสีออกได้ ยางรถยนต์ทั้ง 4 เส้นปกติปี 2022
ภายใน สะอาดเรียบร้อยปกติ แอร์เครื่องเสียงวิทยุ multi function ใช้งานได้ปกติ เครื่องยนต์ ตรวจสอบทำงานปกติ ไม่
พบรอยรั่วซึม ตรวจสอบด้วยเครื่องสแกน obd2 ไม่พบรหัสปัญหาที่ผิดปกติ ไม่ได้ทดสอบขับเคลื่อน โครงสร้าง ตรวจสอบ
ปกติ

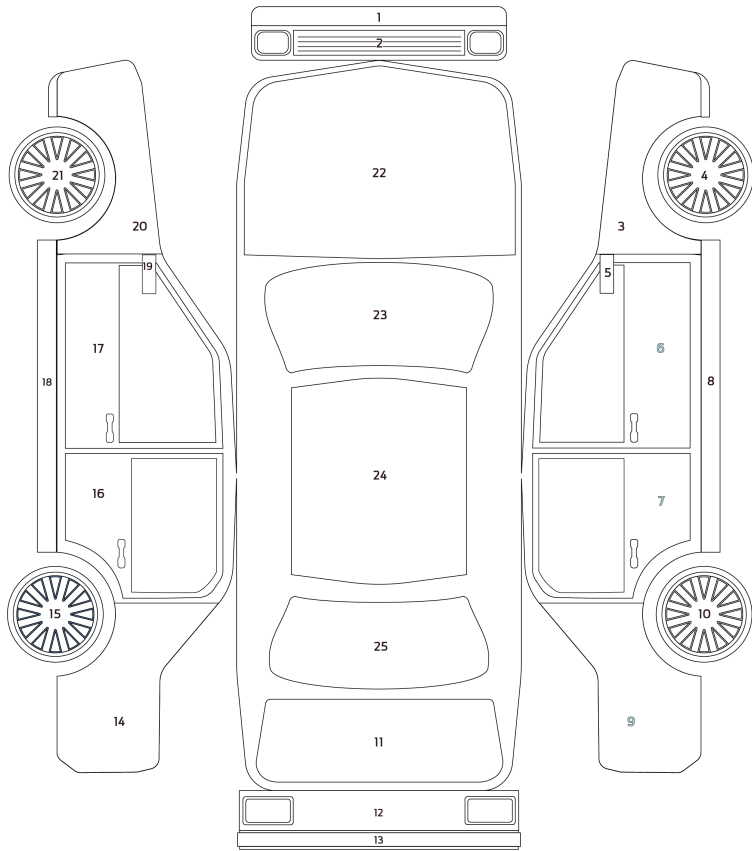
Exterior Inspection Points

1. Front Skirt	O	14. Left Skirt	O
2. Front Bumper	O	15. Left Wing Mirror	O
3. Front Right Fender	O	16. Front Windshield	O
4. Front Right Wheel	O	17. Roof	O
5. Front Left Fender	O	18. Rear Right Fender	O
6. Front Left Wheel	O	19. Rear Bonnet	O
7. Front Bonnet	O	20. Back Right Wheel	O
8. Right Wing Mirror	O	21. Rear Bumper	O
9. Front Right Door	O	22. Rear Skirt	O
10. Rear Right Door	O	23. Rear Left Fender	O
11. Right Skirt	O	24. Back Left Wheel	O
12. Rear Left Door	O	25. Back Windshield	O
13. Front Left Door	O

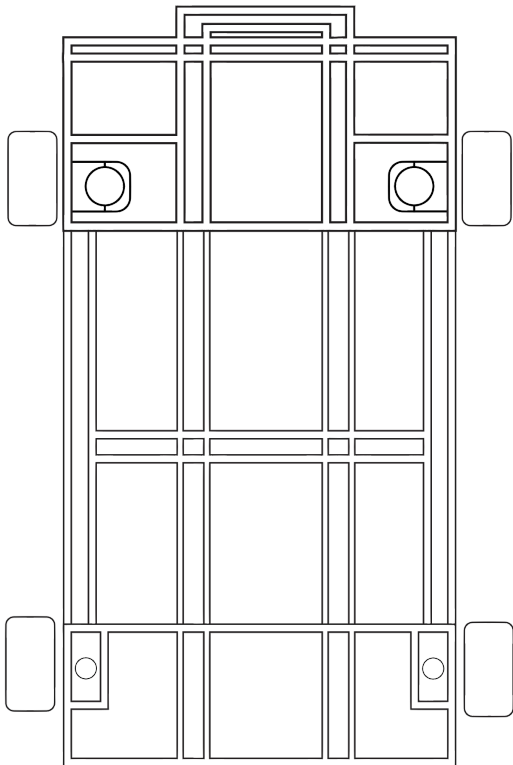
Chassis Report

No dent in the under carriage (th)	PASS
No deform chassis or chassis frame (th)	PASS
No visible corrosion on the chassis or chassis frame (th)	PASS
No missing part on the chassis frame (th)	PASS
Half cut Analysis (th)	PASS

Chassis Damage Level	No Damage
----------------------	-----------

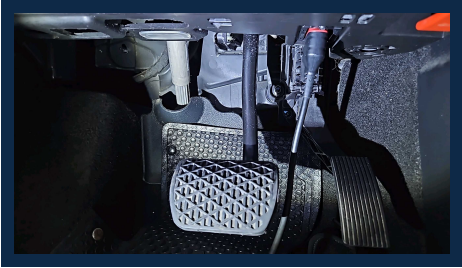
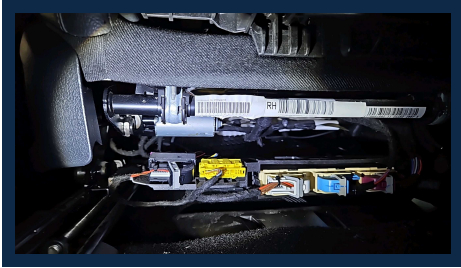
Flood Report

Evidence of Flood	No
-------------------	----

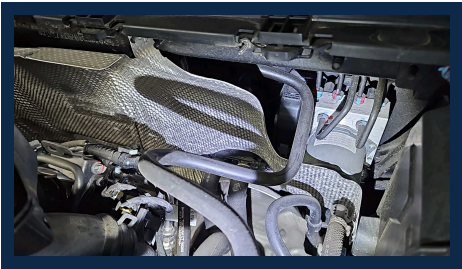
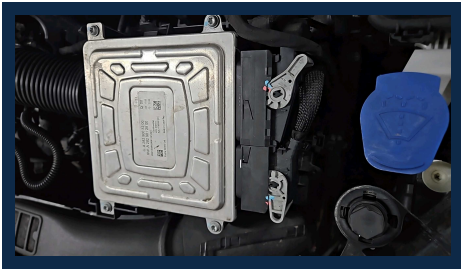
Fire Report

Evidence of Fire	No
------------------	----
