Preowned Vehicle Inspection Report

Premium Inspection Analysis

Brand	MERCEDES BENZ	Model year	2021
Model	GLA200	Engine Code - No.	28291430636010
Sub-model	URBAN	Registration year	2021-12-01
Registration No.	1UQ1924	Chassis No.	W1N2477876L003158
Current Mileage(km.)	84957	Engine Capacity(cc.)	1300

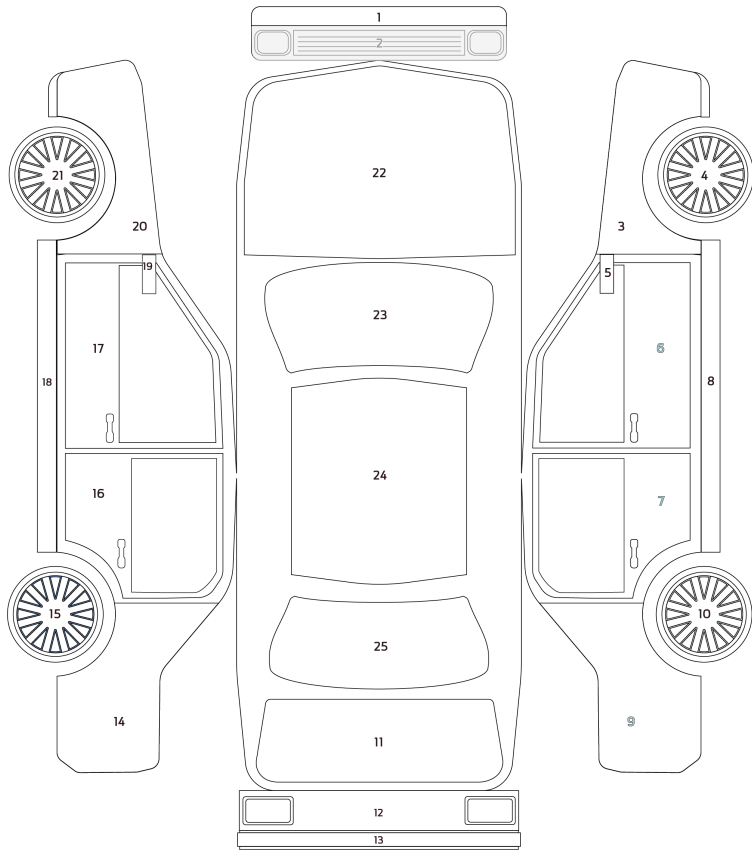
Exterior Inspection Points

1. Front Skirt	O	14. Left Skirt	O
2. Front Bumper	O (D2)	15. Left Wing Mirror	O
3. Front Right Fender	O	16. Front Windshield	O
4. Front Right Wheel	O	17. Roof	O
5. Front Left Fender	O	18. Rear Right Fender	O
6. Front Left Wheel	O	19. Rear Bonnet	O
7. Front Bonnet	O	20. Back Right Wheel	O
8. Right Wing Mirror	O	21. Rear Bumper	O
9. Front Right Door	O	22. Rear Skirt	O
10. Rear Right Door	O	23. Rear Left Fender	O
11. Right Skirt	O	24. Back Left Wheel	O
12. Rear Left Door	O	25. Back Windshield	O
13. Front Left Door	O

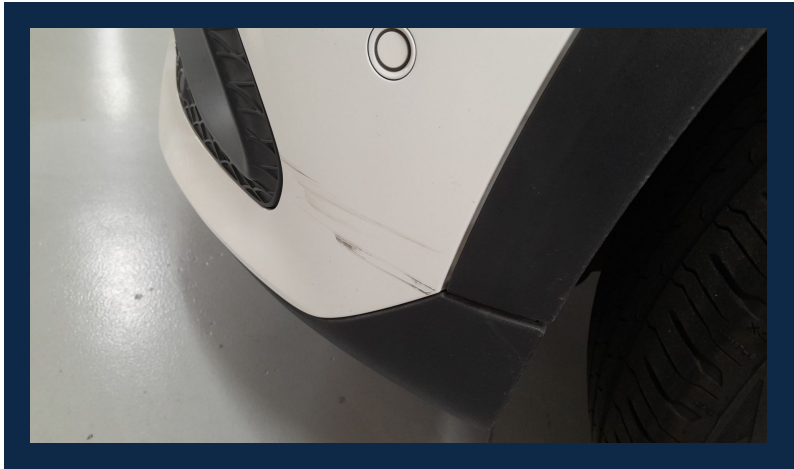
Vehicle Defect Notices

Inspector : รุ่นรถ : ***MERCEDES BENZ GLA 200 Progressive*** ภายนอก : ไม่พบหลักฐานการทำสีเก็บสี
กันชนหน้าถลอก สภาพยางปกติทั้ง 4 เส้น ภายใน : โดยรวมสะอาดเรียบร้อย อุปกรณ์ไฟฟ้าทำงานได้ปกติ เครื่องยนต์
: เครื่องยนต์สามารถทำงานได้ปกติ ตรวจสอบด้วย OBD ไม่มีปัญหา โครงสร้าง : โครงสร้างหลักปกติ ไม่พบหลักฐาน
การซ่อมแซม

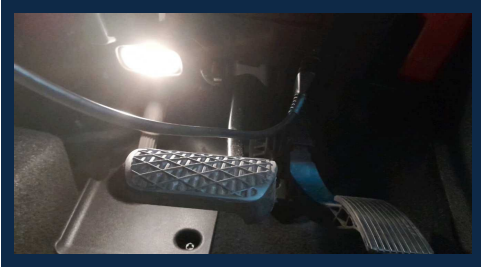
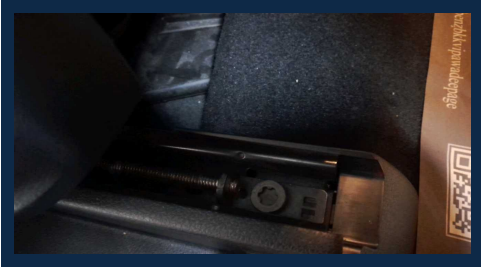
Flood Report

Evidence of Flood	No
-------------------	----

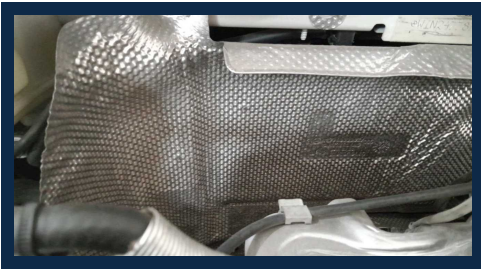
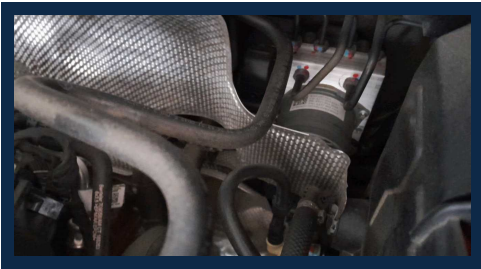
Fire Report

Evidence of Fire	No
------------------	----
