# Preowned Vehicle Inspection Report

Customer Name	: MERCEDES-BENZ MOBILITY (THAILAND) CO., LTD.	Inspection Date	: 2024-04-26
Tel.	: 0873663242	Lemon Inspection ID	: LEMON24040162
Inspector	: tanruk tipin	Approved By	:

Brand	MERCEDES BENZ	Model year	2019
Model	E300 e	Engine Code - No.	27492031892525
Sub-model	AMG Dynamic	Registration year	2021-02-25
Registration No.	1UJ9285	Chassis No.	WDD2130536L029888
Current Mileage(km.)	49853	Engine Capacity(cc.)	2000

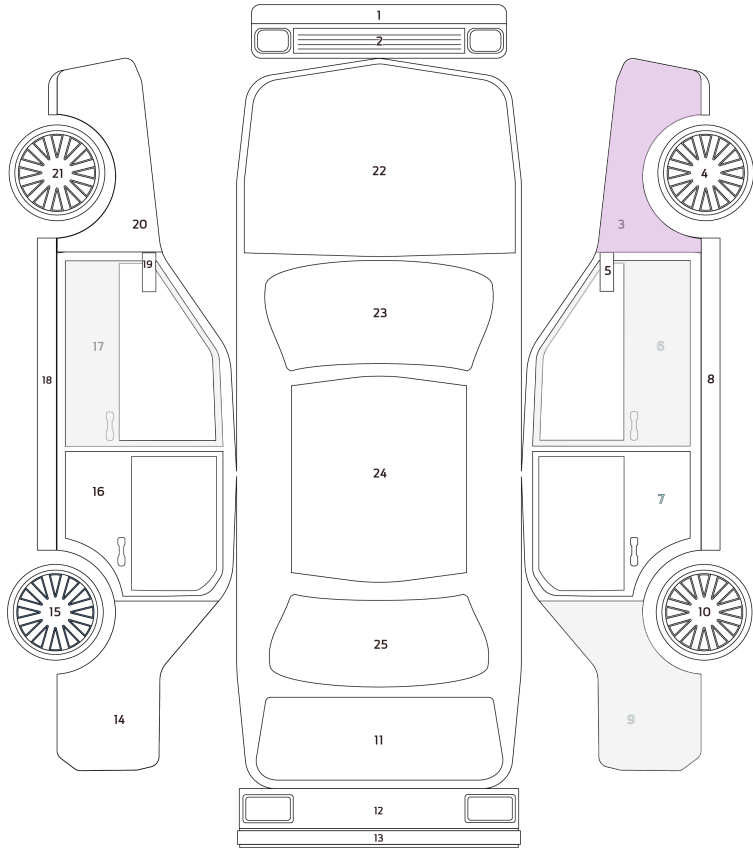
### Exterior Inspection Points

1. Front Skirt	O	14. Left Skirt	O
2. Front Bumper	O	15. Left Wing Mirror	O
3. Front Right Fender	X (D2)	16. Front Windshield	O
4. Front Right Wheel	O	17. Roof	O
5. Front Left Fender	O	18. Rear right fender	O (S1)
6. Front Left Wheel	O	19. Rear Bonnet	O
7. Front Bonnet	O	20. Back Right Wheel	O
8. Right Wing Mirror	O	21. Rear Bumper	O
9. Front right door	O (S1)	22. Rear Skirt	O
10. Rear Right Door	O	23. Rear Left Fender	O
11. Right Skirt	O	24. Back Left Wheel	O
12. Rear Left Door	O	25. Back Windshield	O
13. Front left door	O (S1)

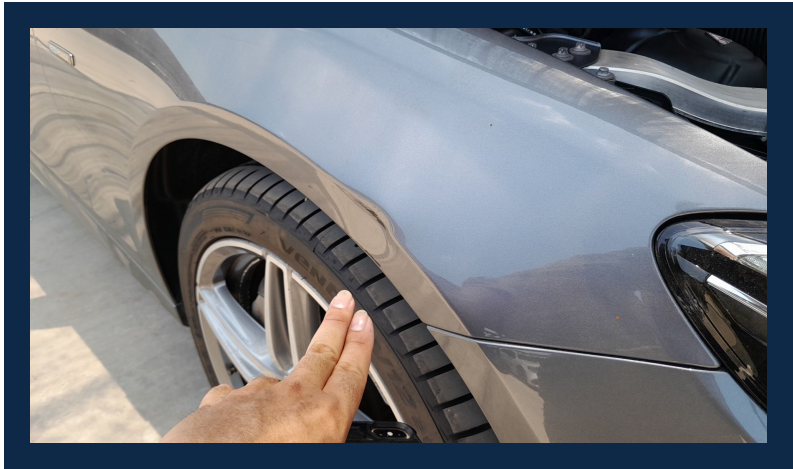
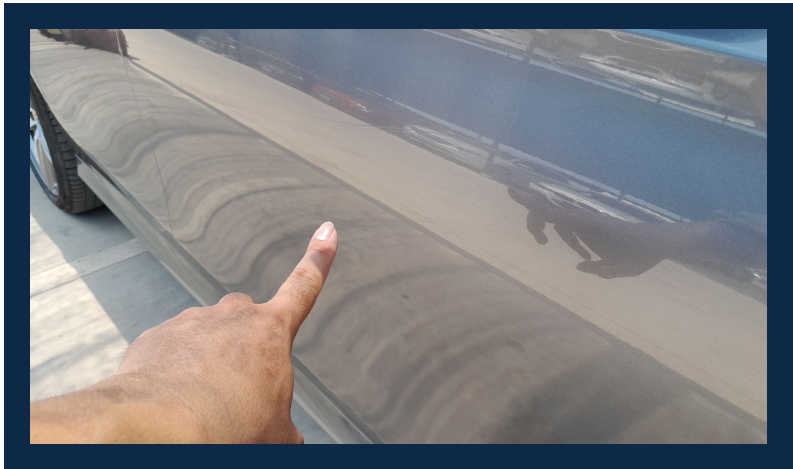
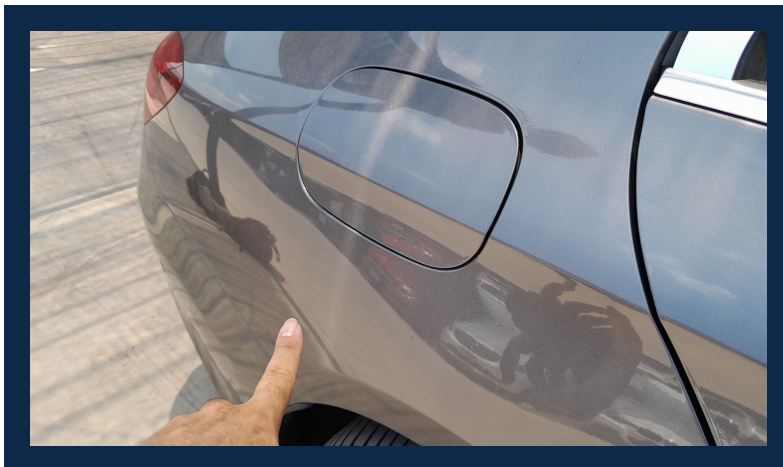
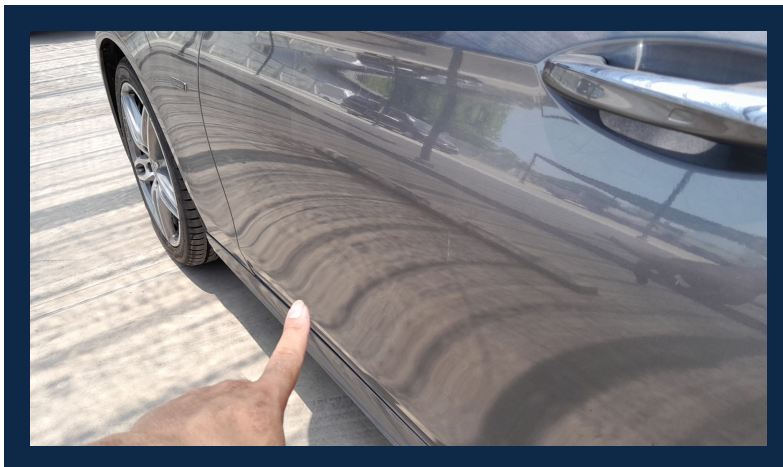
**Vehicle Defect Notices**

**Inspector :** ภายนอก(Exterior) : การตรวจสภาพภายนอกโดยรวมไม่พบหลักฐานการซ่อมแซมทำสี แก้มหน้าขวาเป็นรอยบุบ ประตูหน้าขวากับแก้มหลังขวาเป็นรอยขีดข่วน / สภาพยางปกติทั้ง4เส้น หน้าปี 24 ยางหลังปี 19 เสื่อมสภาพภายใน(Interior) : Navi ใช้งานไม่ได้ เบาะหน้าขวาเป็นคราบและรอยย่น ผ้าบุหลังคาเป็นคราบเจิม ภายในปกติ สะอาดเรียบร้อย ,อุปกรณ์ไฟฟ้า แอร์ วิทยุFM ใช้งานได้สมบูรณ์ครบปกติ เครื่องยนต์(Electric) : เครื่องยนต์ทำงานได้ปกติ ,วิเคราะห์ปัญหาด้วยเครื่อง OBDII พบสิ่งผิดปกติ แบตเตอรี่สำรองเสื่อมสภาพ (ไม่ได้ทดสอบขั้วขี้) โครงสร้าง(Frame) : อุบัติเหตุไม่มี ,โครงสร้างหลักปกติ ไม่มีการซ่อมแซมโครงสร้างหรือมีการชนถึงโครงสร้าง \*\*E300e 2.0 AMG DYNAMIC

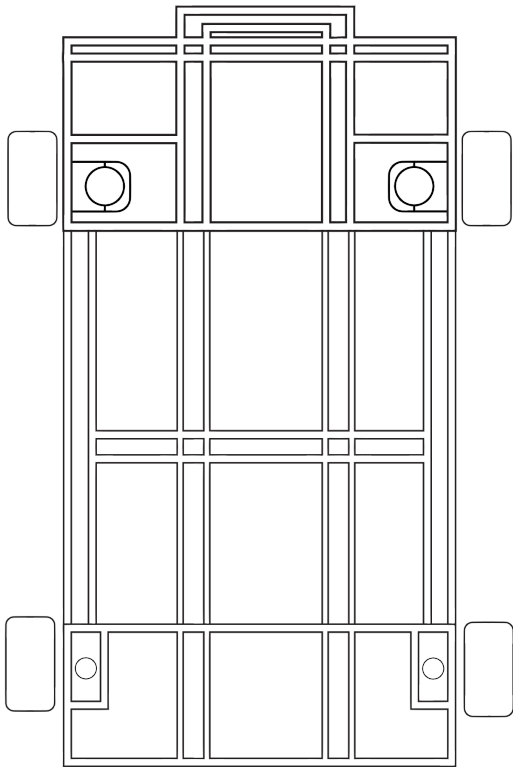
**Chassis Report**

No dent in the under carriage (th)	PASS
No deform chassis or chassis frame (th)	PASS
No visible corrosion on the chassis or chassis frame (th)	PASS
No missing part on the chassis frame (th)	PASS
Half cut Analysis (th)	PASS

Chassis Damage Level	no-damage
----------------------	-----------
