Preowned Vehicle Inspection Report

Premium Inspection Analysis

Customer Name	: MERCEDES-BENZ MOBILITY (THAILAND) CO., LTD.	Inspection Date	: 2024-04-26
Tel.	: 0873663242	Lemon Inspection ID	: LEMON24040162
Inspector	: tanruk tipin	Approved By	:

Brand	MERCEDES BENZ	Model year	2019
Model	E300 e	Engine Code - No.	27492031892525
Sub-model	AMG Dynamic	Registration year	2021-02-25
Registration No.	1UJ9285	Chassis No.	WDD2130536L029888
Current Mileage(km.)	49853	Engine Capacity(cc.)	2000

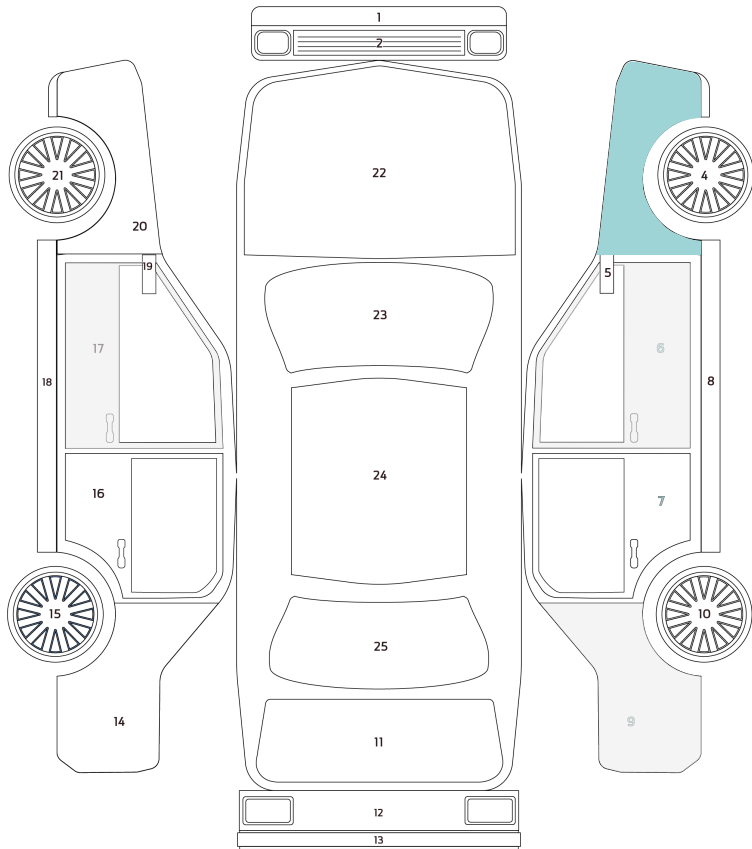
Exterior Inspection Points

1. Front Skirt	O	14. Left Skirt	O
2. Front Bumper	O	15. Left Wing Mirror	O
3. Front Right Fender	X (D2)	16. Front Windshield	O
4. Front Right Wheel	O	17. Roof	O
5. Front Left Fender	O	18. Rear right fender	O (S1)
6. Front Left Wheel	O	19. Rear Bonnet	O
7. Front Bonnet	O	20. Back Right Wheel	O
8. Right Wing Mirror	O	21. Rear Bumper	O
9. Front right door	O (S1)	22. Rear Skirt	O
10. Rear Right Door	O	23. Rear Left Fender	O
11. Right Skirt	O	24. Back Left Wheel	O
12. Rear Left Door	O	25. Back Windshield	O
13. Front left door	O (S1)

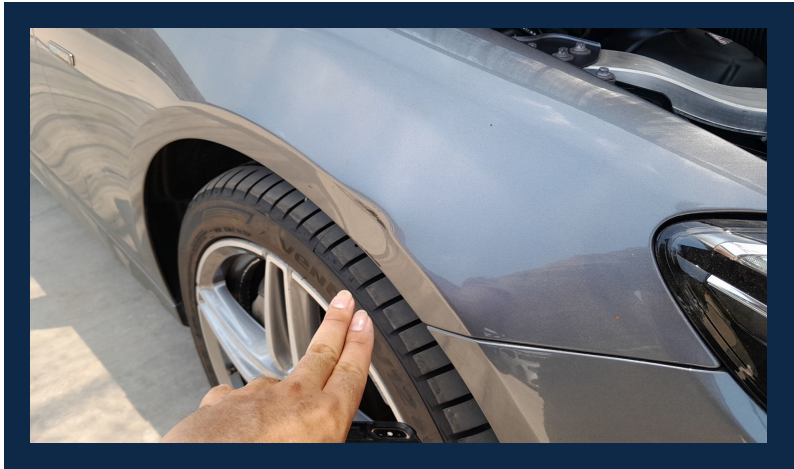
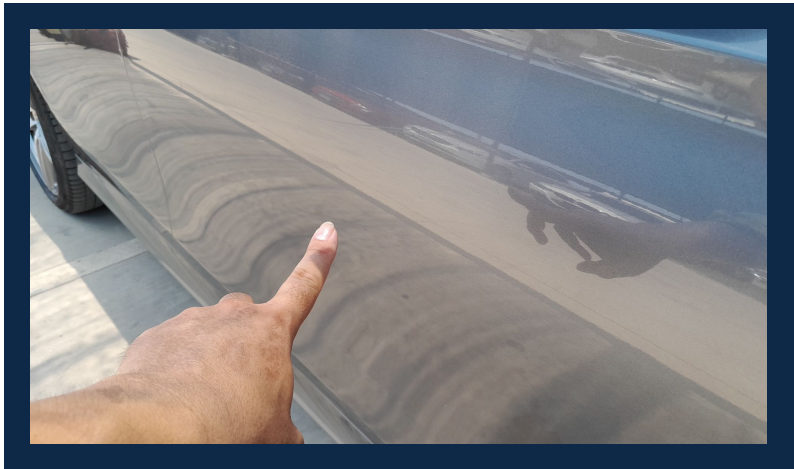
Vehicle Defect Notices

Inspector : ภายนอก(Exterior) : การตรวจสภาพภายนอกโดยรวมไม่พบหลักฐานการซ่อมแซมทำสี แก้มหน้าขวาเป็นรอยบุบ ประตูหน้าขวากับแก้มหลังขวาเป็นรอยขีดข่วน / สภาพยางปกติทั้ง4เส้น หน้าปี 24 ยางหลังปี 19 เสื่อมสภาพภายใน(Interior) : Navi ใช้งานไม่ได้ เบาะหน้าขวาเป็นคราบและรอยย่น ผ้าบุหลังคาเป็นคราบเจิม ภายในปกติ สะอาดเรียบร้อย ,อุปกรณ์ไฟฟ้า แอร์ วิทยุFM ใช้งานได้สมบูรณ์ครบปกติ เครื่องยนต์ (Engine) : เครื่องยนต์ทำงานได้ปกติ ,วิเคราะห์ปัญหาด้วยเครื่อง OBDII พบสิ่งผิดปกติ แบตเตอรี่สำรองเสื่อมสภาพ (ไม่ได้ทดสอบขั้วขี้) โครงสร้าง(Frame) : อุบัติเหตุไม่มี ,โครงสร้างหลักปกติ ไม่มีการซ่อมแซมโครงสร้างหรือมีการชนถึงโครงสร้าง **E300e 2.0 AMG DYNAMIC
