# Preowned Vehicle Inspection Report

Premium Inspection Analysis

Customer Name	: MERCEDES-BENZ MOBILITY (THAILAND) CO., LTD.	Inspection Date	: 2024-04-26
Tel.	:	Lemon Inspection ID	: LEMON24040162
Inspector	: tanruk tipin	Approved By	: tanruk tipin

Brand	MERCEDES BENZ	Model year	2019
Model	E300 e	Engine Code - No.	27492031892525
Sub-model	AMG Dynamic	Registration year	2021-02-25
Registration No.		Chassis No.	WDD2130536L029888
Current Mileage(km.)	49853	Engine Capacity(cc.)	2000

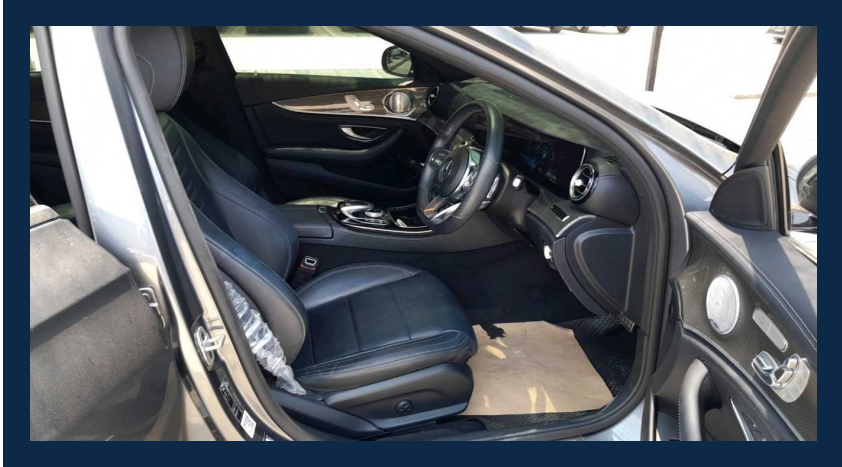
**Passenger Front Seat Image**

ภายใน(Interior) : Navi ใช้งานไม่ได้ เบาะหน้าขวาเป็นคราบและรอยย่น ผ้าบุหลังคาเป็นคราบเจิม ภายในปกติ สะอาด

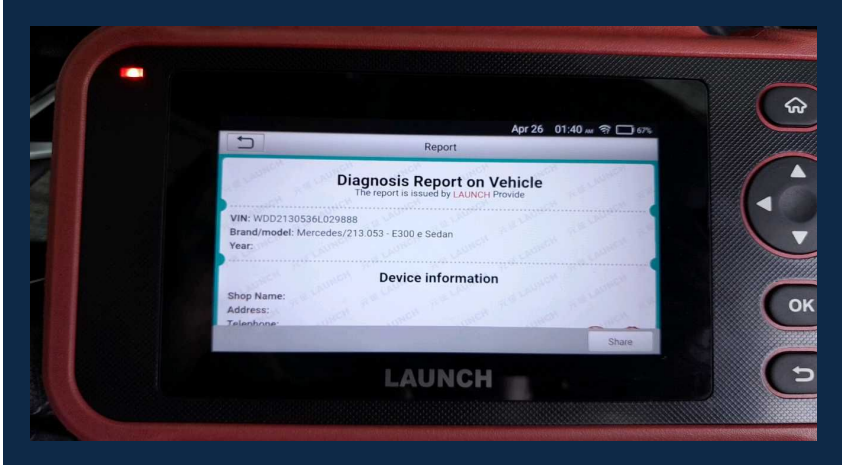
**OBD Vehicle Health Analysis**

,วิเคราะห์ปัญหาด้วยเครื่อง OBDII พบสิ่งผิดปกติ แบตเตอรี่สำรองเสื่อมสภาพ (ไม่ได้ทดสอบขั้วขี้) โครงสร้าง(Frame)

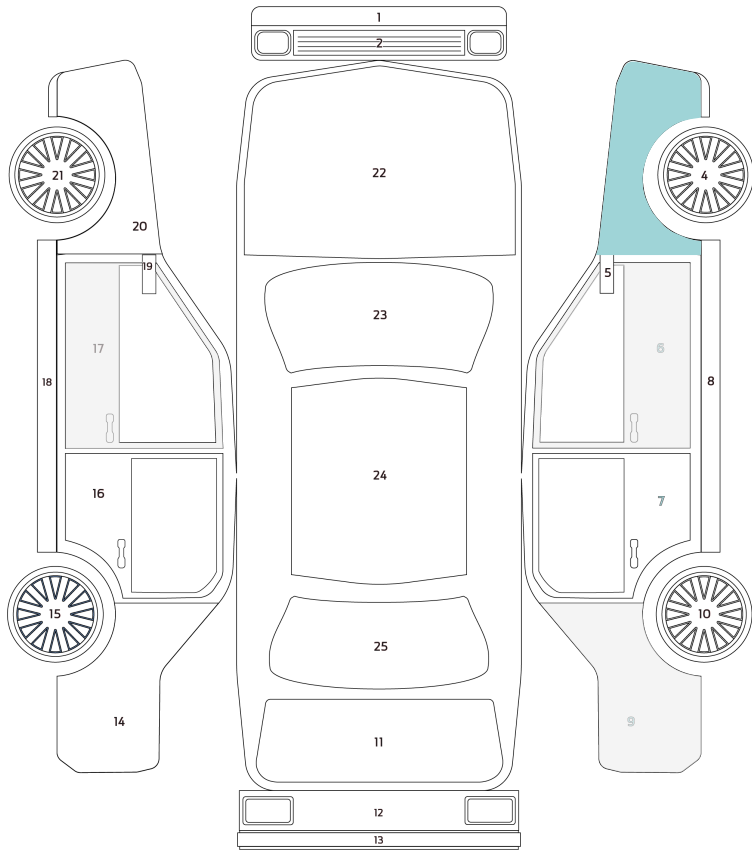
### Exterior Inspection Points

1. Front Skirt	O	14. Left Skirt	O
2. Front Bumper	O	15. Left Wing Mirror	O
3. Front Right Fender	X (D2)	16. Front Windshield	O
4. Front Right Wheel	O	17. Roof	O
5. Front Left Fender	O	18. Rear right fender	O (S1)
6. Front Left Wheel	O	19. Rear Bonnet	O
7. Front Bonnet	O	20. Back Right Wheel	O
8. Right Wing Mirror	O	21. Rear Bumper	O
9. Front right door	O (S1)	22. Rear Skirt	O
10. Rear Right Door	O	23. Rear Left Fender	O
11. Right Skirt	O	24. Back Left Wheel	O
12. Rear Left Door	O	25. Back Windshield	O
13. Front left door	O (S1)

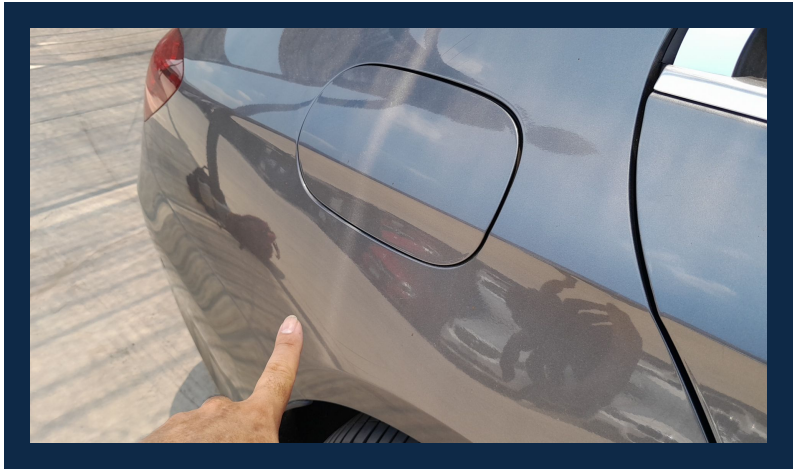
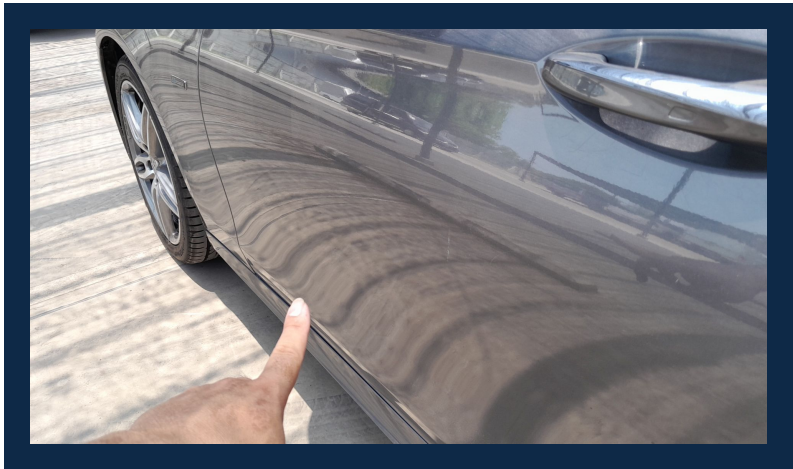
**Vehicle Defect Notices**

**Inspector Note****Vehicle :** MERCEDES B ENZ E300 e AMG DYNAMIC**Chassis number :** WDD2130536L029888**Inspection date :** 2024-04-26**Inspector :** ภายนอก(Exterior) : การตรวจสภาพภายนอกโดยรวมไม่พบหลักฐานการซ่อมแซมทำสี แก้มหน้าขวาเป็นรอยบุบ ประตูหน้าขวากับแก้มหลังขวาเป็นรอยขีดข่วน /ยางหน้าปี 24 ยางหลังปี 19 เสื่อมสภาพ

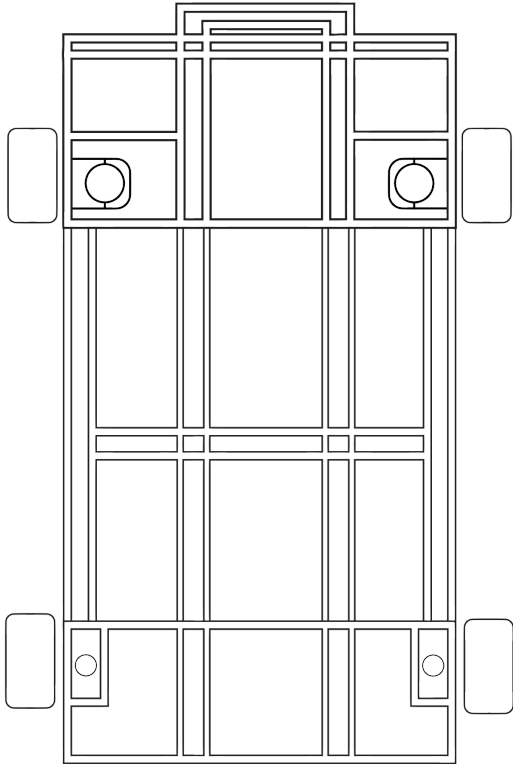
Chassis Report

No dent in the under carriage (th)	PASS
No deform chassis or chassis frame (th)	PASS
No visible corrosion on the chassis or chassis frame (th)	PASS
No missing part on the chassis frame (th)	PASS
Half cut Analysis (th)	PASS

Chassis Damage Level	no-damage
----------------------	-----------

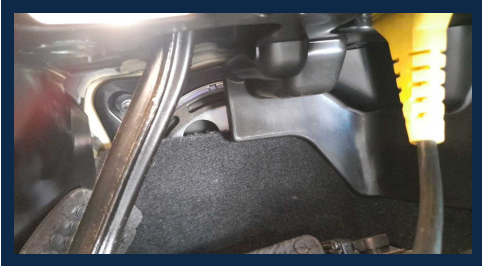
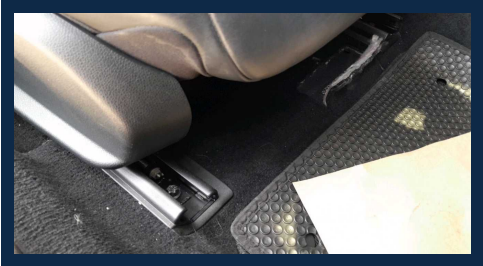
**Flood Report**

Evidence of Flood	No
-------------------	----

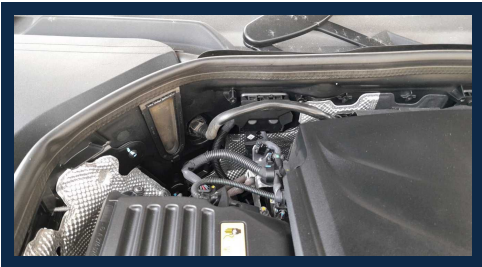
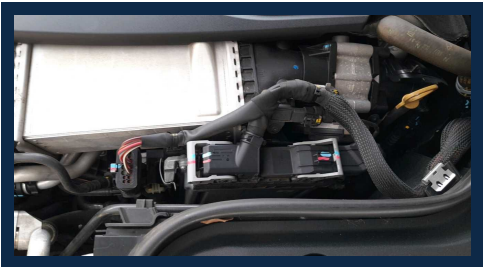
**Fire Report**

Evidence of Fire	No
------------------	----
