# Preowned Vehicle Inspection Report

Premium Inspection Analysis

Customer Name	: MERCEDES-BENZ MOBILITY (THAILAND) CO., LTD.	Inspection Date	: 2024-05-04
Tel.	:	Lemon Inspection ID	: LEMON24050018
Inspector	: tanruk tipin	Approved By	: sakulpong singnarong

Brand	MERCEDES BENZ	Model year	2018
Model	E350E	Engine Code - No.	27492031441971
Sub-model	AMG DYNAMIC	Registration year	2020-02-24
Registration No.		Chassis No.	WDD2130506L016066
Current Mileage(km.)	87916	Engine Capacity(cc.)	2000

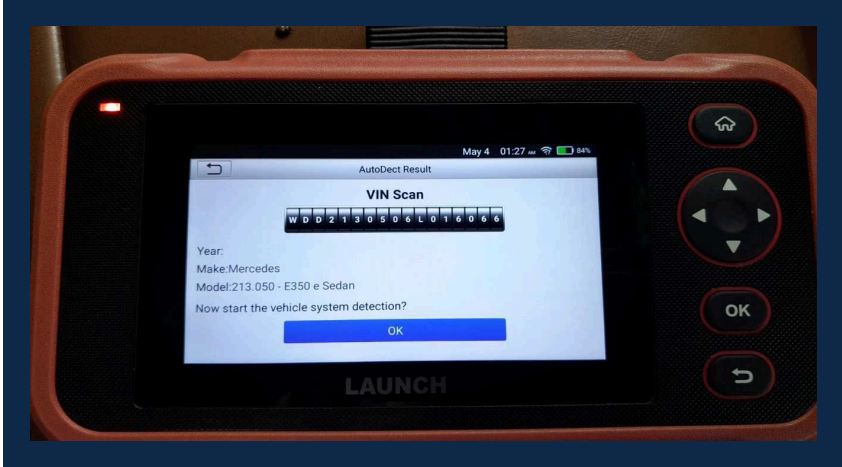
**OBD Vehicle Health Analysis**

1. Vehicle Engine Number Analysis (th)	PASS	14. Air Conditioning and Heating System (th)	PASS
2. Vehicle Chassis Number Analysis (th)	PASS	15. Front and Rear Suspension (th)	PASS
3. Vehicle Original OEM Color Analysis (th)	PASS	16. Drive Axle (th)	PASS
4. Engine System (th)	PASS	17. High Tech (th)	PASS
5. Transmission System (th)	PASS	18. Passenger Comfort (th)	PASS
6. Electrical System (th)	PASS	19. Security System (th)	PASS
7. Brake System (th)	PASS	20. Safety Active (th)	PASS
8. Steering System (th)	PASS	21. Safety Passive (th)	PASS
9. Fuel System (th)	PASS	22. Original Mileage Analysis (th)	PASS
10. Four-wheel Drive (th)	PASS	23. Overall Chassis Analysis (th)	PASS
11. Turbocharger/Supercharger (th)	PASS	24. Overall Exterior Analysis (th)	PASS
12. Fuel Injection and Engine Management System (th)	PASS	25. Overall Interior Analysis (th)	PASS
13. Engine Cooling System (th)	PASS

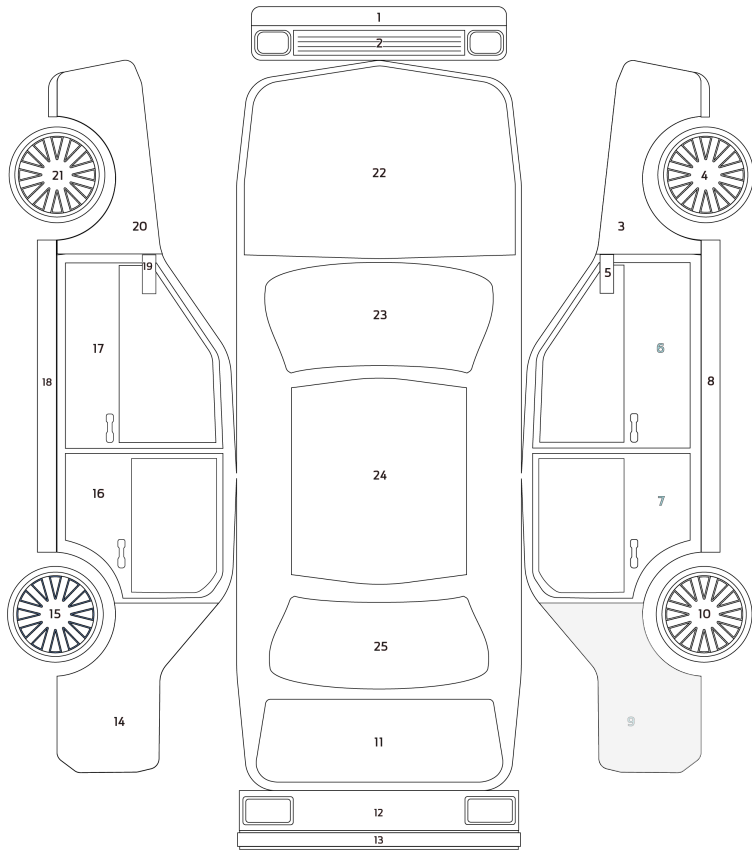
**Exterior Inspection Points**

1. Front Skirt	O	14. Left Skirt	O
2. Front Bumper	O	15. Left Wing Mirror	O
3. Front Right Fender	O	16. Front Windshield	O
4. Front Right Wheel	O	17. Roof	O
5. Front Left Fender	O	18. Rear right fender	O (S1)
6. Front Left Wheel	O	19. Rear Bonnet	O
7. Front Bonnet	O	20. Back Right Wheel	O
8. Right Wing Mirror	O	21. Rear Bumper	O
9. Front Right Door	O	22. Rear Skirt	O
10. Rear Right Door	O	23. Rear Left Fender	O
11. Right Skirt	O	24. Back Left Wheel	O
12. Rear Left Door	O	25. Back Windshield	O
13. Front Left Door	O

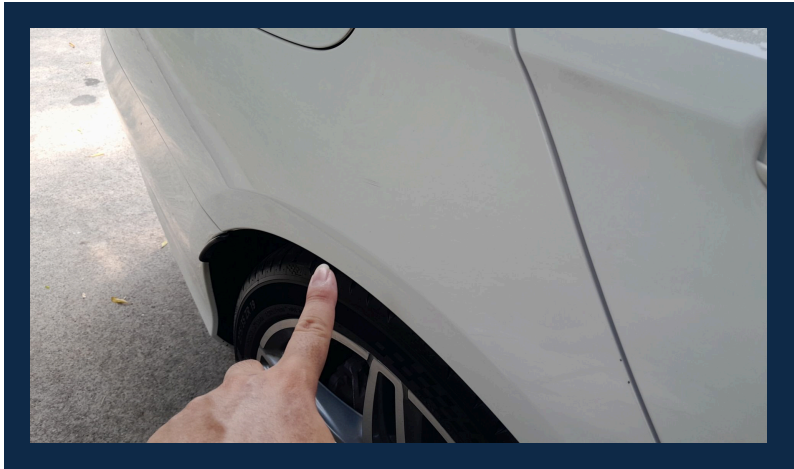
**Vehicle Defect Notices**

**Inspector :** ภายนอก(Exterior) : การตรวจสภาพภายนอกโดยรวมไม่พบหลักฐานการซ่อมแซมทำสี / สภาพยางปกติ กิ่ง4เส้น / กันชนหน้าเป็นรอยสีถลอก / มีริ้วรอยรอบคันทันเล็กน้อย ภายใน(Interior) : เบาะหน้าเป็นรอยยับ ภายในปกติ สะอาดเรียบร้อย ,อุปกรณ์ไฟฟ้า แอร์ วิทยุFM ใช้งานได้สมบูรณ์ครบปกติ เครื่องยนต์(Engine) : เครื่องยนต์ทำงานได้ปกติ ,วิเคราะห์ปัญหาด้วยเครื่อง OBDII ไม่พบสิ่งผิดปกติ (ไม่ได้ทดสอบขับเคลื่อน) โครงสร้าง(Frame) : อุบัติเหตุไม่มี ,โครงสร้างหลักปกติ ไม่มีการซ่อมแซมโครงสร้างหรือมีการชนถึงโครงสร้าง

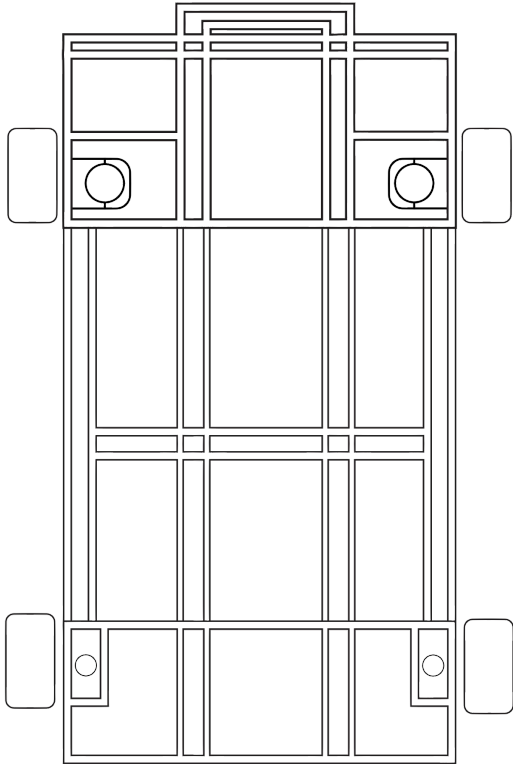
## Chassis Report

No dent in the under carriage (th)	PASS
No deform chassis or chassis frame (th)	PASS
No visible corrosion on the chassis or chassis frame (th)	PASS
No missing part on the chassis frame (th)	PASS
Half cut Analysis (th)	PASS

Chassis Damage Level	No Damage
----------------------	-----------

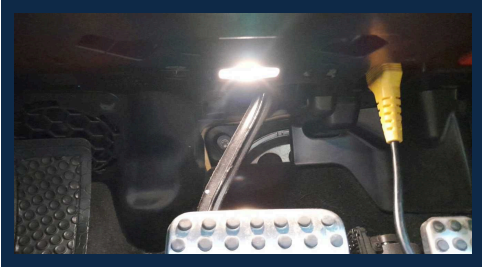
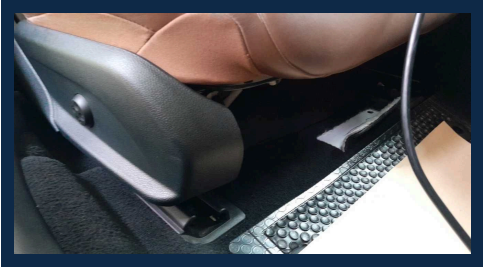
**Flood Report**

Evidence of Flood	No
-------------------	----

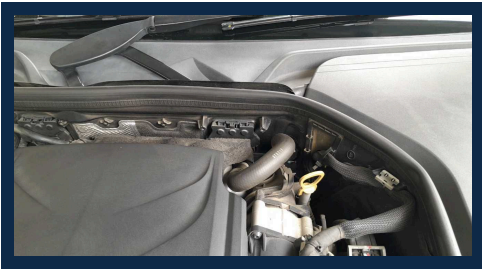
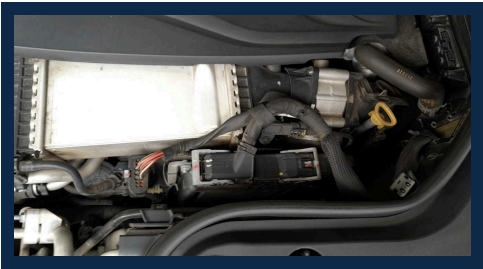
**Fire Report**

Evidence of Fire	No
------------------	----
