Preowned Vehicle Inspection Report

Premium Inspection Analysis

Customer Name	:	_____	Inspection Date	:	2024-05-02
Tel.	:	_____	Lemon Inspection ID	:	LEMON24050001
Inspector	:	Aekkawit Tee Bunleng	Approved By	:	sakulpong singnarong

Brand	MERCEDES BENZ	Model year	2019
Model	C43	Engine Code - No.	27682330977036
Sub-model	AMG 4MATIC COUPE (CKD)	Registration year	2019-04-03
Registration No.		Chassis No.	WDD2053646L044272
Current Mileage(km.)	30837	Engine Capacity(cc.)	3000

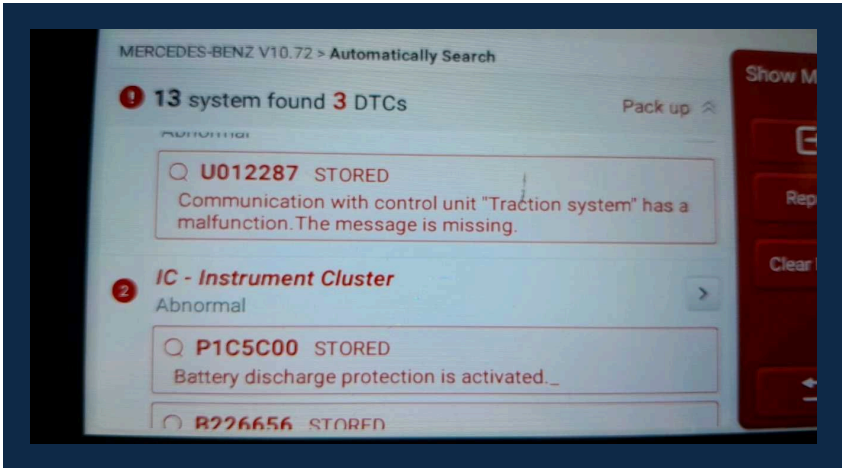
OBD Vehicle Health Analysis

Inspector : ภายนอก : พบหลักฐานการทำสีเก็บสีบางส่วนคือ ประตูขวา แก้มหลังขวา , ประตูหน้าขวามีรอยขีดข่วนเล็กน้อย ฝาท้ายมีรอยขีดข่วนเล็กน้อย สภาพยางเสื่อมสภาพทั้ง 4 ล้อ ภายใน : ภายในโดยรวมสะอาดเรียบร้อย อุปกรณ์ไฟฟ้าทำงานได้ปกติ เครื่องยนต์ : ไม่สามารถถ่ายเลขเครื่องยนต์ได้ เครื่องยนต์ทำงานได้ครบปกติ ตรวจสอบด้วย OBD พบ CodeU012287STORED Communication with control unit "Traction system" has a malfunction. The message is missing P1C5C00 STORED Battery discharge protection is activated B226656 STORED The drive authorization data are implausible.An incorrect or incompatible configuration was detected แนะนำให้นำรถไปรีเซ็ตระบบกับทางศูนย์บริการเนื่องจากรถไม่ค่อยได้ใช้งาน โครงสร้าง : โครงสร้างหลักปกติ ไม่พบอุบัติเหตุถึงโครงสร้างหรือหลักฐานการซ่อมแซมโครงสร้าง

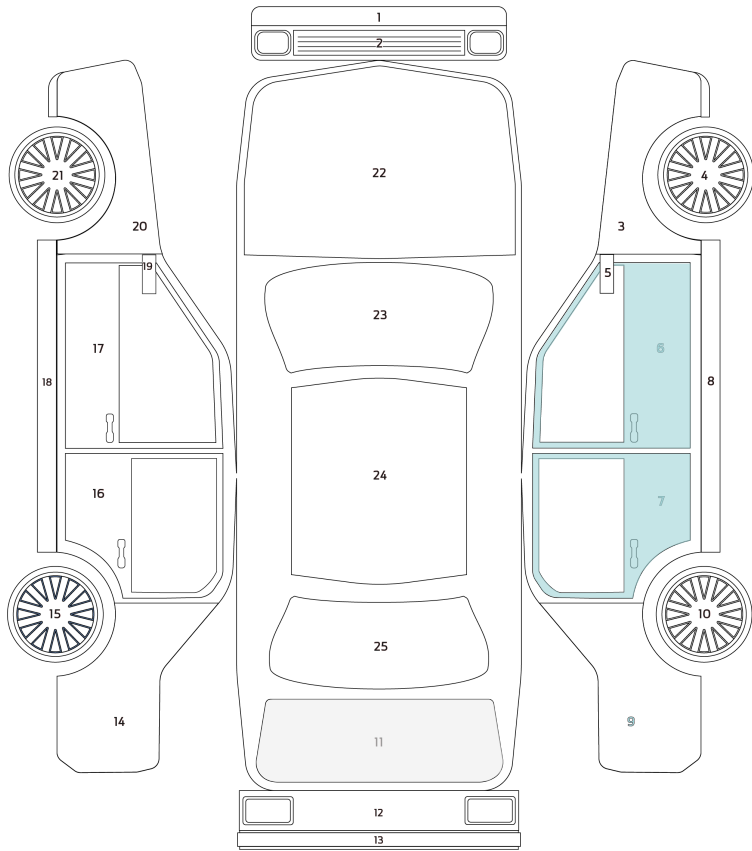
Exterior Inspection Points

1. Front Skirt	O	14. Left Skirt	O
2. Front Bumper	O	15. Left Wing Mirror	O
3. Front Right Fender	O	16. Front Windshield	O
4. Front Right Wheel	O	17. Roof	O
5. Front Left Fender	O	18. Rear Right Fender	O
6. Front Left Wheel	O	19. Rear Bonnet	O (S1)
7. Front Bonnet	O	20. Back Right Wheel	O
8. Right Wing Mirror	O	21. Rear Bumper	O
9. Front right door	BP (S1)	22. Rear Skirt	O
10. Rear right door	BP	23. Rear Left Fender	O
11. Right Skirt	O	24. Back Left Wheel	O
12. Rear Left Door	O	25. Back Windshield	O
13. Front Left Door	O
