Preowned Vehicle Inspection Report

Premium Inspection Analysis

Customer Name	:	Inspection Date	:	2024-05-04
Tel.	:	Lemon Inspection ID	:	LEMON24050018
Inspector	:	Approved By	:	sakulpong singnarong

Brand	MERCEDES BENZ	Model year	2018
Model	E350E	Engine Code - No.	27492031441971
Sub-model	AMG DYNAMIC	Registration year	2020-02-24
Registration No.		Chassis No.	WDD2130506L016066
Current Mileage(km.)	87916	Engine Capacity(cc.)	2000

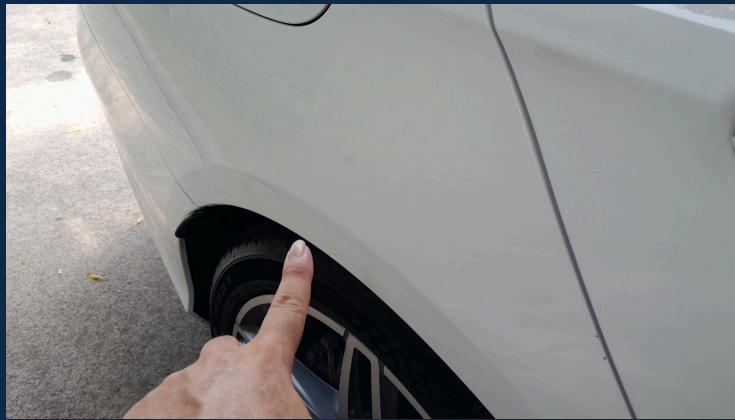
Vehicle Defect Notices

1. Front Skirt	O	14. Left Skirt	O
2. Front Bumper	O	15. Left Wing Mirror	O
3. Front Right Fender	O	16. Front Windshield	O
4. Front Right Wheel	O	17. Roof	O
5. Front Left Fender	O	18. Rear right fender	O (S1)
6. Front Left Wheel	O	19. Rear Bonnet	O
7. Front Bonnet	O	20. Back Right Wheel	O
8. Right Wing Mirror	O	21. Rear Bumper	O
9. Front Right Door	O	22. Rear Skirt	O
10. Rear Right Door	O	23. Rear Left Fender	O
11. Right Skirt	O	24. Back Left Wheel	O
12. Rear Left Door	O	25. Back Windshield	O
13. Front Left Door	O

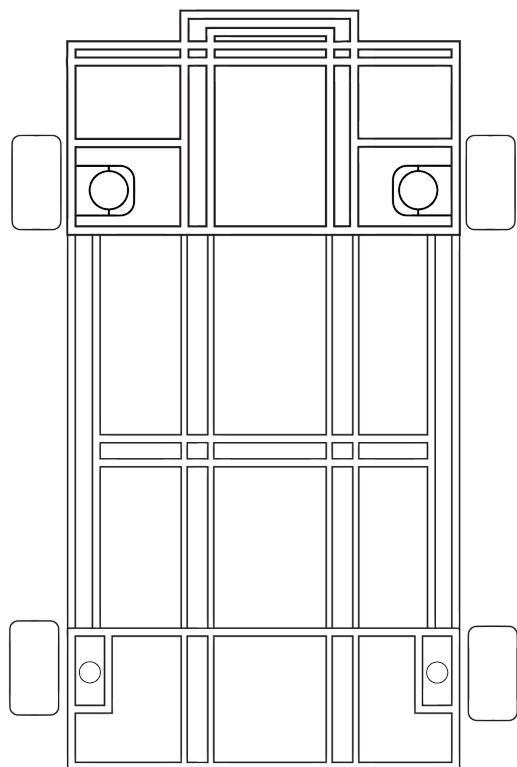
Chassis Report

No dent in the under carriage (th)	PASS
No deform chassis or chassis frame (th)	PASS
No visible corrosion on the chassis or chassis frame (th)	PASS
No missing part on the chassis frame (th)	PASS
Half cut Analysis (th)	PASS
Chassis Damage Level	No Damage
