Preowned Vehicle Inspection Report

Premium Inspection Analysis

| Brand | MERCEDES BENZ | Model year | 2022 |
| Model | A200 | Engine Code - No. | 28291430608842 |

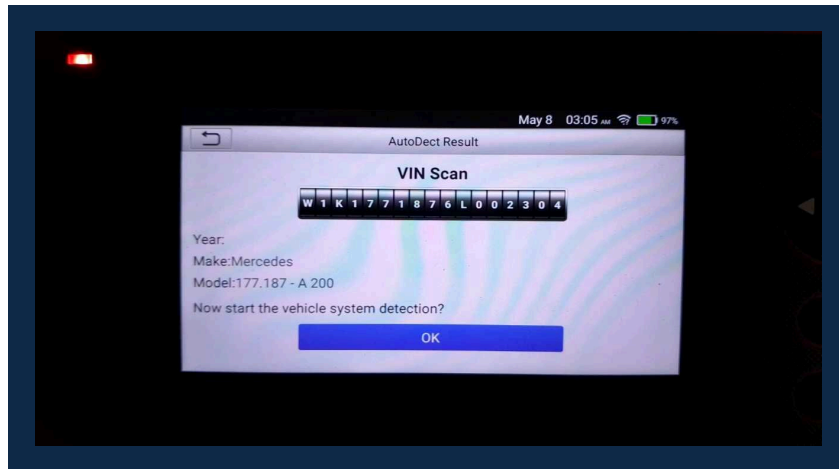
OBD Vehicle Health Analysis

เครื่องยนต์(Engine) : เครื่องยนต์ทำงานปกติ ,วิเคราะห์ปัญหาด้วยเครื่อง OBDII ไม่พบสิ่งผิดปกติ (ไม่ได้ทดสอบขับขี่)

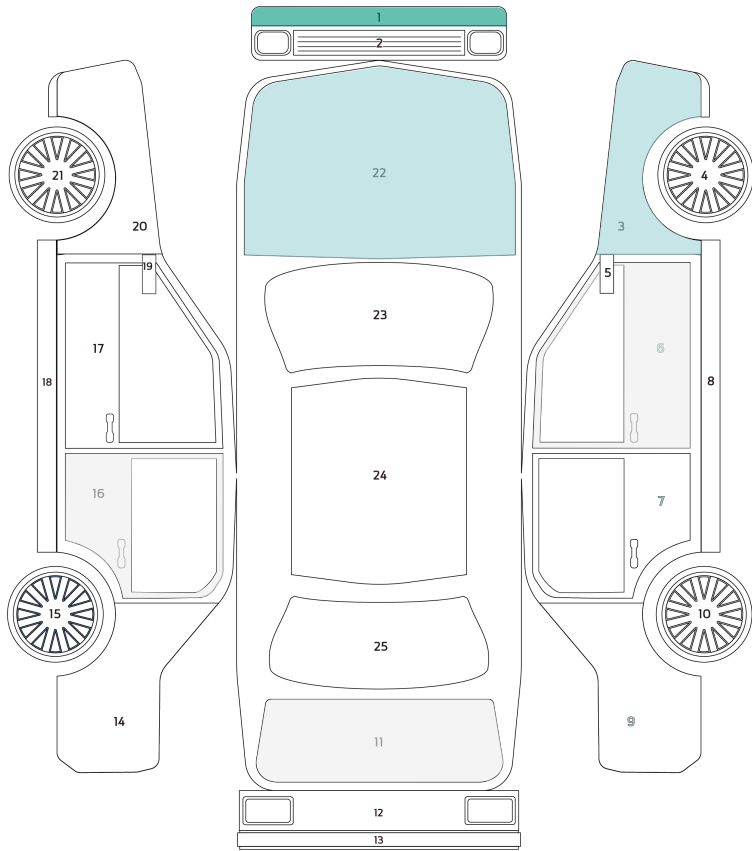
Exterior Inspection Points

| 1. Front Skirt | N | 14. Left Skirt | O |
| 3. Front Right Fender | BP | 16. Front Windshield | O |
| 6. Front Left Wheel | O | 19. Rear Bonnet | O (S1) |
| 7. Front bonnet | BP | 20. Back Right Wheel | O |
| 9. Front right door | O (S1) | 22. Rear Skirt | O |
| 12. Rear Left door | O (S1) | 25. Back Windshield | O |

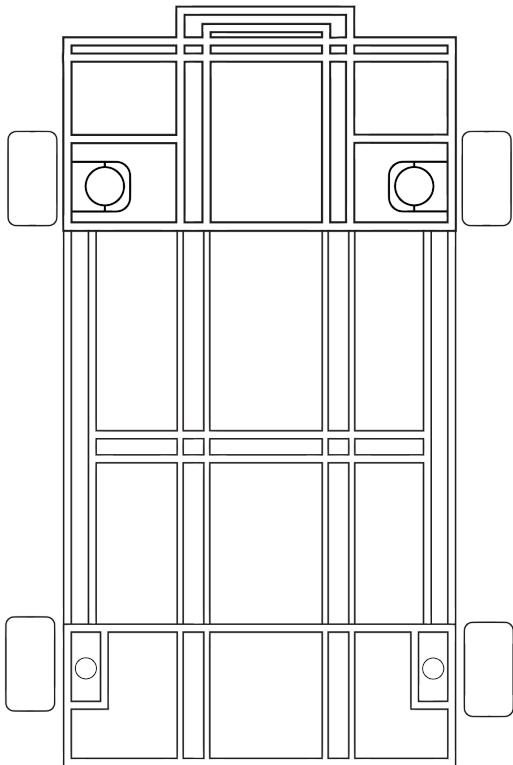
Chassis Report

| No dent in the under carriage (th) | PASS |
| No deform chassis or chassis frame (th) | PASS |
| No visible corrosion on the chassis or chassis frame (th) | PASS |
| No missing part on the chassis frame (th) | PASS |
| Half cut Analysis (th) | PASS |

| Chassis Damage Level | No Damage |

โครงสร้าง(Frame) : ตรวจสอบไม่พบอุบัติเหตุถึงโครงสร้าง ,โครงสร้างหลักปกติ ไม่มีการซ่อมแซมโครงสร้าง

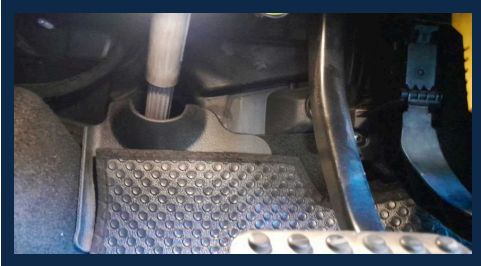
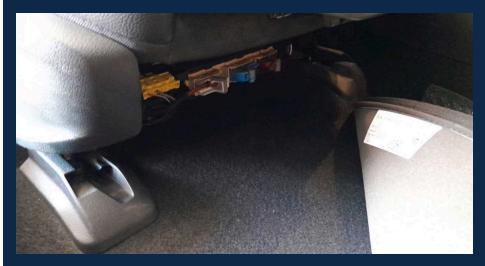
Flood Report

| Evidence of Flood | No |

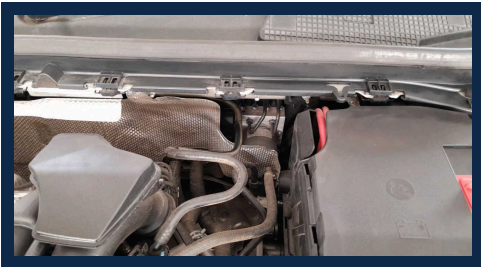
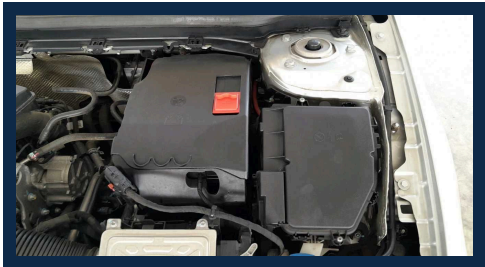
Fire Report

| Evidence of Fire | No |
