Preowned Vehicle Inspection Report

Premium Inspection Analysis

Customer Name	: MERCEDES-BENZ MOBILITY (THAILAND) CO., LTD.	Inspection Date	: 2024-05-15
Tel.	:	Lemon Inspection ID	: LEMON24050129
Inspector	: tanruk tipin	Approved By	: sakulpong singnarong

Brand	MERCEDES BENZ	Model year	2022
Model	C43	Engine Code - No.	27682331148055
Sub-model	AMG 4MATIC Coupe Special EDITION	Registration year	2022-12-28
Registration No.		Chassis No.	W1K2053646L066198
Current Mileage(km.)	15462	Engine Capacity(cc.)	2996

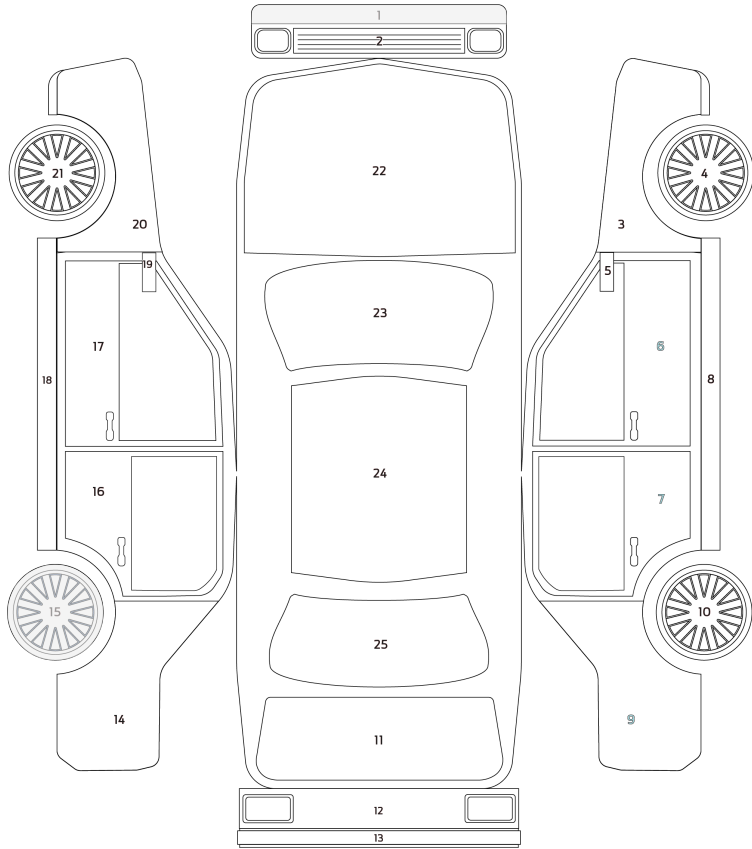
Exterior Inspection Points

1. Front Skirt	O (S1)	14. Left Skirt	O
2. Front Bumper	O	15. Left Wing Mirror	O
3. Front Right Fender	O	16. Front Windshield	O
4. Front Right Wheel	O	17. Roof	O
5. Front Left Fender	O	18. Rear Right Fender	O
6. Front Left Wheel	O	19. Rear Bonnet	O
7. Front Bonnet	O	20. Back Right Wheel	O
8. Right Wing Mirror	O	21. Rear Bumper	O
9. Front Right Door	O	22. Rear Skirt	O
10. Rear Right Door	O	23. Rear Left Fender	O
11. Right Skirt	O	24. Back left wheel	O (S1)
12. Rear Left Door	O	25. Back Windshield	O
13. Front Left Door	O

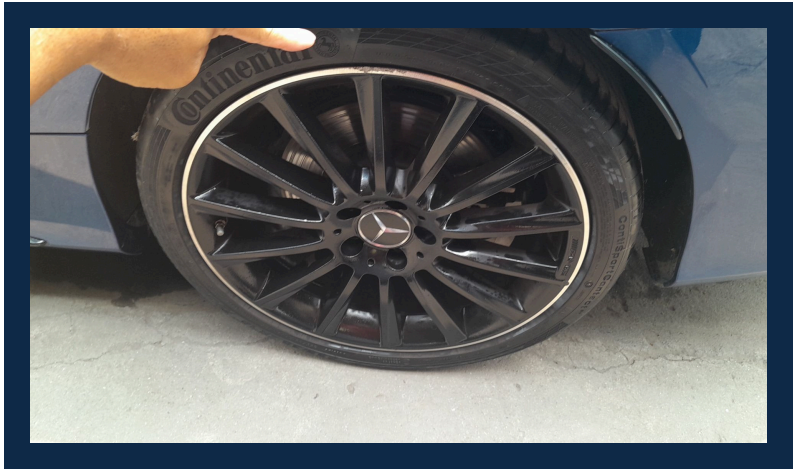
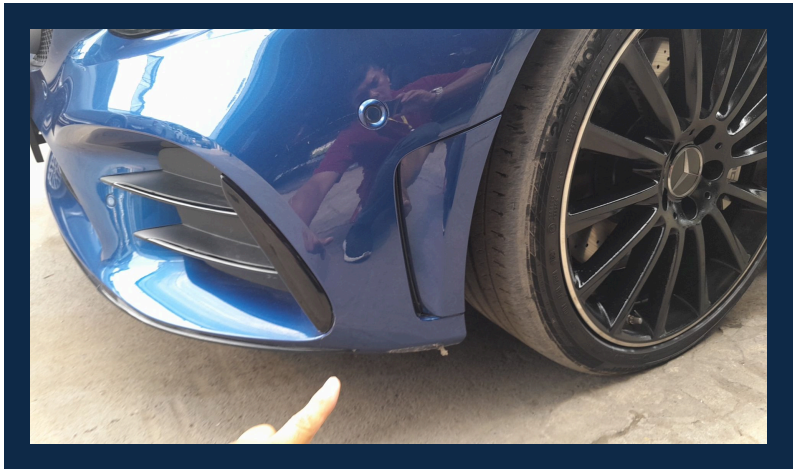
Vehicle Defect Notices

Inspector : ภายนอก(Exterior) : สภาพภายนอกโดยรวมไม่พบหลักฐานการซ่อมแซมทำสี / กั้นชนหน้าเป็นรอยถลอก / สภาพยางทั้ง4เส้น เสื่อมสภาพ รถสวย พร้อมใช้งาน ภายใน(Interior) : ภายในปกติ สะอาดเรียบร้อย ,อุปกรณ์ไฟฟ้า แอร์ วิทยุFM ใช้งานได้ปกติ เครื่องยนต์(Engine) : เครื่องยนต์ทำงานปกติ ,ไม่สามารถตรวจสอบเครื่อง OBDII ได้ รุ่นไม่รับรอง (ไม่ได้ทดสอบขับเคลื่อน) เลขเครื่องไม่สามารถตรวจสอบได้ โครงสร้าง(Frame) : ตรวจสอบไม่พบอุบัติเหตุ ,โครงสร้างหลักปกติ ไม่มีการซ่อมแซมโครงสร้าง

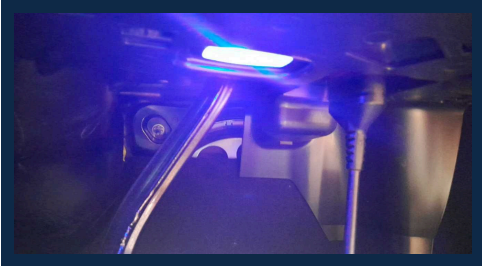
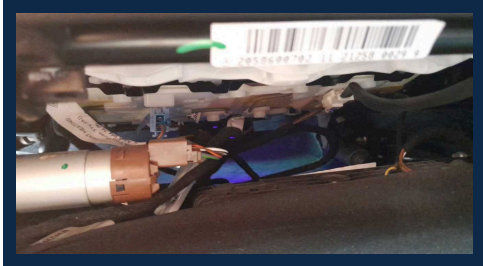
Flood Report

Evidence of Flood	No
-------------------	----

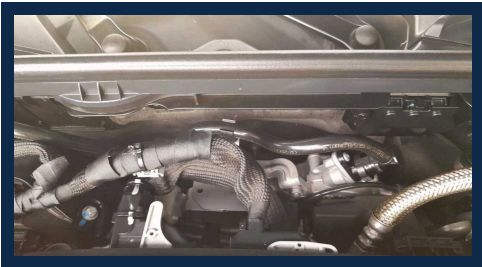
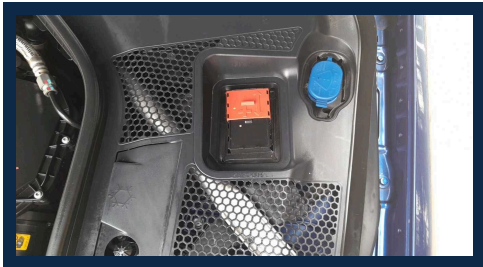
Fire Report

Evidence of Fire	No
------------------	----
