Preowned Vehicle Inspection Report

Premium Inspection Analysis

Customer Name	: MERCEDES-BENZ MOBILITY (THAILAND) CO., LTD.	Inspection Date	: 2024-05-15
Tel.	:	Lemon Inspection ID	: LEMON24050126
Inspector	: tanruk tipin	Approved By	: sakulpong singnarong

Brand	MERCEDES BENZ	Model year	2018
Model	CLA200	Engine Code - No.	27091031694728
Sub-model	URBAN FACELIFT	Registration year	2019-11-15
Registration No.		Chassis No.	WDD1173436L010520
Current Mileage(km.)	88970	Engine Capacity(cc.)	1595

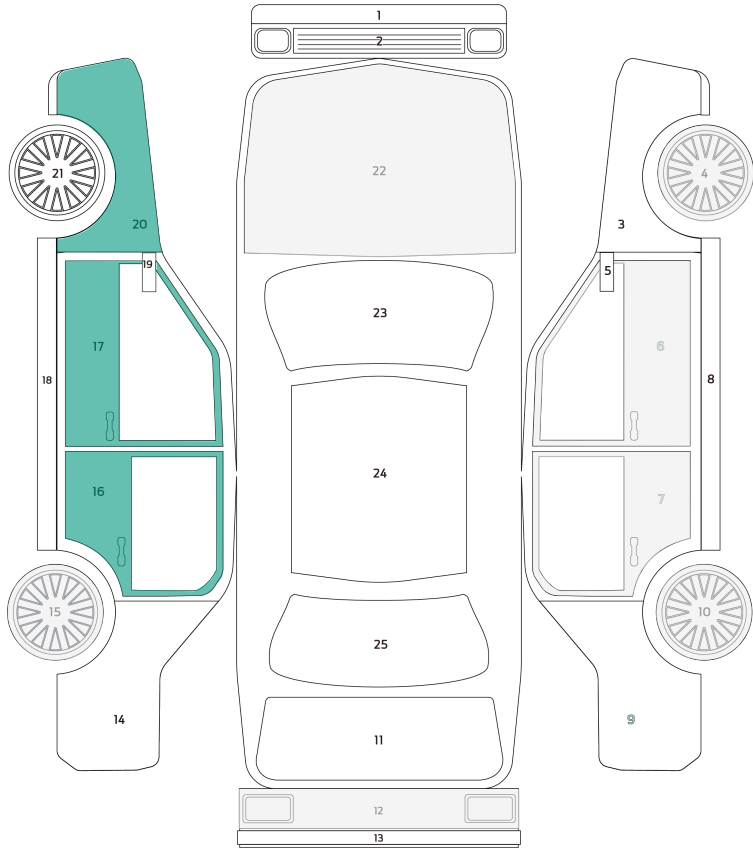
Exterior Inspection Points

1. Front Skirt	O	14. Left Skirt	O
2. Front Bumper	O	15. Left Wing Mirror	O
3. Front Right Fender	O	16. Front Windshield	O
4. Front Right Wheel	O (S1)	17. Roof	O
5. Front Left Fender	N	18. Rear Right Fender	O
6. Front Left Wheel	O	19. Rear Bonnet	O
7. Front bonnet	O (S1)	20. Back right wheel	O (S1)
8. Right Wing Mirror	O	21. Rear Bumper	O (S1)
9. Front right door	O (S1)	22. Rear Skirt	O
10. Rear right door	O (S1)	23. Rear Left Fender	O
11. Right Skirt	O	24. Back left wheel	O (S1)
12. Rear Left door	N (S1)	25. Back Windshield	O
13. Front left door	N (S1)

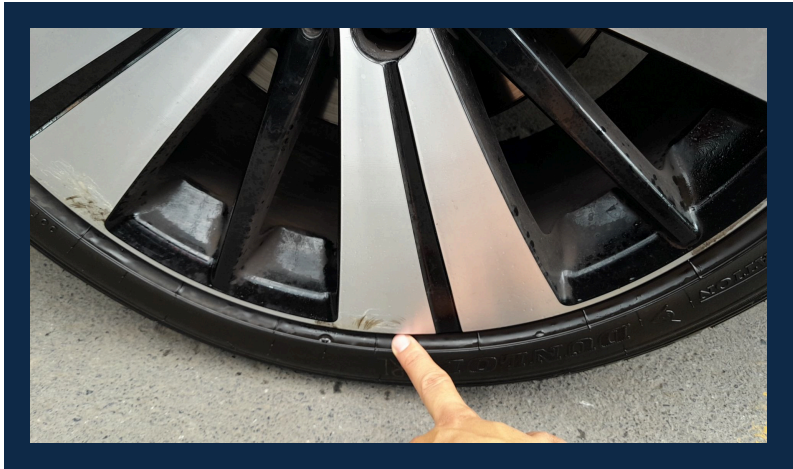
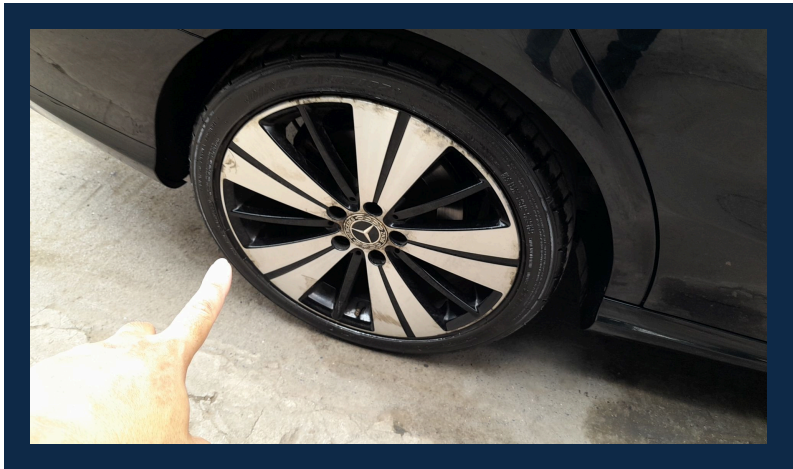
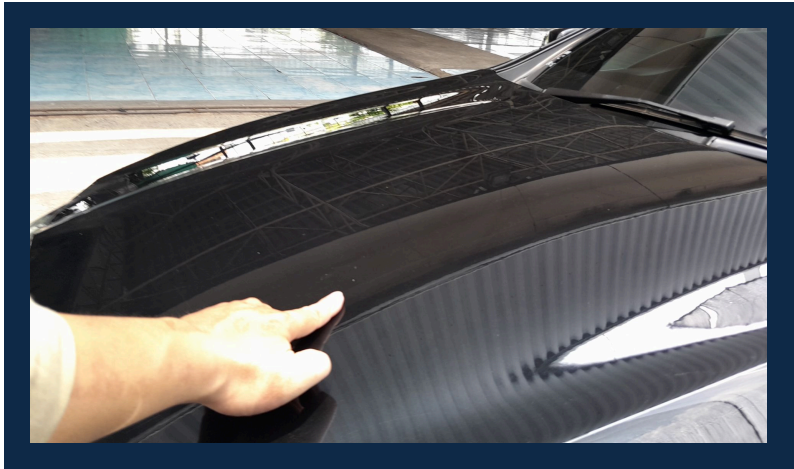
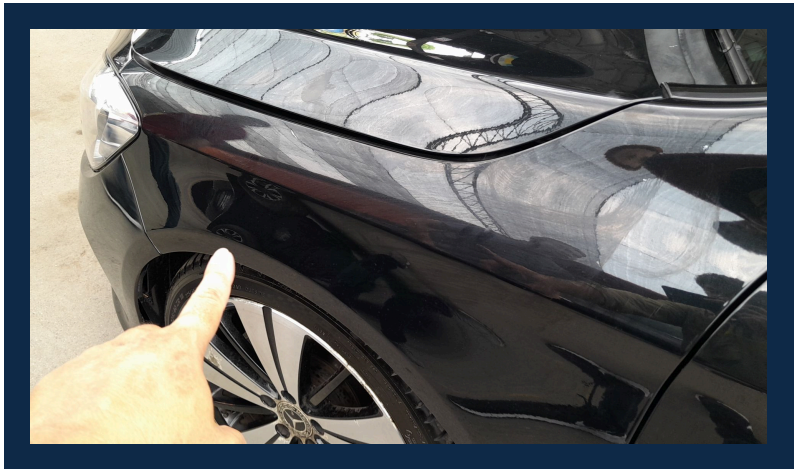
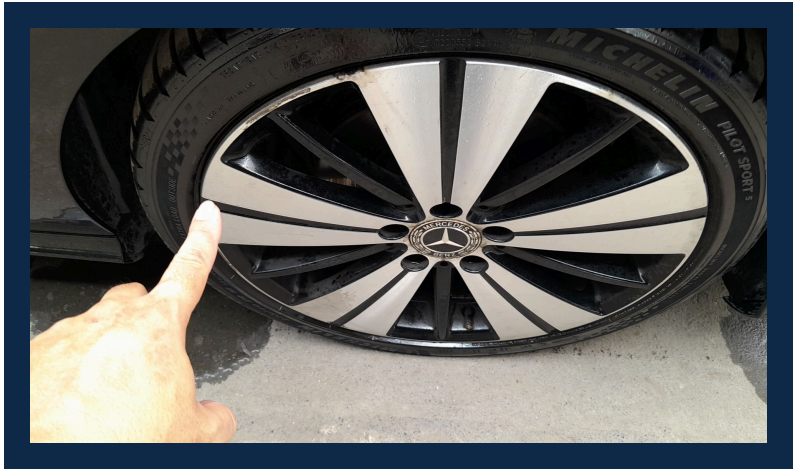
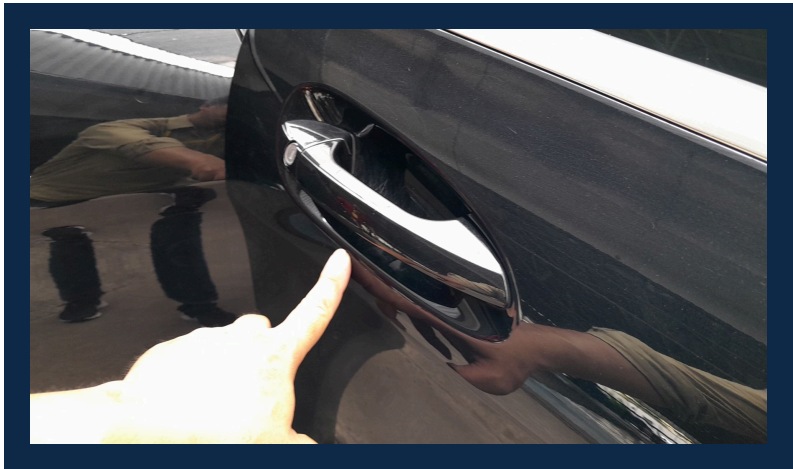
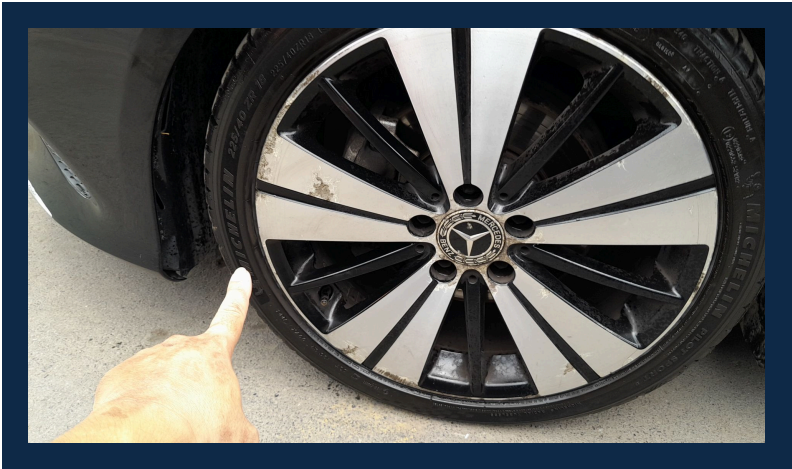
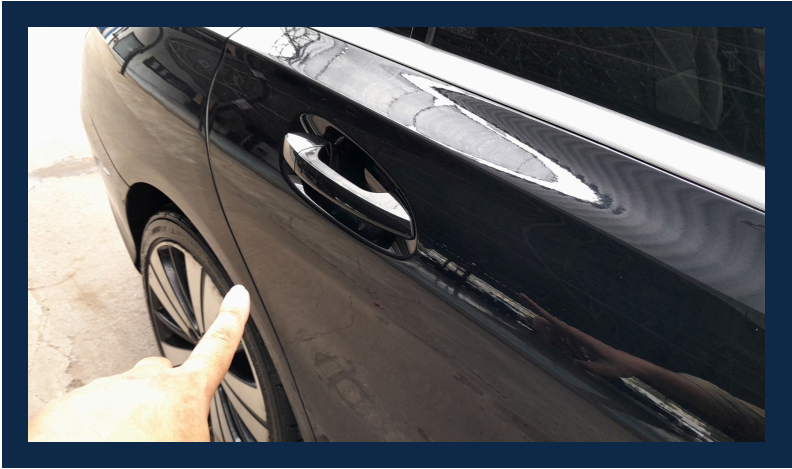
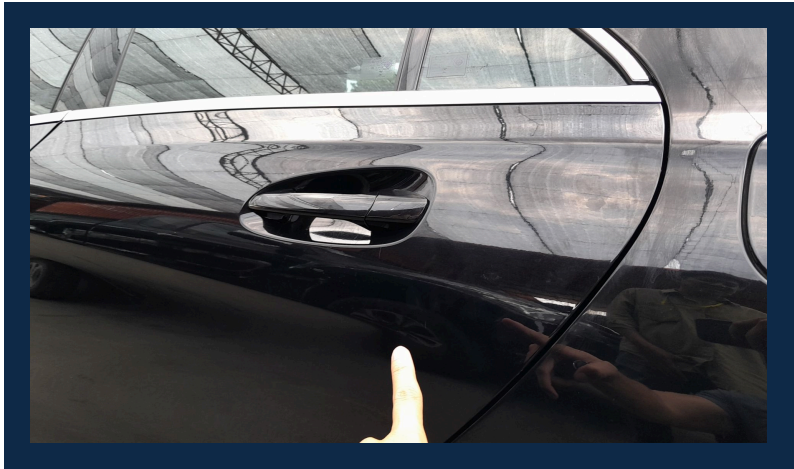
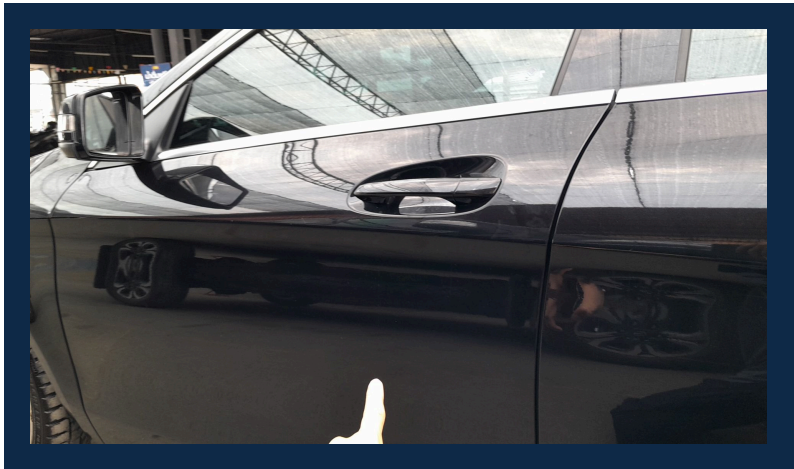
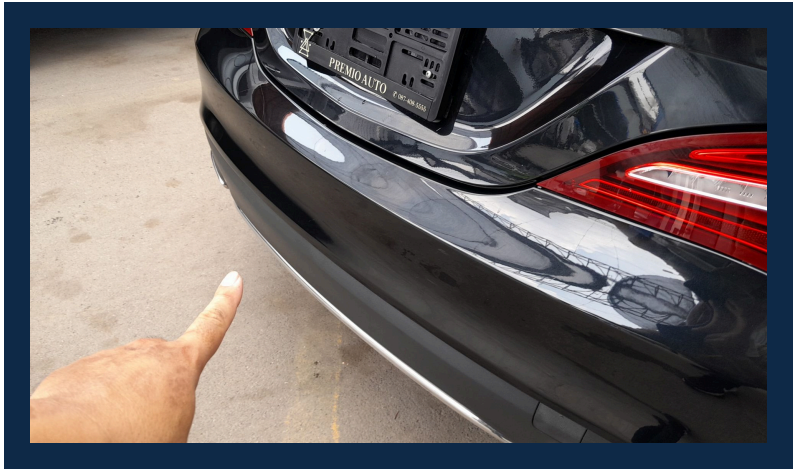
Vehicle Defect Notices

Inspector : ภายนอก(Exterior) : สภาพภายนอกโดยรวม พบหลักฐานการซ่อมแซมสีรอบคัน ฝากระโปรงหน้ามีรอยสะเก็ดหิน / สภาพยางปกติทั้ง 4เส้น ปี 23 / แก้มหน้าซ้ายเปลี่ยนชิ้น ประตูหน้าหลังฝั่งซ้ายเปลี่ยนชิ้น / ล้อแม็กมีรอยถลอกทั้ง 4ล้อ รถสวย สภาพพร้อมใช้งาน ภายใน(Interior) : ภายในเบาะหน้าขวา มีรอยขาด พลาสติกกระจกประตูหลังซ้ายเป็นรอย ภายในสะอาดเรียบร้อย , อุปกรณ์ไฟฟ้า แอร์ วิทยุFM ใช้งานได้ปกติ เครื่องยนต์(Engine) : เครื่องยนต์ทำงานปกติ , วิเคราะห์ปัญหาด้วยเครื่อง OBDII ไม่พบสิ่งผิดปกติ (ไม่ได้ทดสอบขับขี) โครงสร้าง(Frame) : ไม่พบอุบัติเหตุการชนเข้าโครงสร้าง , โครงสร้างหลักปกติ ไม่มีการซ่อมแซมโครงสร้าง
