# Preowned Vehicle Inspection Report

Customer Name	: MERCEDES-BENZ MOBILITY (THAILAND) CO., LTD.	Inspection Date	: 2024-05-22
Tel.	:	Lemon Inspection ID	: LEMON24050214
Inspector	: tanruk tipin	Approved By	: sakulpong singnarong

Brand	MERCEDES BENZ	Model year	2021
Model	E350E	Engine Code - No.	27492031956187
Sub-model	AMG DYNAMIC	Registration year	2021-04-05
Registration No.		Chassis No.	W1K2130536L035090
Current Mileage(km.)	38895	Engine Capacity(cc.)	2000

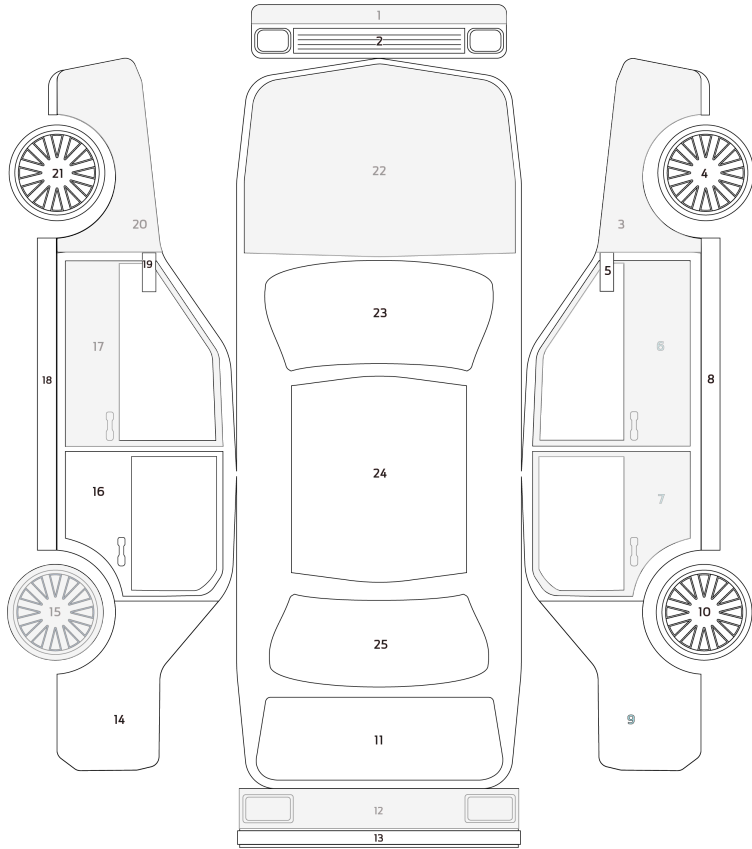
**Exterior Inspection Points**

1. Front Skirt	O (S1)	14. Left Skirt	O
2. Front Bumper	O	15. Left Wing Mirror	O
3. Front Right Fender	O (S1)	16. Front Windshield	O
4. Front Right Wheel	O	17. Roof	O
5. Front Left Fender	O (S1)	18. Rear Right Fender	O
6. Front Left Wheel	O	19. Rear Bonnet	O
7. Front bonnet	O (S1)	20. Back Right Wheel	O
8. Right Wing Mirror	O	21. Rear Bumper	O (S1)
9. Front right door	O (S1)	22. Rear Skirt	O
10. Rear right door	O (D1)	23. Rear Left Fender	O
11. Right Skirt	O	24. Back left wheel	O (S1)
12. Rear Left Door	O	25. Back Windshield	O
13. Front left door	O (S1)

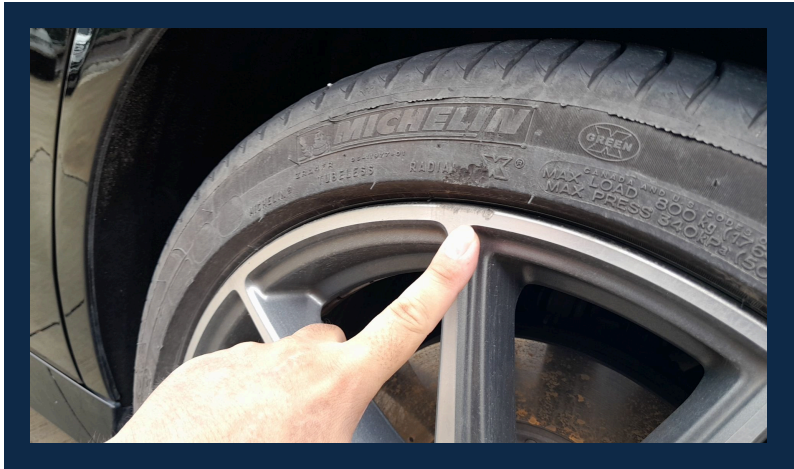
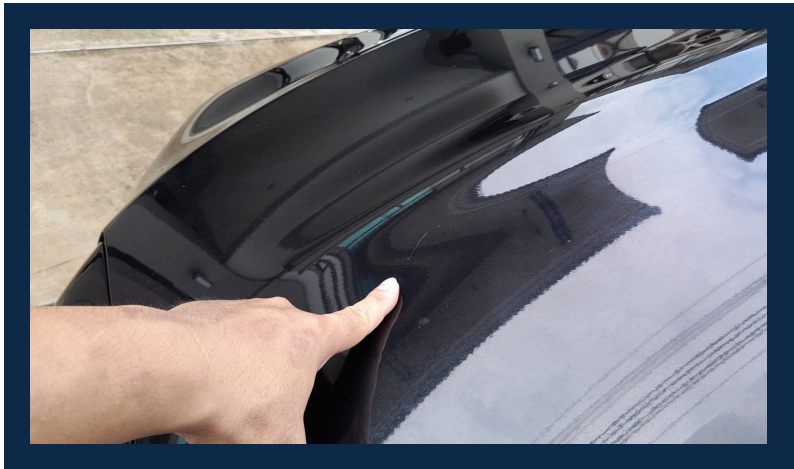
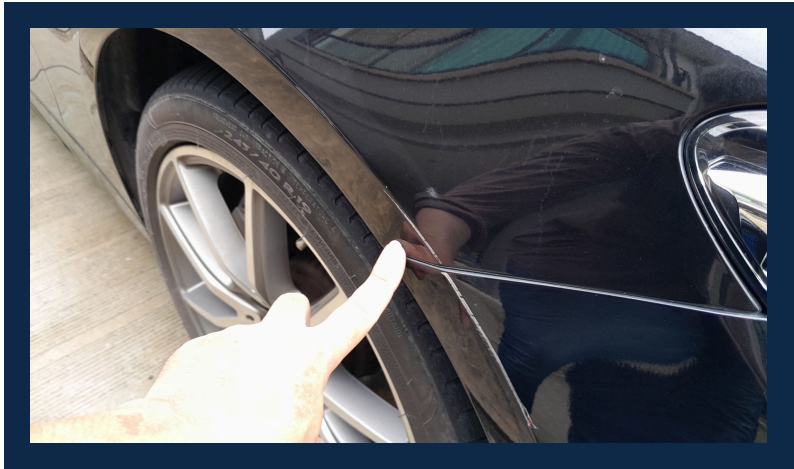
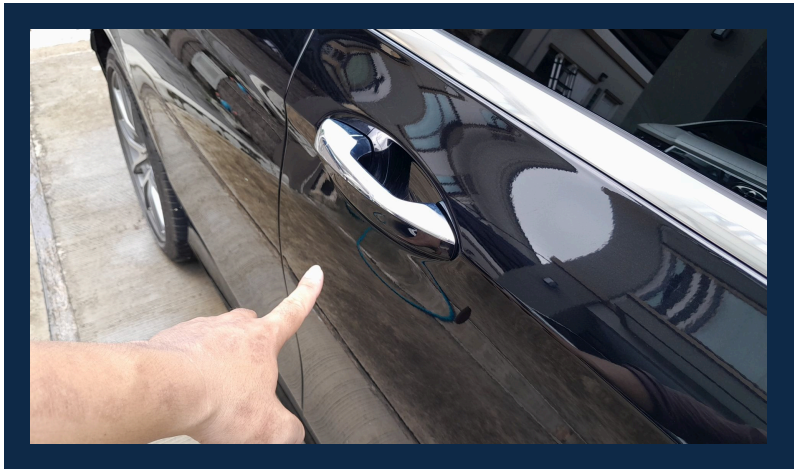
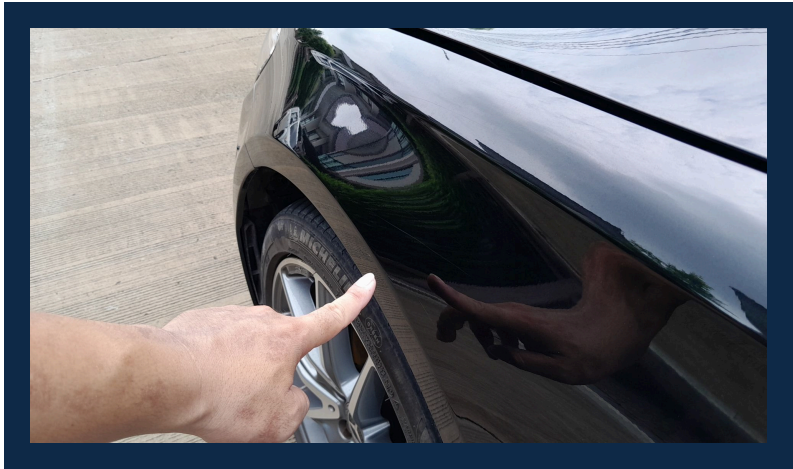
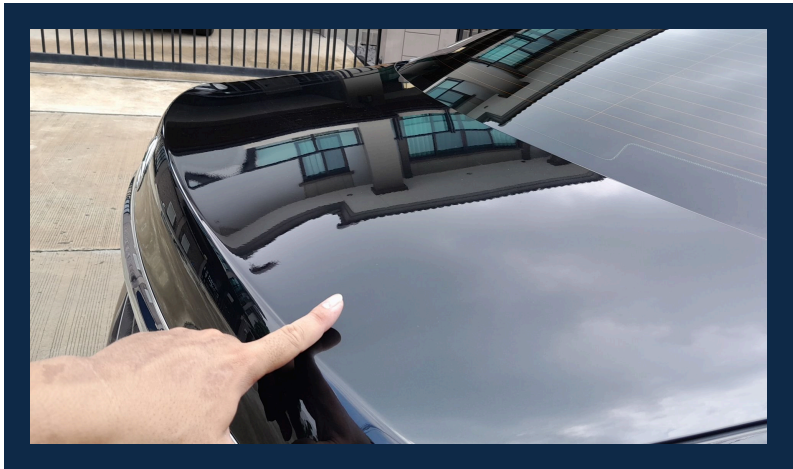
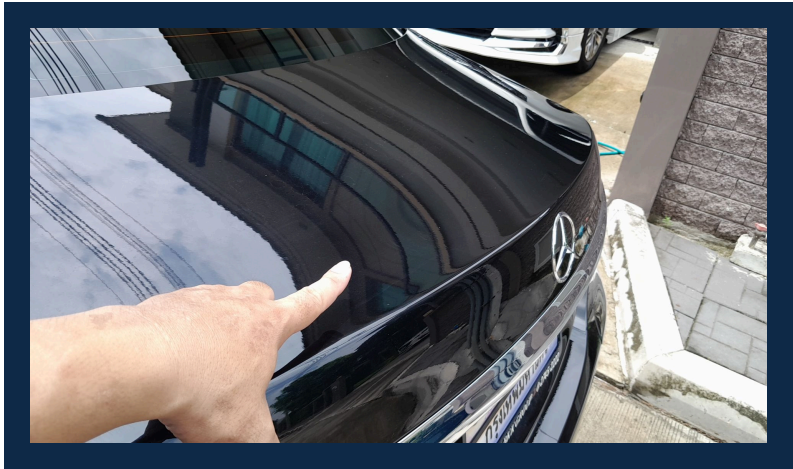
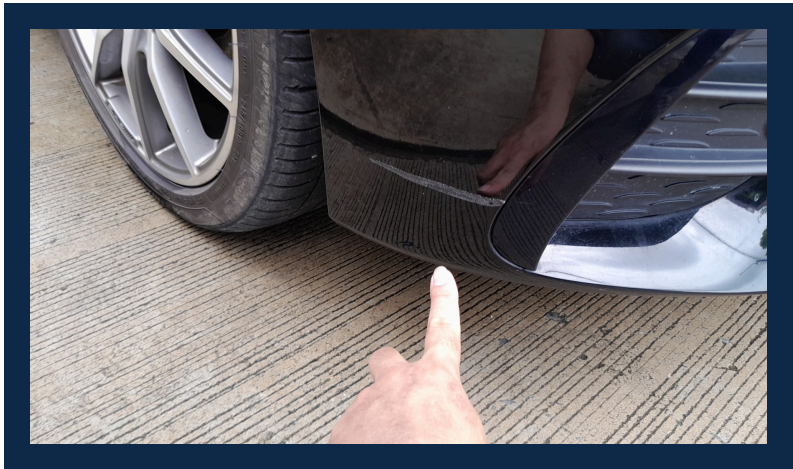
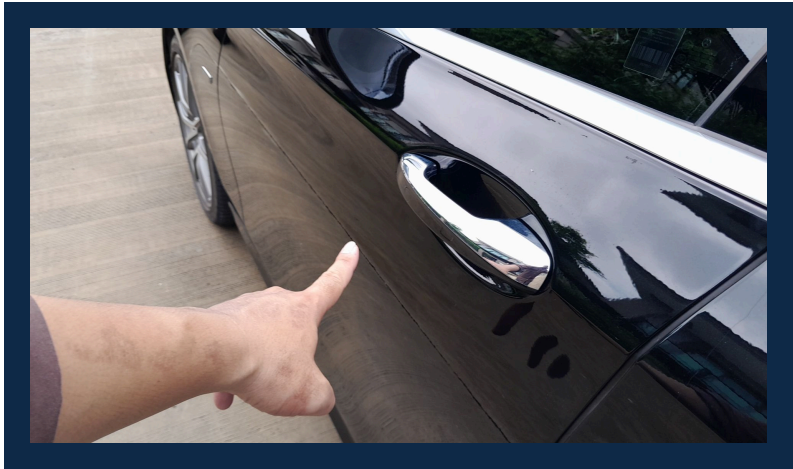
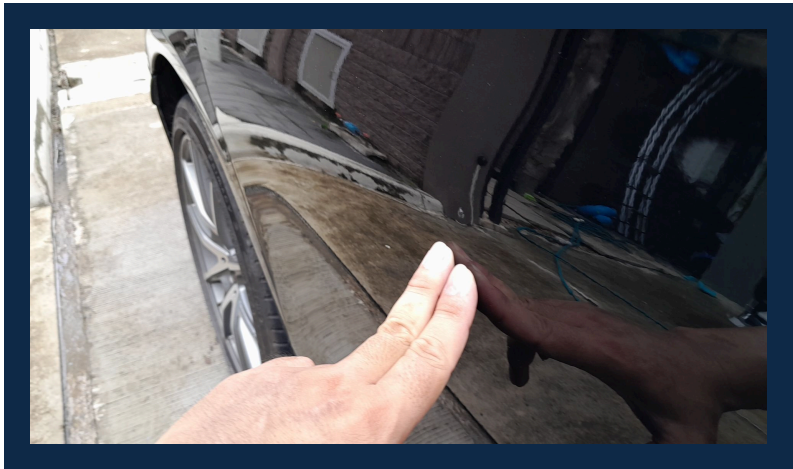
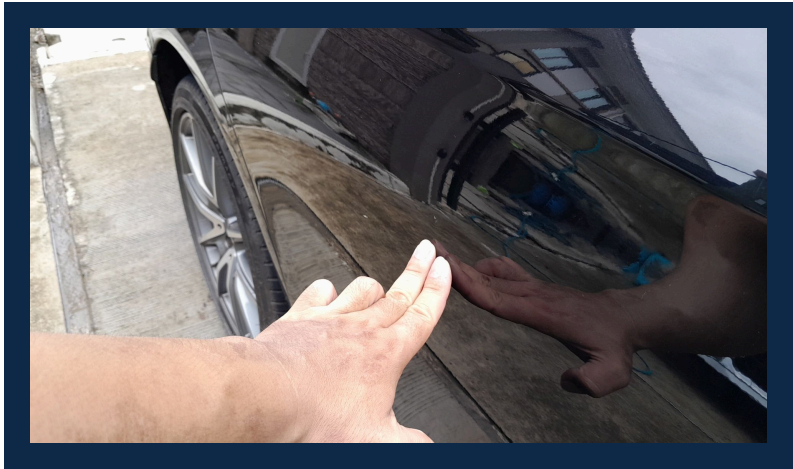
**Vehicle Defect Notices**

**Inspector :** # MERCEDES BENZ E300e AMG DYNAMIC ภายนอก(Exterior) : สภาพภายนอกพหุหลักฐานการซ่อมแซมสีฝากระโปรงหลัง / โดยรวมรถมีรอยขีดข่วนเล็กน้อย / ยางเสื่อมสภาพทั้ง 4เส้น ภายใน(Interior) : สภาพภายในปกติ สะอาดเรียบร้อย , อุปกรณ์ไฟฟ้า แอร์ วิทยุ ใช้งานได้ปกติ เครื่องยนต์(Engine) : เครื่องยนต์ทำงานปกติ , วิเคราะห์ปัญหาด้วยเครื่อง OBDII พบโค้ดเซ็นเซอร์โซว แนะนำ Learning ระบบใหม่กับทางศูนย์บริการ (ไม่ได้ทดสอบขับขี) โครงสร้าง(Frame) : ตรวจสอบไม่พบอุบัติเหตุ , โครงสร้างหลักปกติ ไม่มีการซ่อมแซมโครงสร้าง

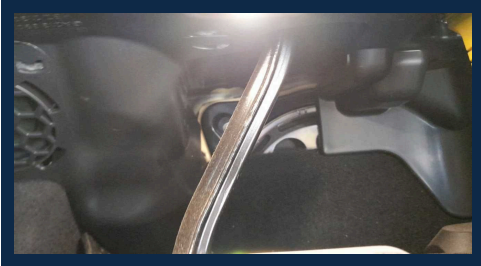
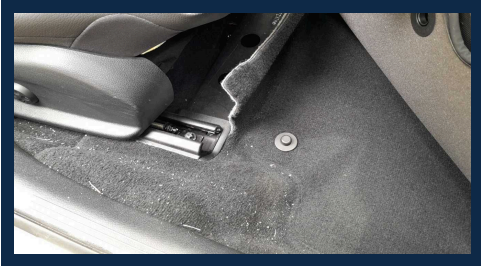
**Flood Report**

Evidence of Flood	No
-------------------	----

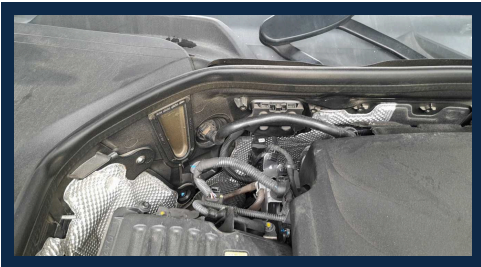
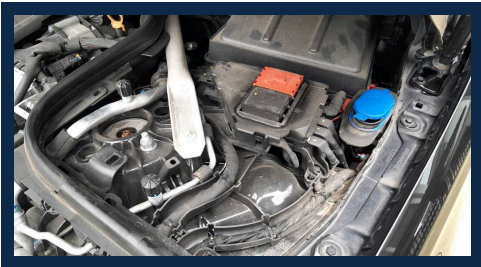
**Fire Report**

Evidence of Fire	No
------------------	----
