# Preowned Vehicle Inspection Report

Premium Inspection Analysis

Customer Name	: MERCEDES-BENZ MOBILITY (THAILAND) CO., LTD.	Inspection Date	: 2024-05-24
Tel.	:	Lemon Inspection ID	: LEMON24050237
Inspector	: suwat thongpim	Approved By	: tanruk tipin

Brand	MERCEDES BENZ	Model year	2020
Model	C300e	Engine Code - No.	27492031902311
Sub-model	Avantgarde	Registration year	2021-01-13
Registration No.		Chassis No.	W1K2050536L057331
Current Mileage(km.)	21264	Engine Capacity(cc.)	20000

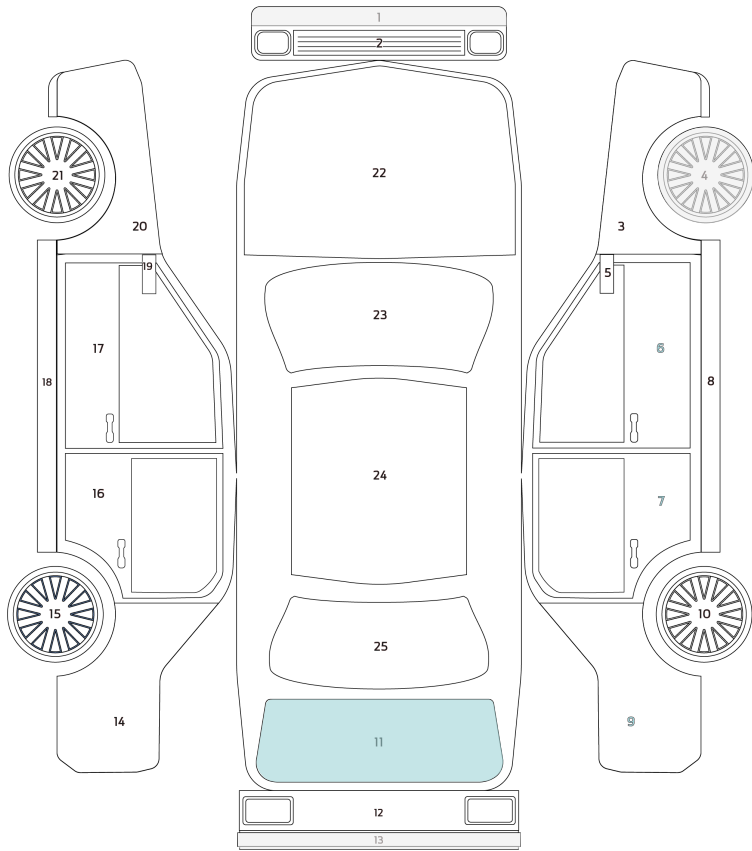
**Exterior Inspection Points**

1. Front Skirt	O (S1)	14. Left Skirt	O
2. Front Bumper	O	15. Left Wing Mirror	O
3. Front Right Fender	O	16. Front Windshield	O
4. Front Right Wheel	O (S1)	17. Roof	O
5. Front Left Fender	O	18. Rear Right Fender	O
6. Front Left Wheel	O	19. Rear Bonnet	BP
7. Front Bonnet	O	20. Back Right Wheel	O
8. Right Wing Mirror	O	21. Rear Bumper	O
9. Front Right Door	O	22. Rear skirt	O (S1)
10. Rear Right Door	O	23. Rear Left Fender	O
11. Right Skirt	O	24. Back Left Wheel	O
12. Rear Left Door	O	25. Back Windshield	O
13. Front Left Door	O

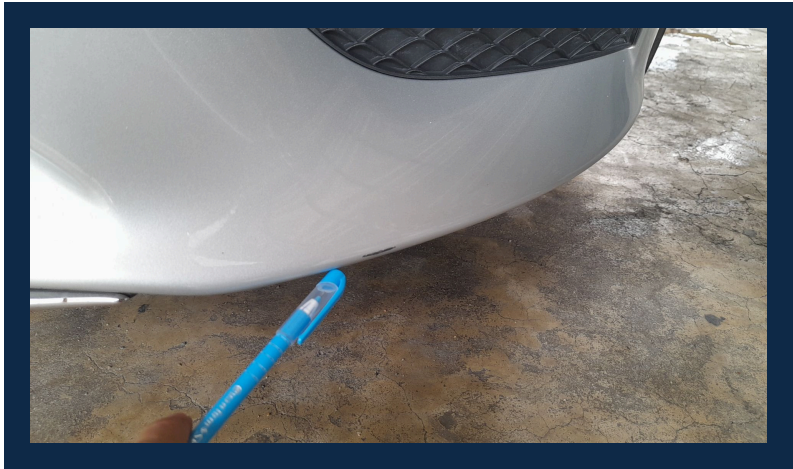
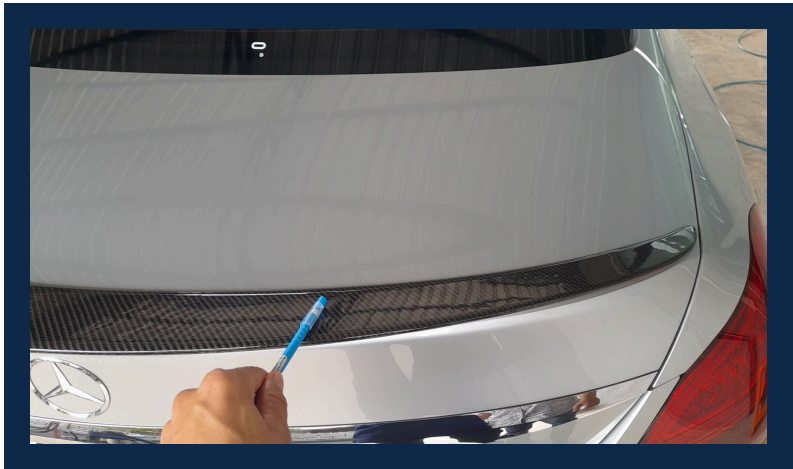
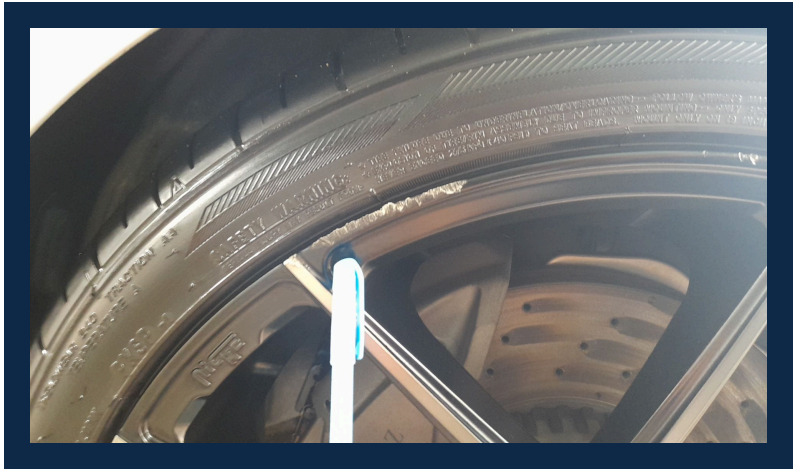
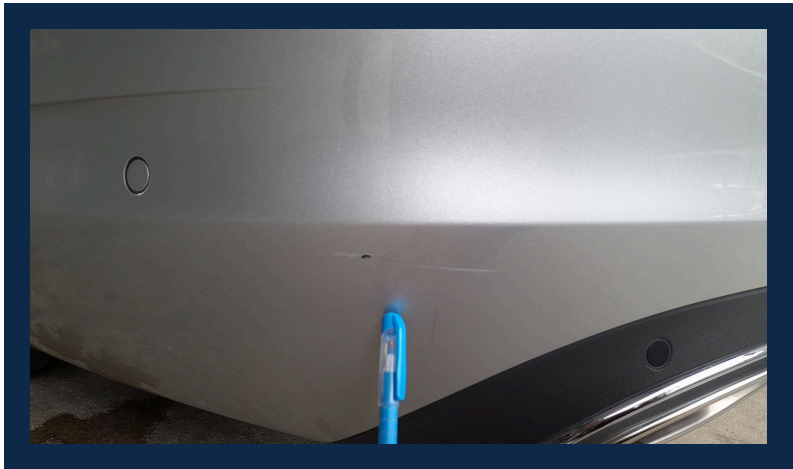
**Vehicle Defect Notices**

**Inspector :** \*\*Benz C300e Avantgarde ภายนอก(Exterior) : การตรวจสภาพภายนอกโดยรวมพบหลักฐานการซ่อมแซมทำสีฝากระโปรงท้าย / สภาพยางปกติทั้ง4เส้น ปี22 / กระจกหน้ามีรอยถลอก / กันชนหน้าหลังมีรอยถลอกเล็กน้อย / ล้อหน้าขวามีรอยครูดเล็กน้อย ภายใน(Interior) : ภายในปกติ สะอาดเรียบร้อย , อุปกรณ์ไฟฟ้า แอร์ วิทยุFM ใช้งานได้สมบูรณ์ครบปกติ เครื่องยนต์(Engine) : เครื่องยนต์ทำงานได้ปกติ , วิเคราะห์ปัญหาด้วยเครื่อง OBDII พบโค้ดสิ่งผิดปกติ P0610FF แนะนำเข้าเช็คศูนย์(ไม่ได้ทดสอบขับขี) โครงสร้าง(Frame) : อุบัติเหตุไม่มี , โครงสร้างหลักปกติ ไม่มีการซ่อมแซมโครงสร้างหรือมีการชนถึงโครงสร้าง

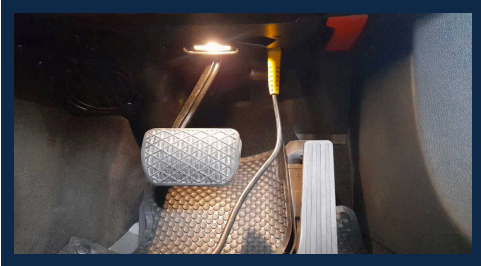
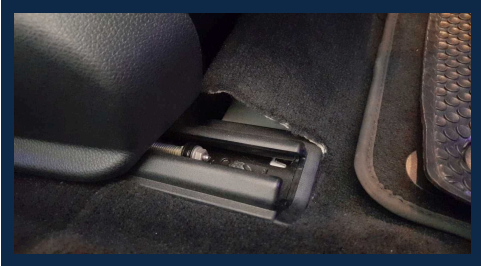
**Flood Report**

Evidence of Flood	No
-------------------	----

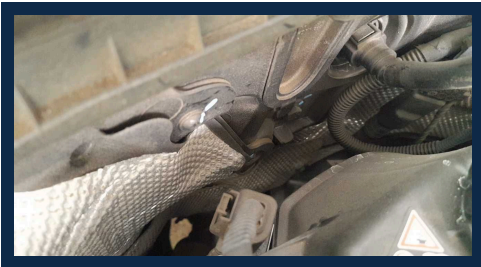
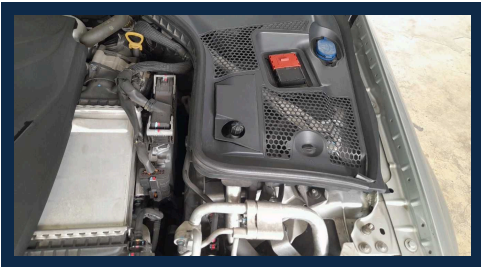
**Fire Report**

Evidence of Fire	No
------------------	----
