# Preowned Vehicle Inspection Report

Premium Inspection Analysis

Customer Name	: MERCEDES-BENZ MOBILITY (THAILAND) CO., LTD.	Inspection Date	: 2024-05-27
Tel.		Lemon Inspection ID	: LEMON24050273
Inspector	: suwat thongpim	Approved By	: tanruk tipin

Brand	MERCEDES BENZ	Model year	2019
Model	GLA250	Engine Code - No.	27092031823630
Sub-model	AMG DYNAMIC	Registration year	2019-12-18
Registration No.		Chassis No.	WDC1569446L012045
Current Mileage(km.)	109472	Engine Capacity(cc.)	1991

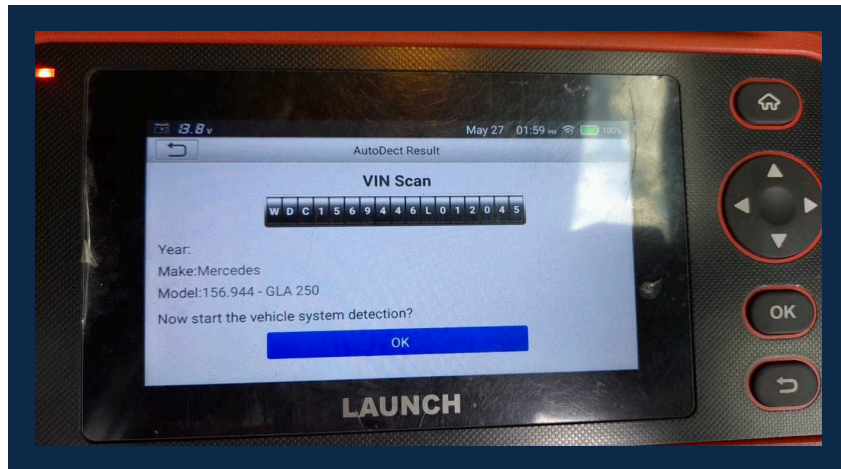
**OBD Vehicle Health Analysis**

**เครื่องยนต์(Electric) :** เครื่องยนต์ทำงานได้ปกติ , ยางแท่นเครื่องเสื่อมสภาพ หนูกันท่อกรองอากาศ , วิศวาระห์ปัญหาด้วยเครื่อง OBDII พบโค้ดผิดปกติ P13C523 แนะนำตรวจเช็คศูนย์บริการ (ไม่ได้ทดสอบขับเคลื่อน) โครงสร้าง(Frame) : อุบัติเหตุไม่มี , โครงสร้างหลักปกติ ไม่มีการซ่อมแซมโครงสร้างหรือมีการชนถึงโครงสร้าง

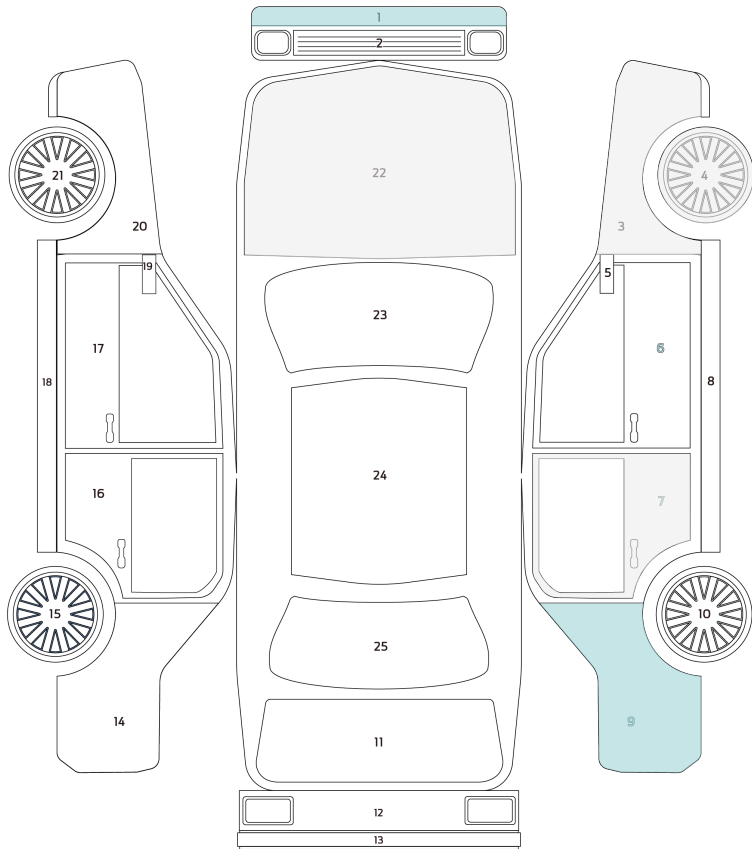
### Exterior Inspection Points

1. Front Skirt	BP	14. Left Skirt	O
2. Front Bumper	O	15. Left Wing Mirror	O
3. Front Right Fender	O (S1)	16. Front Windshield	O
4. Front Right Wheel	O (S1)	17. Roof	O
5. Front Left Fender	O	18. Rear right fender	BP (S1)
6. Front Left Wheel	O	19. Rear Bonnet	O
7. Front bonnet	O	20. Back Right Wheel	O
8. Right Wing Mirror	O	21. Rear Bumper	O
9. Front Right Door	O	22. Rear Skirt	O
10. Rear right door	O (S1)	23. Rear Left Fender	O
11. Right Skirt	O	24. Back Left Wheel	O
12. Rear Left Door	O	25. Back Windshield	O
13. Front Left Door	O

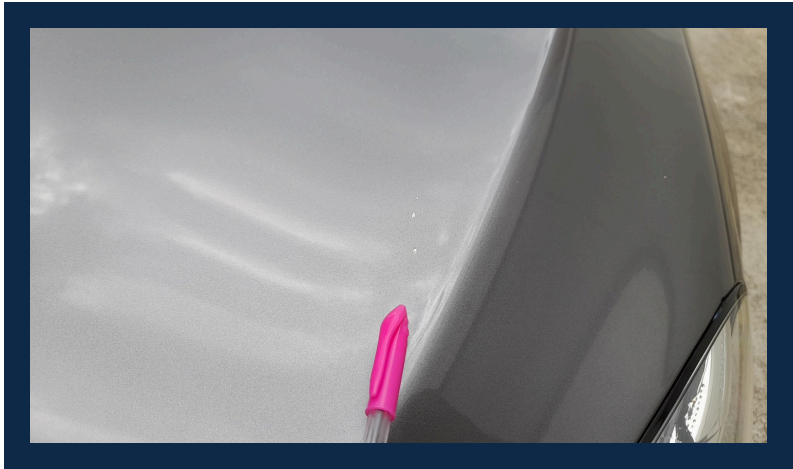
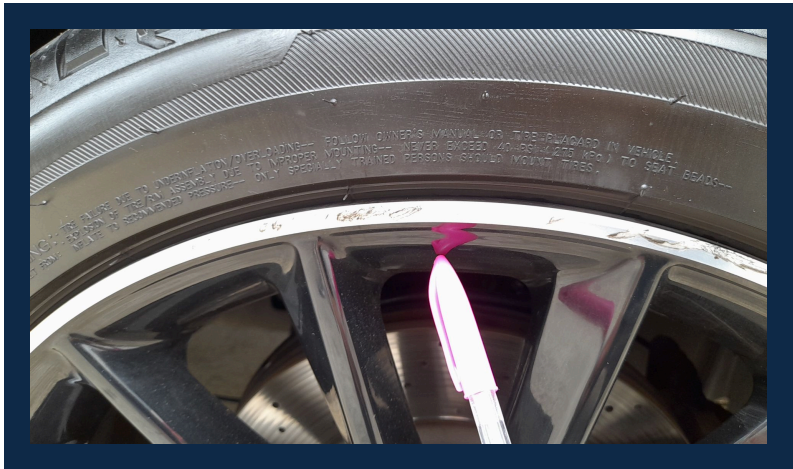
**Vehicle Defect Notices**

**Inspector :** หมายเอก\* ภายนอก(Exterior) : การตรวจสภาพภายนอกโดยรวมพบหลักฐานการซ่อมแซมทำสี กันชนหน้าทำสี ฝากระโปรงหลังซ่อมทำสี บังโคลนหลังขวาซ่อมทำสี ล้อแม็กหน้าหลังขวาครูดลอกเล็กน้อย ฝากระโปรงหน้ารอยสะเก็ดหินเล็กน้อย / สภาพยางปกติทั้ง4เส้น ปี23 ภายใน(Interior) : ปุ่มกดแผงประตูหน้าขวากับแผงสวิตช์เปิดปิดแอร์รอยถลอกพอง ภายในสะอาดเรียบร้อย , อุปกรณ์ไฟฟ้า แอร์ วิทยุFM ใช้งานได้สมบูรณ์ครบปกติ
