Preowned Vehicle Inspection Report

Premium Inspection Analysis

Brand	MERCEDES BENZ	Model year	2019
Model	GLA250	Engine Code - No.	27092031792034
Sub-model	AMG DYNAMIC	Registration year	2019-04-04
Registration No.		Chassis No.	WDC1569446L011351
Current Mileage(km.)	71818	Engine Capacity(cc.)	1991

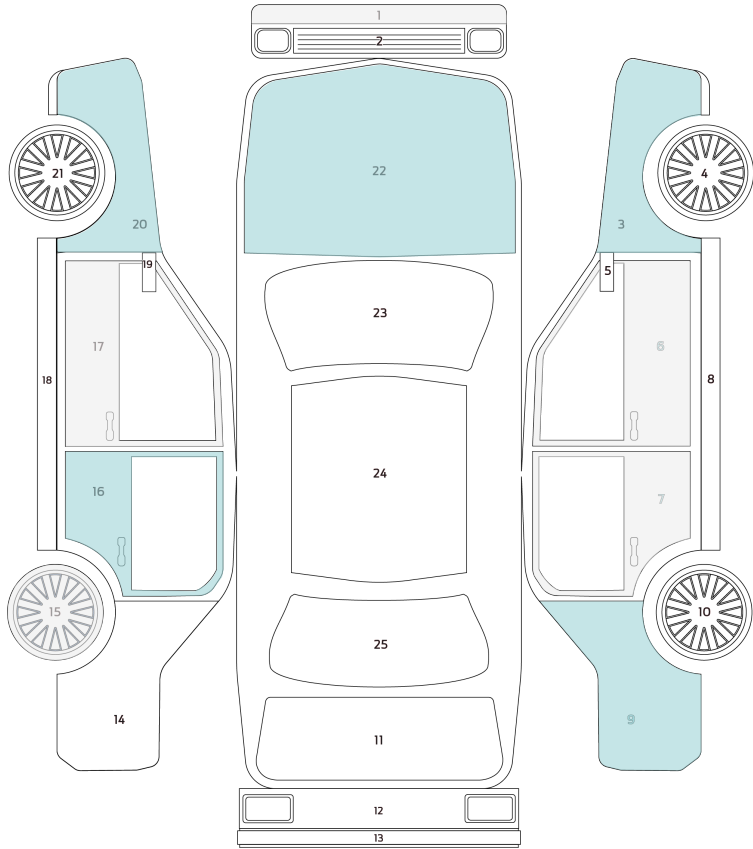
Exterior Inspection Points

1. Front Skirt	O (S1)	14. Left Skirt	O
2. Front Bumper	O	15. Left Wing Mirror	O
3. Front Right Fender	BP (D1)	16. Front Windshield	O
4. Front Right Wheel	O	17. Roof	O
5. Front Left Fender	BP (S1)	18. Rear right fender	BP (S2)
6. Front Left Wheel	O	19. Rear Bonnet	O
7. Front bonnet	BP (S1)	20. Back Right Wheel	O
8. Right Wing Mirror	O	21. Rear Bumper	O
9. Front right door	O (S1)	22. Rear Skirt	O
10. Rear right door	O (S1)	23. Rear Left Fender	O
11. Right Skirt	O	24. Back left wheel	O (S1)
12. Rear Left door	BP (S1)	25. Back Windshield	O
13. Front left door	O (S1)

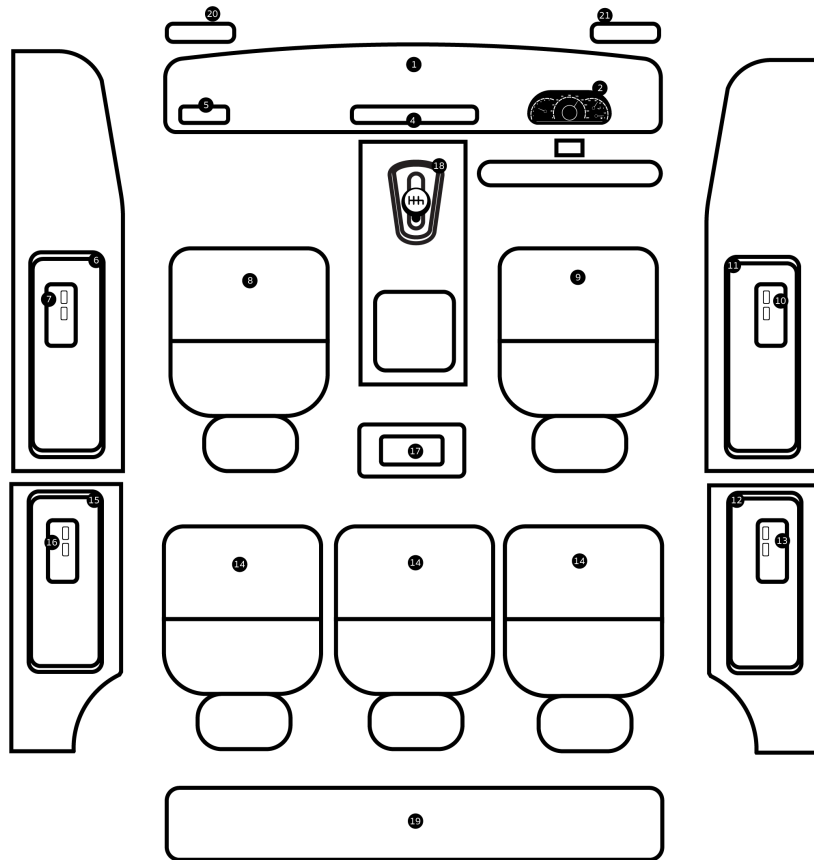
Interior Inspection Points

Inspector : ภายนอก(Exterior) : ภายนอกโดยรวม พบหลักฐานการซ่อมแซมสีมาบางชิ้น รถมีริ้วรอยกลอกรอบคัน / ยางเสื่อมสภาพทั้ง 4 เส้น ภายใน(Interior) : ภายในโดยรวม เบาะหน้าซ้ายมีคราบเปื้อนเล็กน้อย , ผ้าบุหลังคาคราบเปื้อนเล็กน้อย , อุปกรณ์ไฟฟ้า แอร์ วิทยุ ใช้งานได้ปกติ เครื่องยนต์(Engine) : เครื่องยนต์ทำงานปกติ , วิเคราะห์ปัญหาด้วยเครื่อง OBDII พบโศัด แรงดันแบตเตอรี่ต่ำ เนื่องจากแบตเตอรี่เสื่อมสภาพ (ไม่ได้ทดสอบขั้วขี้) โครงสร้าง(Frame) : ตรวจสอบไม่พบอุบัติเหตุ , โครงสร้างหลักปกติ ไม่มีการซ่อมแซมโครงสร้างหรือมีการชนถึงโครงสร้าง โดยรวม รถสวายน่าใช้ โครงสร้างเดิม

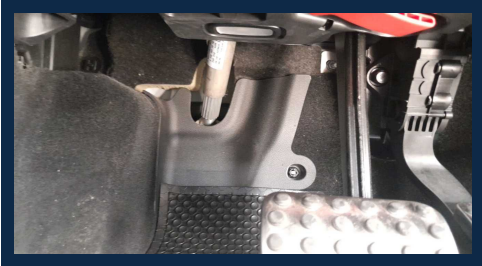
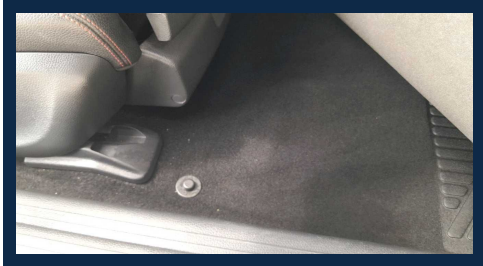
Flood Report

Evidence of Flood	No
-------------------	----

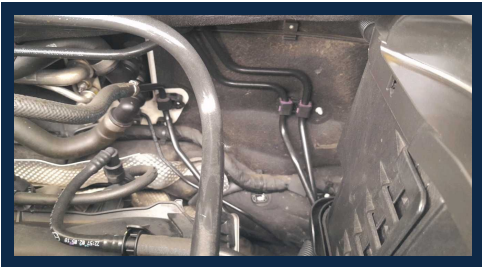
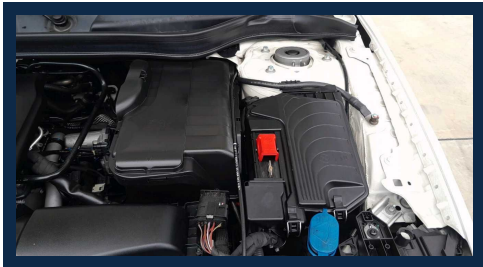
Fire Report

Evidence of Fire	No
------------------	----
