Preowned Vehicle Inspection Report

Premium Inspection Analysis

Customer Name	: MERCEDES-BENZ MOBILITY (THAILAND) CO., LTD.	Inspection Date	: 2024-05-28
Tel.	:	Lemon Inspection ID	: LEMON24050279
Inspector	: Natthapong Tong Suksing	Approved By	: Sakulpong Singnarong

Brand	MERCEDES BENZ	Model year	2018
Model	C220D	Engine Code - No.	65492080297549
Sub-model	AMG DYNAMIC	Registration year	2019-05-17
Registration No.		Chassis No.	WDD2050146L042757
Current Mileage(km.)	67467	Engine Capacity(cc.)	1950

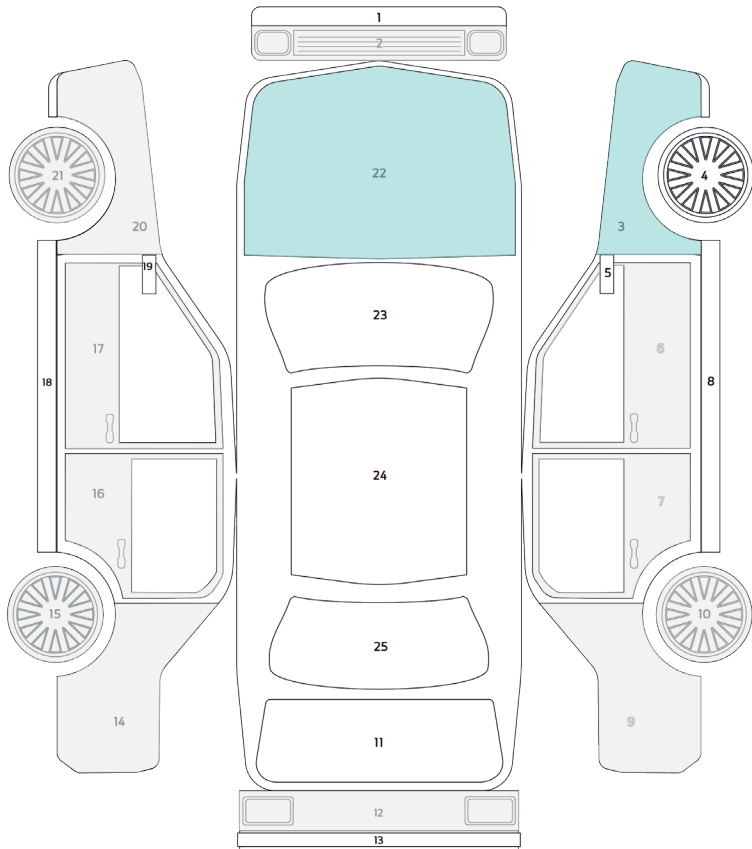
Exterior Inspection Points

1. Front Skirt	O	14. Left Skirt	O
2. Front Bumper	O (S1)	15. Left Wing Mirror	O
3. Front Right Fender	BP	16. Front Windshield	O
4. Front Right Wheel	O	17. Roof	O
5. Front Left Fender	O (S1)	18. Rear right fender	O (S1)
6. Front Left Wheel	O (S1)	19. Rear Bonnet	O
7. Front bonnet	BP (S1)	20. Back right wheel	O (S1)
8. Right Wing Mirror	O	21. Rear Bumper	O (S1)
9. Front right door	O (S1)	22. Rear Skirt	O
10. Rear right door	O (S1)	23. Rear left fender	O (S1)
11. Right Skirt	O	24. Back left wheel	O (S1)
12. Rear Left door	O (S1,D1)	25. Back Windshield	O
13. Front left door	O (S1)

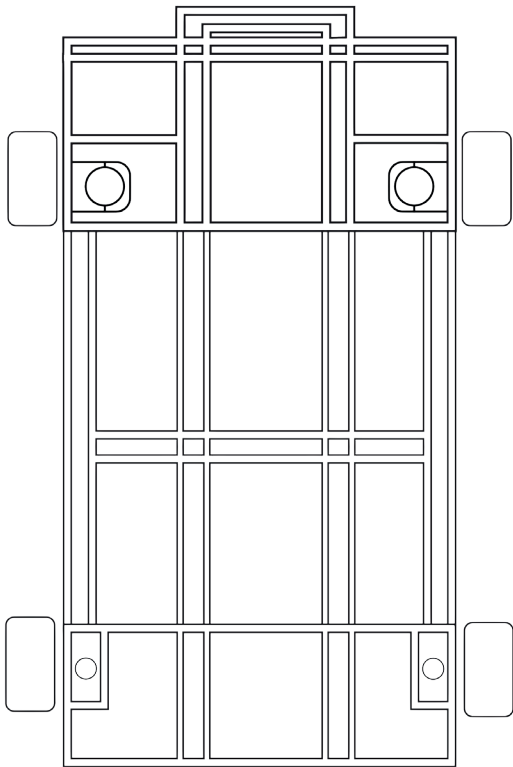
Chassis Report

No dent in the under carriage (th)	PASS
No deform chassis or chassis frame (th)	PASS
No visible corrosion on the chassis or chassis frame (th)	PASS
No missing part on the chassis frame (th)	PASS
Half cut Analysis (th)	PASS

Chassis Damage Level	no-damage
----------------------	-----------

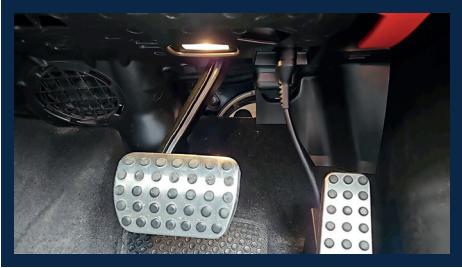
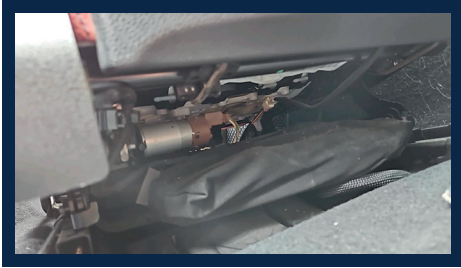
Flood Report

Evidence of Flood	No
-------------------	----

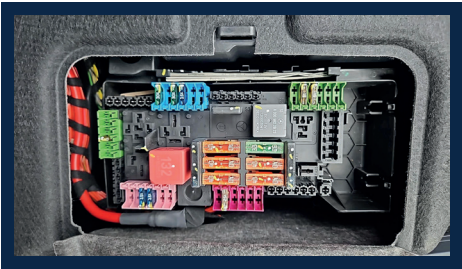
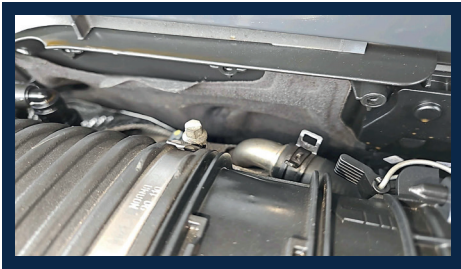
Fire Report

Evidence of Fire	No
------------------	----
