# Preowned Vehicle Inspection Report

Premium Inspection Analysis

Customer Name	: MERCEDES-BENZ MOBILITY (THAILAND) CO., LTD.	Inspection Date	: 2024-05-30
Tel.	:	Lemon Inspection ID	: LEMON24050312
Inspector	: suwat thongpim	Approved By	: Sakulpong Singnarong

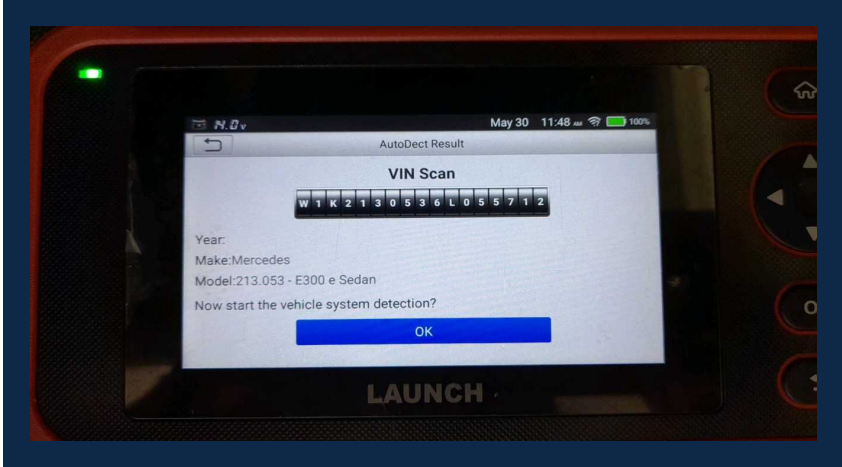
**OBD Vehicle Health Analysis**

**Inspector :** หมายเหตุ\* ภายนอก(Exterior) : ภายนอกไม่พบหลักฐานการซ่อมแซมทำสี / ยางปกติทั้ง 4 เส้น  
ภายใน(Interior) : ภายในสะอาดเรียบร้อย ไม่มีความเสียหาย , อุปกรณ์ไฟฟ้า แอร์ วิทยุ ใช้งานได้ปกติ  
เครื่องยนต์(Electric) : เครื่องยนต์ทำงานปกติ , วิเคราะห์ปัญหาด้วยเครื่อง OBDII พบข้อผิดพลาดปกติ แนะนำเข้าสู่ศูนย์  
บริการตรวจเช็ค (ไม่ได้ทดสอบขับเคลื่อน) โครงสร้าง(Frame) : ตรวจสอบไม่พบอุบัติเหตุ , โครงสร้างหลักปกติ ไม่มีการ  
ซ่อมแซมโครงสร้างหรือมีการชนถึงโครงสร้าง โดยรวม รถสวย โครงสร้างรถดี

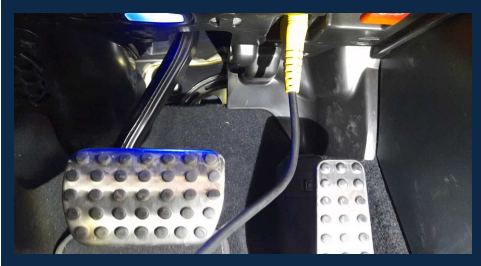
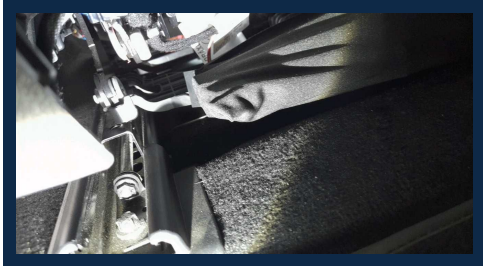
**Flood Report**

Evidence of Flood	No
-------------------	----

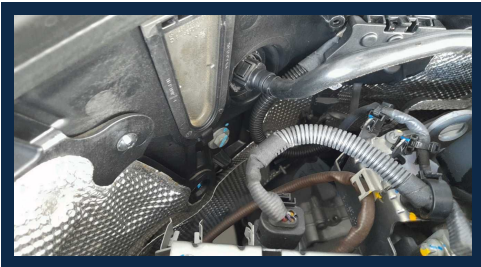
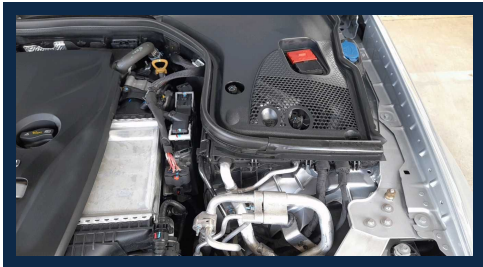
**Fire Report**

Evidence of Fire	No
------------------	----
