Preowned Vehicle Inspection Report

Premium Inspection Analysis

Customer Name	: MERCEDES-BENZ MOBILITY (THAILAND) CO., LTD.	Inspection Date	: 2024-05-29
Tel.	:	Lemon Inspection ID	: LEMON24050297
Inspector	: suwat thongpim	Approved By	: Sakulpong Singnarong

Brand	MERCEDES BENZ	Model year	2023
Model	E300e	Engine Code - No.	27492032031864
Sub-model	AMG Dymamic	Registration year	2023-10-06
Registration No.		Chassis No.	W1K2130536L055714
Current Mileage(km.)	7772	Engine Capacity(cc.)	1991

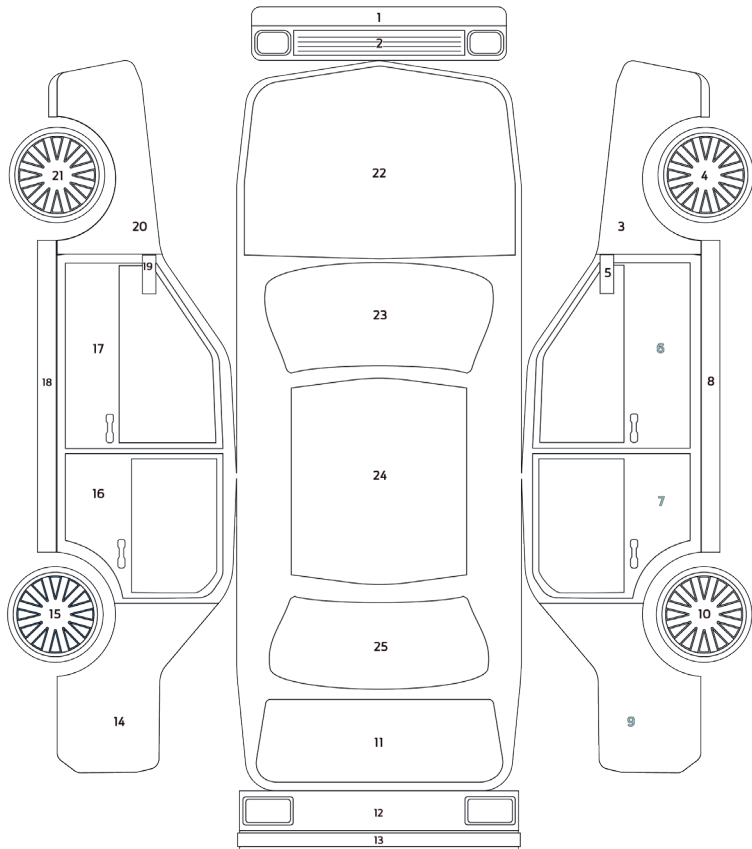
Exterior Inspection Points

1. Front Skirt	O	14. Left Skirt	O
2. Front Bumper	O	15. Left Wing Mirror	O
3. Front Right Fender	O	16. Front Windshield	O
4. Front Right Wheel	O	17. Roof	O
5. Front Left Fender	O	18. Rear Right Fender	O
6. Front Left Wheel	O	19. Rear Bonnet	O
7. Front Bonnet	O	20. Back Right Wheel	O
8. Right Wing Mirror	O	21. Rear Bumper	O
9. Front Right Door	O	22. Rear Skirt	O
10. Rear Right Door	O	23. Rear Left Fender	O
11. Right Skirt	O	24. Back Left Wheel	O
12. Rear Left Door	O	25. Back Windshield	O
13. Front Left Door	O

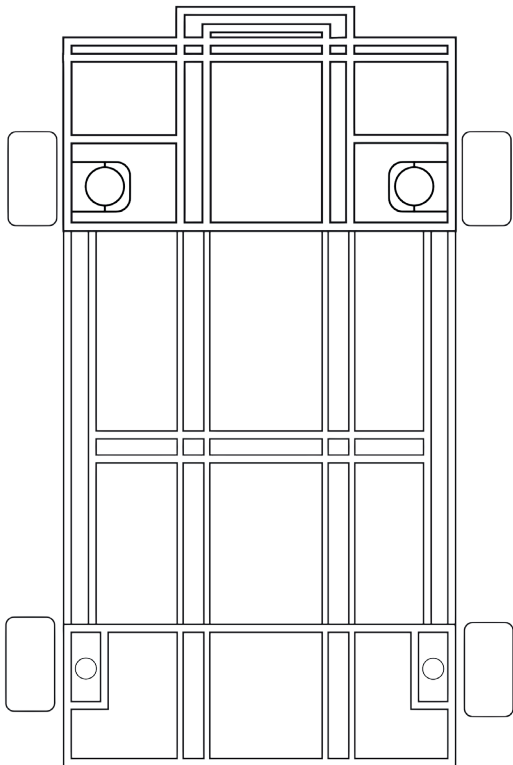
Chassis Report

No dent in the under carriage (th)	PASS
No deform chassis or chassis frame (th)	PASS
No visible corrosion on the chassis or chassis frame (th)	PASS
No missing part on the chassis frame (th)	PASS
Half cut Analysis (th)	PASS

Chassis Damage Level	No Damage
----------------------	-----------

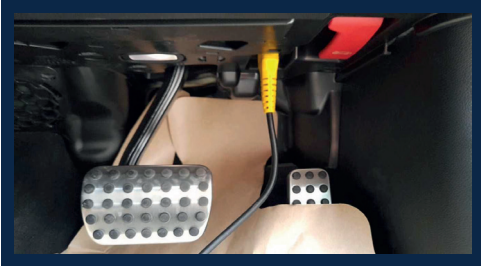
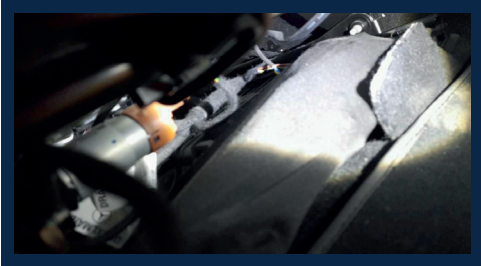
Flood Report

Evidence of Flood	No
-------------------	----

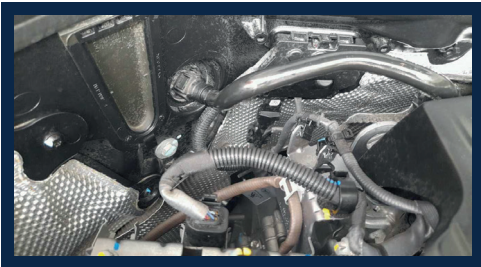
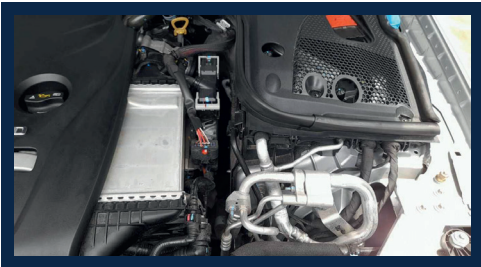
Fire Report

Evidence of Fire	No
------------------	----
