Preowned Vehicle Inspection Report

Premium Inspection Analysis

Customer Name	: MERCEDES-BENZ MOBILITY (THAILAND) CO., LTD.	Inspection Date	: 2024-05-31
Tel.	:	Lemon Inspection ID	: LEMON24050329
Inspector	: tanruk tipin	Approved By	: Sakulpong Singnarong

Brand	MERCEDES BENZ	Model year	2019
Model	GLC250D	Engine Code - No.	65192134947724
Sub-model	4MATIC AMG PLUS	Registration year	2019-09-03
Registration No.		Chassis No.	WDC2539096L021434
Current Mileage(km.)	105939	Engine Capacity(cc.)	2143

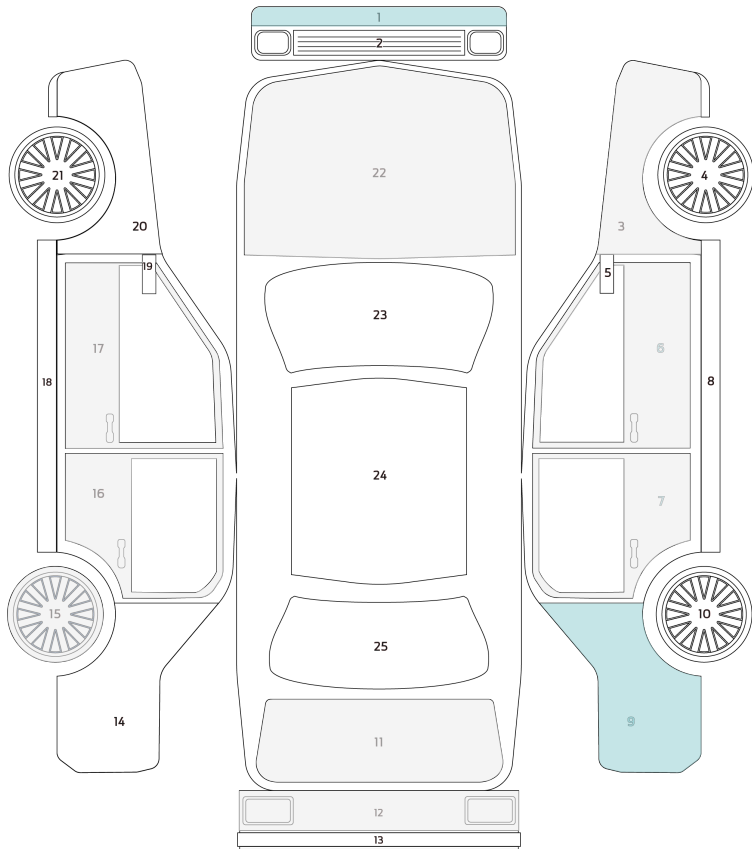
Exterior Inspection Points

1. Front Skirt	BP (S1)	14. Left Skirt	O
2. Front Bumper	O	15. Left Wing Mirror	O
3. Front Right Fender	O (S1)	16. Front Windshield	O
4. Front Right Wheel	O	17. Roof	O
5. Front Left Fender	O	18. Rear right fender	BP (D1)
6. Front Left Wheel	O	19. Rear Bonnet	O (S1)
7. Front bonnet	O (G1)	20. Back Right Wheel	O
8. Right Wing Mirror	O	21. Rear Bumper	O (S1)
9. Front right door	O (S1)	22. Rear Skirt	O
10. Rear right door	O (S1)	23. Rear Left Fender	O
11. Right Skirt	O	24. Back left wheel	O (S1)
12. Rear Left door	O (S1)	25. Back Windshield	O
13. Front left door	O (S1)

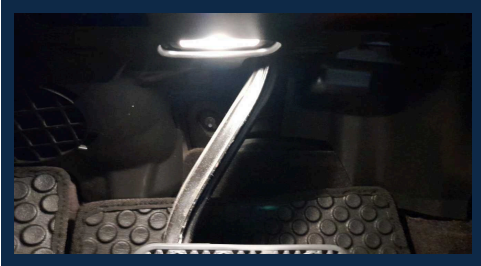
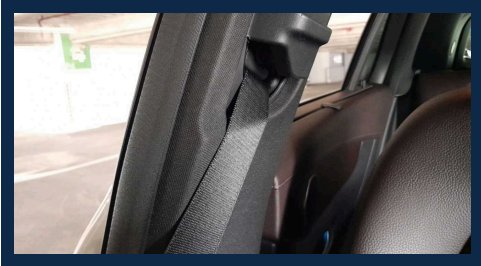
Flood Report

Evidence of Flood	No
-------------------	----

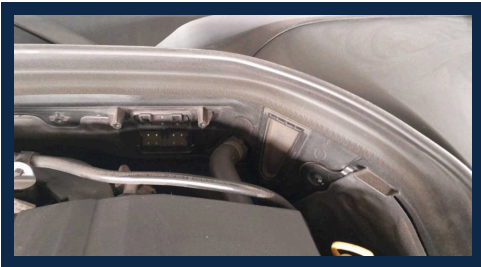
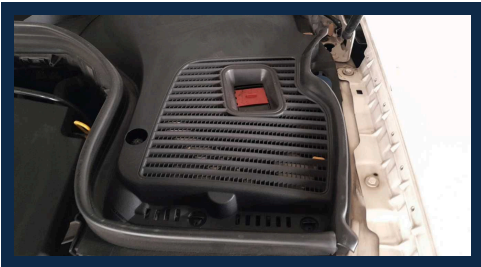
Fire Report

Evidence of Fire	No
------------------	----
