Preowned Vehicle Inspection Report

Premium Inspection Analysis

Customer Name	: MERCEDES-BENZ MOBILITY (THAILAND) CO., LTD.	Inspection Date	: 2024-06-06
Tel.	:	Lemon Inspection ID	: LEMON24060055
Inspector	: tanruk tipin	Approved By	: Sakulpong Singnarong

Brand	MERCEDES BENZ	Model year	2019
Model	S350	Engine Code - No.	65692980032448
Sub-model	CDI BLUEEFFICIENCY EXCLUSIVE	Registration year	2019-08-22
Registration No.		Chassis No.	WDD2221206L012322
Current Mileage(km.)	86463	Engine Capacity(cc.)	3000

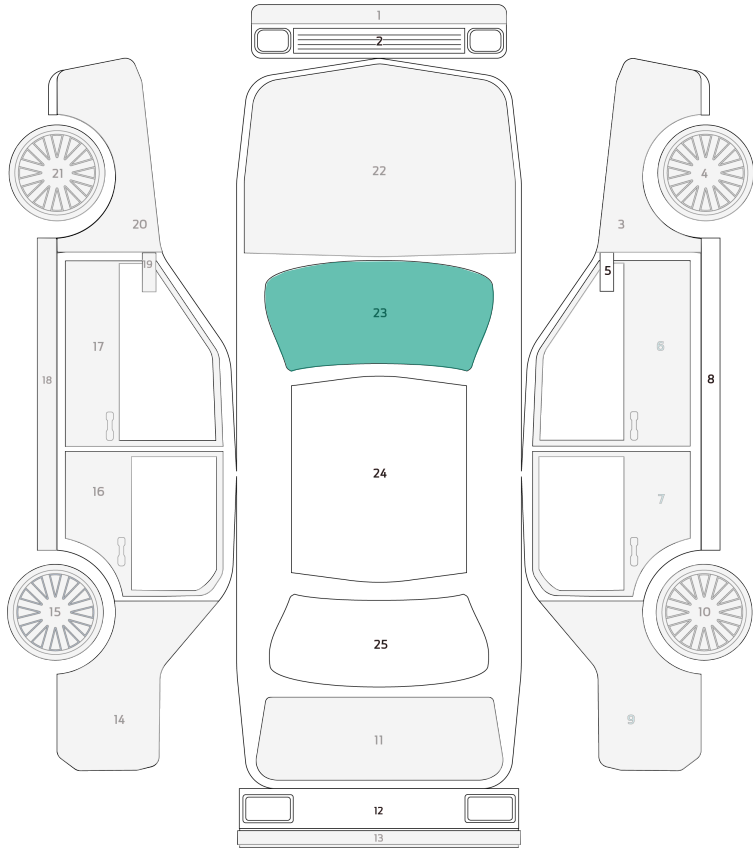
Exterior Inspection Points

1. Front Skirt	O (S1)	14. Left skirt	O (S1)
2. Front Bumper	O	15. Left wing mirror	O (S1)
3. Front Right Fender	O (S1)	16. Front windshield	N (G1)
4. Front Right Wheel	O (S1)	17. Roof	O
5. Front Left Fender	O (S1)	18. Rear right fender	O (S2)
6. Front Left Wheel	O (S2)	19. Rear Bonnet	O (S1)
7. Front bonnet	O (S1)	20. Back right wheel	O (S1)
8. Right Wing Mirror	O	21. Rear Bumper	O
9. Front right door	O (S1)	22. Rear skirt	O (S2)
10. Rear right door	O (S1)	23. Rear left fender	O (S1)
11. Right Skirt	O	24. Back left wheel	O (S1)
12. Rear Left door	O (S1)	25. Back Windshield	O
13. Front left door	O (S1)

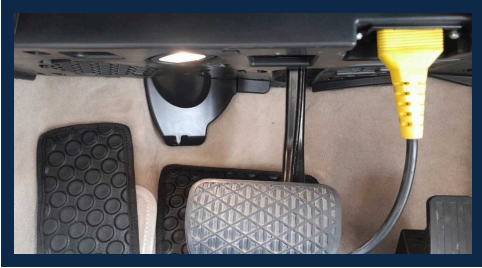
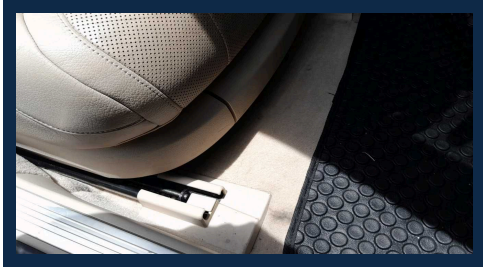
Flood Report

Evidence of Flood	No
-------------------	----

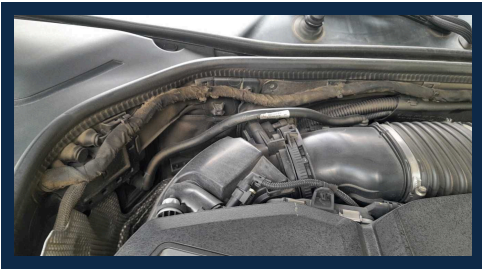
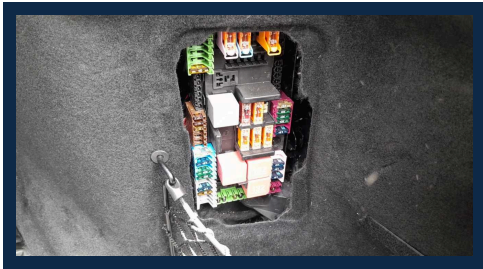
Fire Report

Evidence of Fire	No
------------------	----
