Preowned Vehicle Inspection Report

Premium Inspection Analysis

Customer Name	: MERCEDES-BENZ MOBILITY (THAILAND) CO., LTD.	Inspection Date	: 2024-06-12
Tel.	:	Lemon Inspection ID	: LEMON24060109
Inspector	: suwat thongpim	Approved By	: Tanrak T

Brand	MERCEDES BENZ	Model year	2022
Model	GLA 200	Engine Code - No.	28291430731968
Sub-model	AMG Dynamic	Registration year	2022-08-30
Registration No.		Chassis No.	W1N2477876L0025503
Current Mileage(km.)	26628	Engine Capacity(cc.)	1300

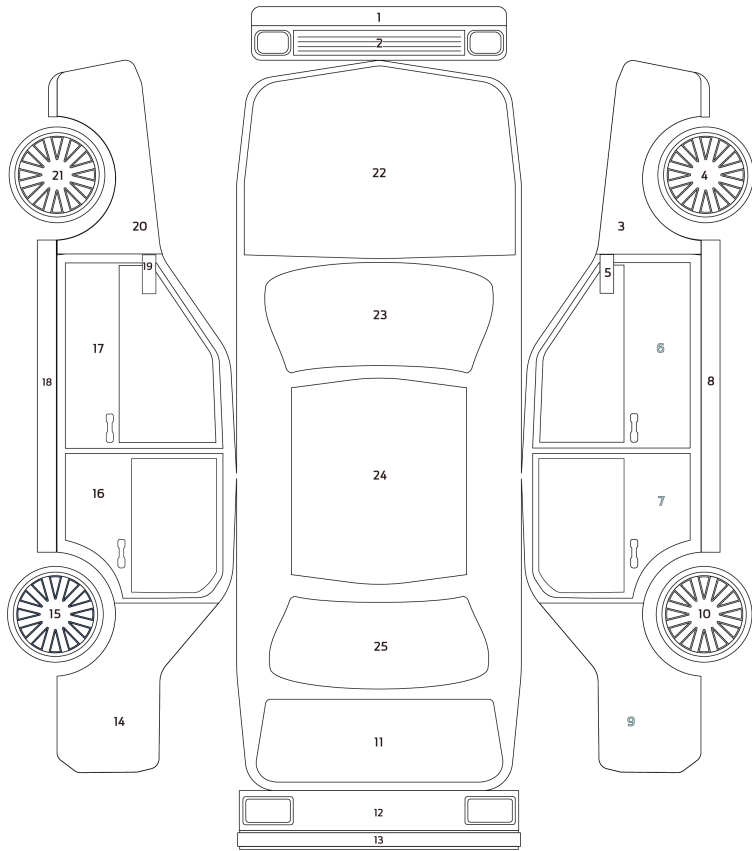
Exterior Inspection Points

1. Front Skirt	O	14. Left Skirt	O
2. Front Bumper	O	15. Left Wing Mirror	O
3. Front Right Fender	O	16. Front Windshield	O
4. Front Right Wheel	O	17. Roof	O
5. Front Left Fender	O	18. Rear Right Fender	O
6. Front Left Wheel	O	19. Rear Bonnet	O
7. Front Bonnet	O	20. Back Right Wheel	O
8. Right Wing Mirror	O	21. Rear Bumper	O
9. Front Right Door	O	22. Rear Skirt	O
10. Rear Right Door	O	23. Rear Left Fender	O
11. Right Skirt	O	24. Back Left Wheel	O
12. Rear Left Door	O	25. Back Windshield	O
13. Front Left Door	O

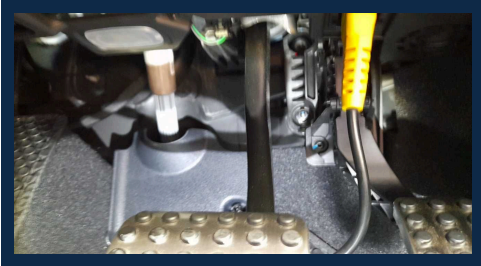
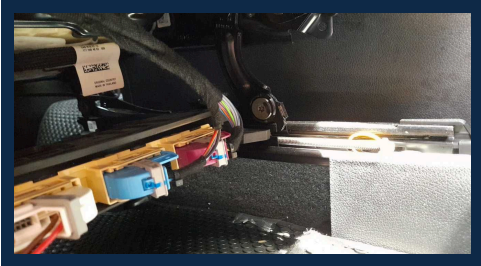
Flood Report

Evidence of Flood	No
-------------------	----

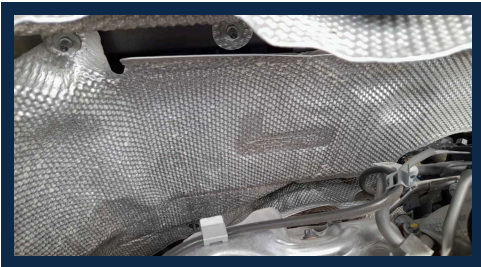
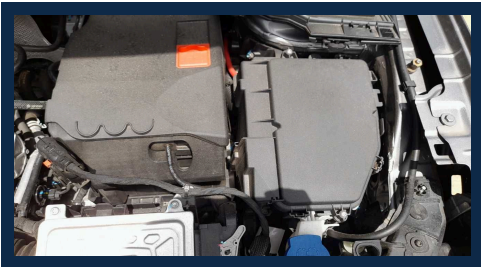
Fire Report

Evidence of Fire	No
------------------	----
