# Preowned Vehicle Inspection Report

Premium Inspection Analysis

Customer Name	: MERCEDES-BENZ MOBILITY (THAILAND) CO., LTD.	Inspection Date	: 2024-06-18
Tel.	:	Lemon Inspection ID	: LEMON24060183
Inspector	: Porramaet Tam Jaichoen	Approved By	: Tanrak T

Brand	MERCEDES BENZ	Model year	2019
Model	GLA	Engine Code - No.	27091031791657
Sub-model	200 URBAN	Registration year	2019-08-07
Registration No.		Chassis No.	WDC1569436L011166
Current Mileage(km.)	139045	Engine Capacity(cc.)	1600

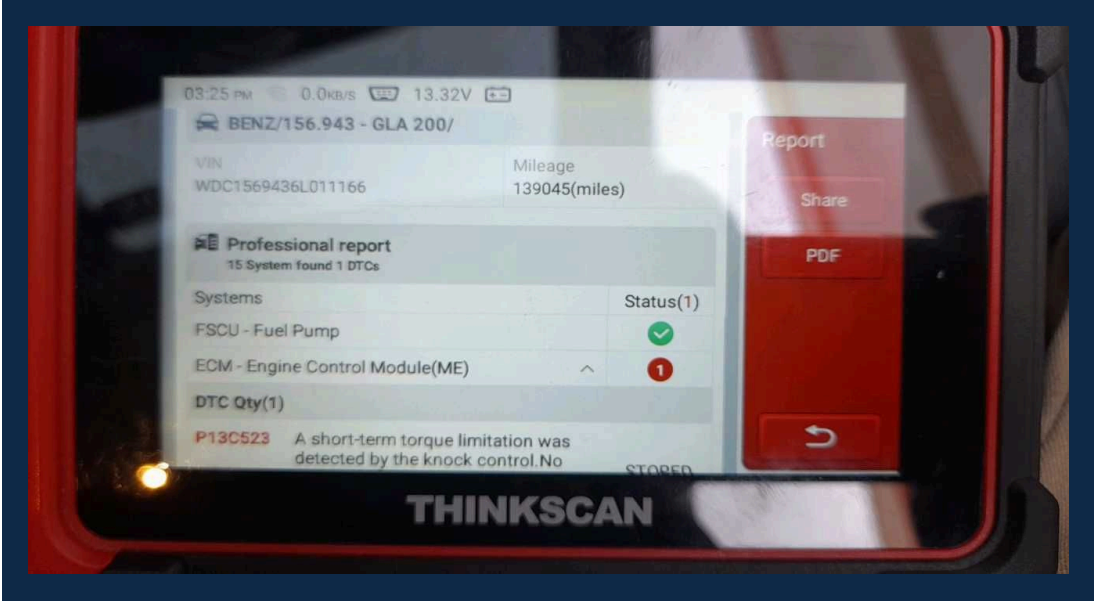
**OBD Vehicle Health Analysis**

**Inspector :** ภายนอก(Exterior) : จากการตรวจพบร่องรอยการทำสีรอบคัน พบรอยถลอกบริเวณกันชนหน้า พบรอยขีดข่วนเล็กน้อยรอบคัน เปลี่ยนกระจกหน้าใหม่ ยางเสื่อมสภาพทั้ง 4 เส้น ยางปี 21 ภายใน(Interior) : ภายในพบรอยเจิมแป้น ระบบไฟส่องสว่างใช้งานได้ปกติ แอร์วิทยุใช้งานได้ปกติ เครื่องยนต์(Electric) : เครื่องยนต์พบคราบน้ำมัน เครื่องชี้เล็กน้อย วิเคราะห์ด้วย OBD พบโค้ด P13C523 เกี่ยวกับแรงดันไฟ โครงสร้าง(Frame) : โครงสร้างหลักปกติ ไม่พบร่องรอยซ่อมแซมโครงสร้าง

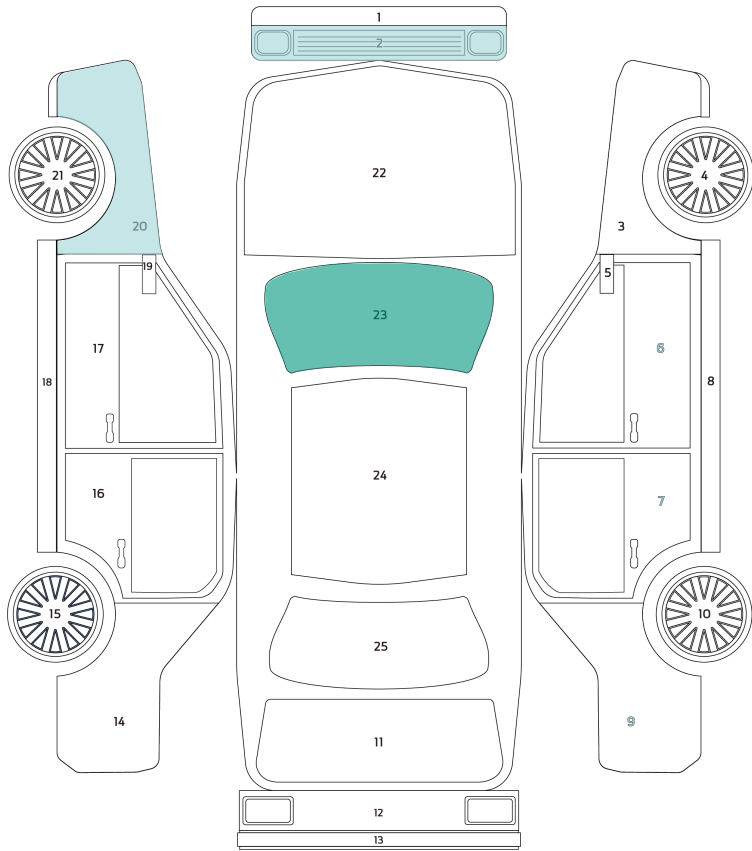
**Exterior Inspection Points**

1. Front Skirt	O	14. Left Skirt	O
2. Front Bumper	BP (S2)	15. Left Wing Mirror	O
3. Front Right Fender	O	16. Front windshield	N
4. Front Right Wheel	O	17. Roof	O
5. Front Left Fender	BP (S1)	18. Rear Right Fender	O
6. Front Left Wheel	O	19. Rear Bonnet	O
7. Front Bonnet	O	20. Back Right Wheel	O
8. Right Wing Mirror	O	21. Rear Bumper	O
9. Front Right Door	O	22. Rear Skirt	O
10. Rear Right Door	O	23. Rear Left Fender	O
11. Right Skirt	O	24. Back Left Wheel	O
12. Rear Left Door	O	25. Back Windshield	O
13. Front Left Door	O

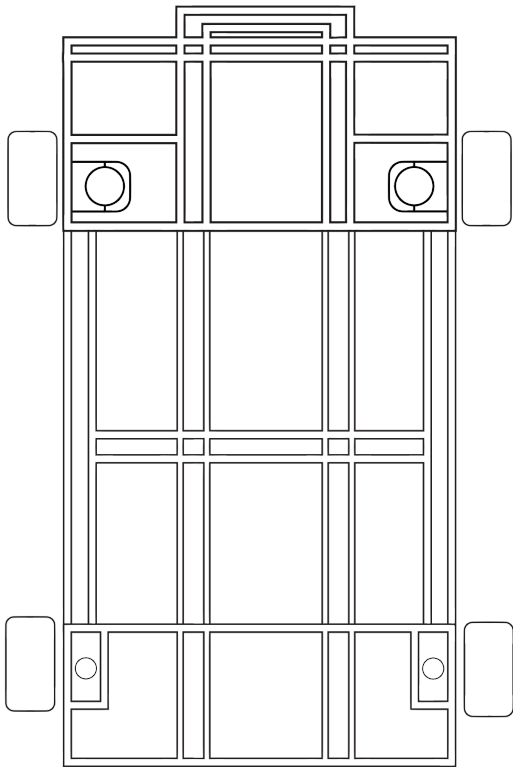
## Chassis Report

No dent in the under carriage (th)	PASS
No deform chassis or chassis frame (th)	PASS
No visible corrosion on the chassis or chassis frame (th)	PASS
No missing part on the chassis frame (th)	PASS
Half cut Analysis (th)	PASS

Chassis Damage Level	No Damage
----------------------	-----------

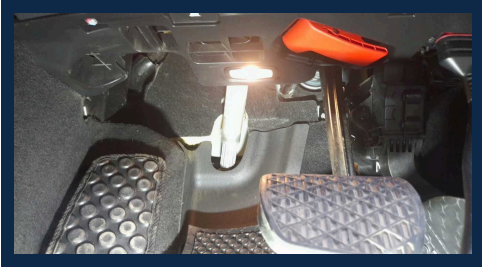
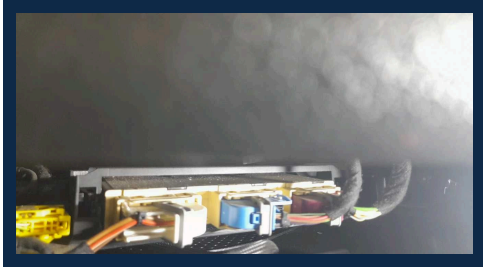
**Flood Report**

Evidence of Flood	No
-------------------	----

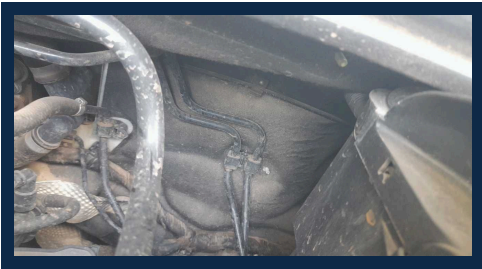
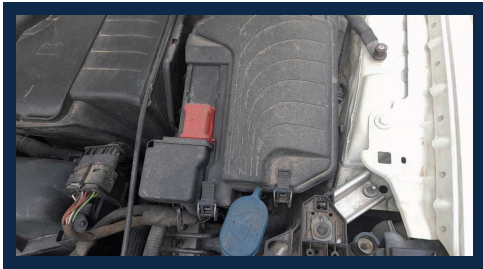
**Fire Report**

Evidence of Fire	No
------------------	----
