# Preowned Vehicle Inspection Report

Premium Inspection Analysis

| Tel. | : | Lemon Inspection ID | : LEMON24060188 |

| Model | C200 | Engine Code - No. | 26491530072619 |

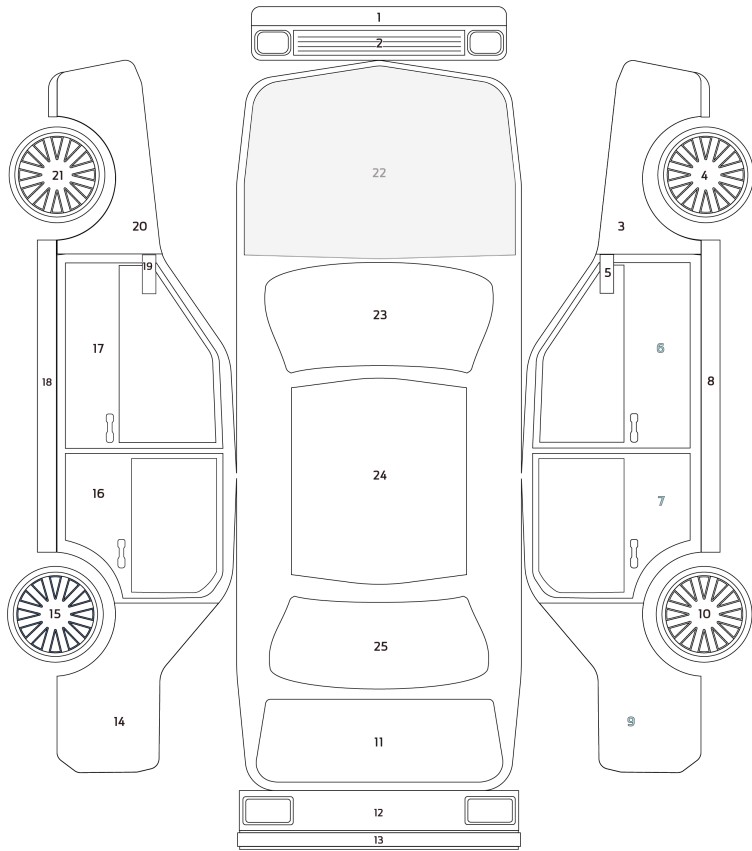
**Exterior Inspection Points**

| 7. Front bonnet | O (G1) | 20. Back Right Wheel | O |

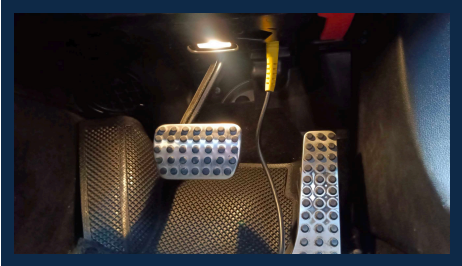
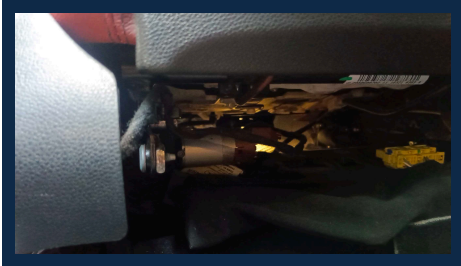
**Flood Report**

| Evidence of Flood | No |

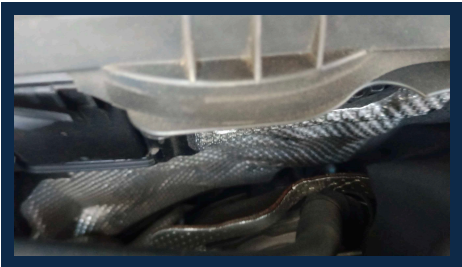
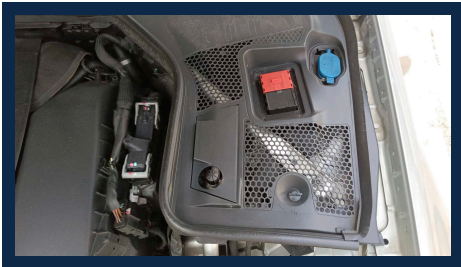
**Fire Report**

| Evidence of Fire | No |
