Preowned Vehicle Inspection Report

Premium Inspection Analysis

Customer Name	: MERCEDES-BENZ MOBILITY (THAILAND) CO., LTD.	Inspection Date	: 2024-06-25
Tel.	:	Lemon Inspection ID	: LEMON24060262
Inspector	: สุวัฒน์ วัฒน ทองพิมพ์	Approved By	: Chaimongkol C

Brand	MERCEDES BENZ	Model year	2021
Model	CLA45	Engine Code - No.	13998060022018
Sub-model	S 4MATIC+ AMG	Registration year	2021-10-12
Registration No.		Chassis No.	W1K1183542N235927
Current Mileage(km.)	34135	Engine Capacity(cc.)	2000

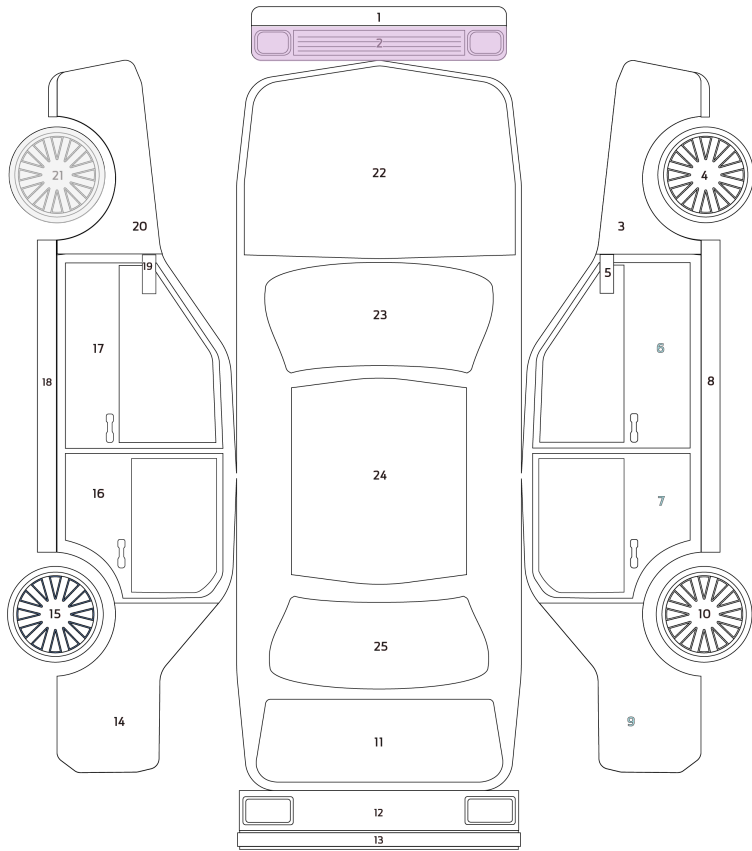
Exterior Inspection Points

1. Front Skirt	O	14. Left Skirt	O
2. Front Bumper	X (Y)	15. Left Wing Mirror	O
3. Front Right Fender	O	16. Front Windshield	O
4. Front Right Wheel	O	17. Roof	O
5. Front Left Fender	O	18. Rear Right Fender	O
6. Front Left Wheel	O (S2)	19. Rear Bonnet	O
7. Front Bonnet	O	20. Back Right Wheel	O
8. Right Wing Mirror	O	21. Rear Bumper	O
9. Front Right Door	O	22. Rear Skirt	O
10. Rear Right Door	O	23. Rear Left Fender	O
11. Right Skirt	O	24. Back Left Wheel	O
12. Rear Left Door	O	25. Back Windshield	O
13. Front Left Door	O

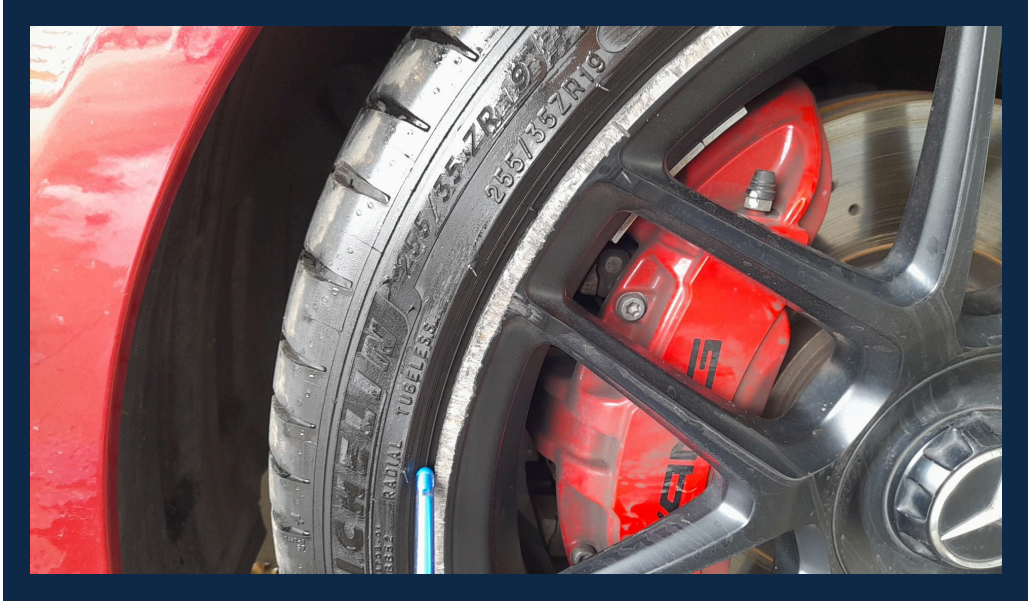
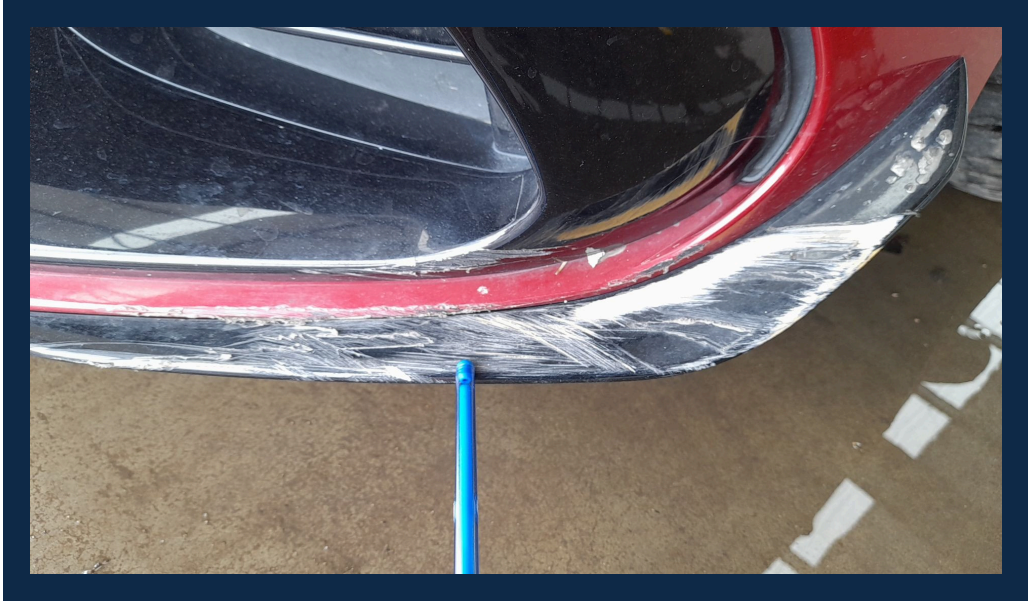
Vehicle Defect Notices

Inspector : หมายเหตุ* ภายนอก(Exterior) : การตรวจสภาพภายนอกโดยรวมไม่พบหลักฐานการซ่อมแซมทำสี บังโคลนหน้าซ้ายขวา ฝากระโปรงหน้า กันชนหน้าแล็ปสติกเกอร์มา กันชนหน้าครูดปีกกันชนหน้าขวาหายไป / ล้อหน้าซ้ายครูด / สภาพยางปกติทั้ง4เส้น ปี23 ภายใน(Interior) : ภายในปกติไม่มีความเสียหาย สะอาดเรียบร้อย อุปกรณ์ไฟฟ้า แอร์ วิทยุFM ใช้งานได้สมบูรณ์ครบปกติ เครื่องยนต์(Electric) : เครื่องยนต์ทำงานได้ปกติ วิเคราะห์ปัญหาด้วยเครื่อง OBDII พบโค้ดผิดปกติ P049700 P049600 P02FF02 แนะนำเข้าเช็คศูนย์ (ไม่ได้ทดสอบขับขี) โครงสร้าง(Frame) : อุบัติเหตุไม่มี โครงสร้างหลักปกติ ไม่มีการซ่อมแซมโครงสร้างหรือมีการชนถึงโครงสร้าง
