Preowned Vehicle Inspection Report

Premium Inspection Analysis

Customer Name	: MERCEDES-BENZ MOBILITY (THAILAND) CO., LTD.	Inspection Date	: 2024-06-25
Tel.	:	Lemon Inspection ID	: LEMON24060258
Inspector	: ไชยมงคล เบิร์ด ไพโรเลี้ยง	Approved By	: Tanrak T

Brand	MERCEDES BENZ	Model year	2023
Model	GLE	Engine Code - No.	25693030630733
Sub-model	53 4MATIC+ AMG	Registration year	2023-09-11
Registration No.		Chassis No.	W1N1671616M014824
Current Mileage(km.)	12570	Engine Capacity(cc.)	3000

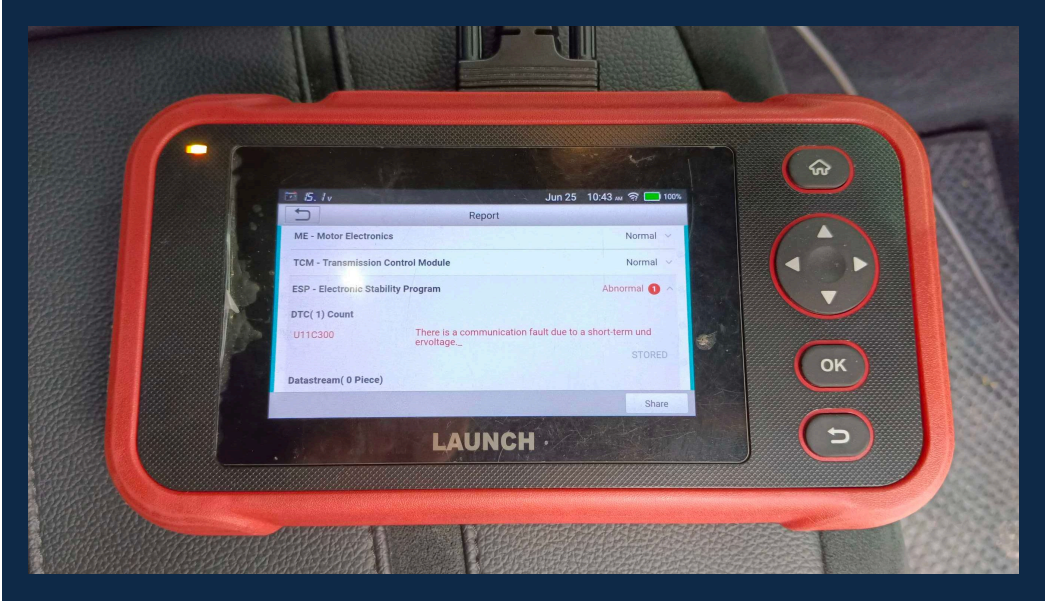
OBD Vehicle Health Analysis

Inspector : ภายนอก(Exterior) : การตรวจสภาพภายนอกโดยรวมไม่พบหลักฐานการซ่อมแซมทำสี / สภาพยางปกติ
ถัง4เส้น ปี22 ภายใน(Interior) : ภายในปกติ เรียบร้อย อุปกรณ์ไฟฟ้า แอร์ วิทยุFM ใช้งานได้สมบูรณ์ครบปกติ
เครื่องยนต์(Engine) : เครื่องยนต์ทำงานได้ปกติ วิเคราะห์ปัญหาด้วยเครื่อง OBDII พบสิ่งผิดปกติ U11C300
electronic stability program แนะนำเข้าศูนย์ตรวจเช็ค (ไม่ได้ทดสอบขับเคลื่อน) โครงสร้าง(Frame) : อุบัติเหตุไม่มี
โครงสร้างหลักปกติ ไม่มีการซ่อมแซมโครงสร้างหรือมีการชนถึงโครงสร้าง

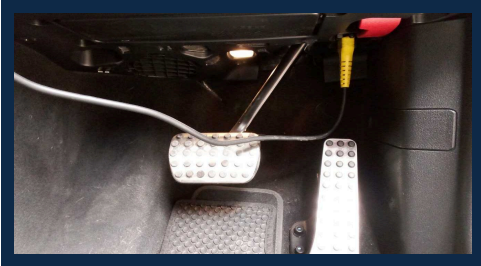
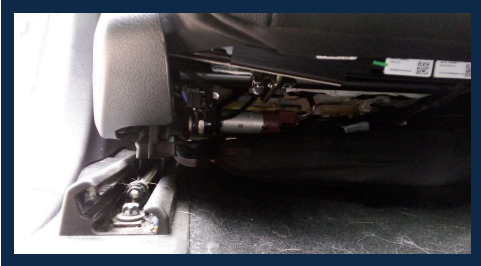
Flood Report

Evidence of Flood	No
-------------------	----

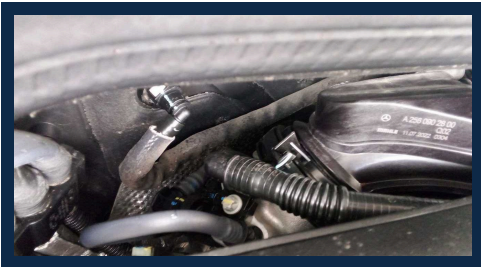
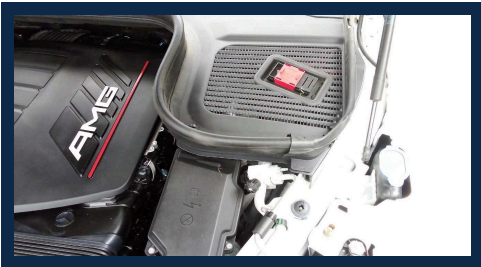
Fire Report

Evidence of Fire	No
------------------	----
