Premium Inspection Analysis

Customer Name	: MERCEDES-BENZ MOBILITY (THAILAND) CO., LTD.	Inspection Date	: 2024-06-25
Tel.	:	Lemon Inspection ID	: LEMON24060257
Inspector	: แทนรัก ทอย ทิพย์อินทร์	Approved By	: Chaimongkol C

Brand	MERCEDES BENZ	Model year	2018
Model	C200	Engine Code - No.	26491530043511
Sub-model	COUPE AMG DYNAMIC	Registration year	2019-10-28
Registration No.		Chassis No.	WDD2053776L043159
Current Mileage(km.)	131872	Engine Capacity(cc.)	1500

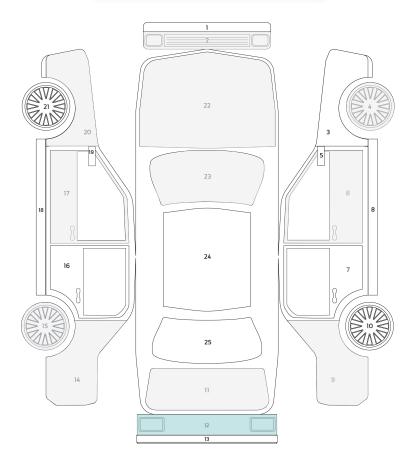
#### **Exterior Inspection Points**

1. Front Skirt	0	14. Left Skirt	0
2. Front Bumper	O (S2,Y)	15. Left Wing Mirror	0
3. Front Right Fender	0	16. Front windshield	O (G1)
4. Front Right Wheel	O (S1)	17. Roof	0
5. Front Left Fender	O (S2)	18. Rear right fender	O (D2)
6. Front Left Wheel	0	19. Rear Bonnet	O (D2)
7. Front bonnet	O (G1)	20. Back Right Wheel	0
8. Right Wing Mirror	0	21. Rear Bumper	BP (S1)
9. Front right door	O (D1)	22. Rear Skirt	0
10. Rear Right Door	0	23. Rear left fender	O (D2)
11. Right Skirt	0	24. Back left wheel	O (S1)
12. Rear Left Door	0	25. Back Windshield	0
13. Front left door	O (D1)

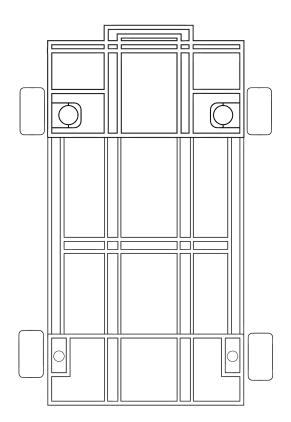
#### Chassis Report

No dent in the under carriage (th)	PASS
No deform chassis or chassis frame (th)	PASS
No visible corrosion on the chassis or chassis frame (th)	PASS
No missing part on the chassis frame (th)	PASS
Half cut Analysis (th)	PASS

Chassis Damage Level	No Damage
----------------------	-----------
