Preowned Vehicle Inspection Report

Premium Inspection Analysis

Customer Name	: MERCEDES-BENZ MOBILITY (THAILAND) CO., LTD.	Inspection Date	: 2024-06-26
Tel.	:	Lemon Inspection ID	: LEMON24060284
Inspector	: แทนรัก น้อย ทิพย์อินทร์	Approved By	: Chaimongkol C

Brand	MERCEDES BENZ	Model year	2021
Model	C220	Engine Code - No.	65492081082169
Sub-model	d Avantgarde	Registration year	2021-09-09
Registration No.		Chassis No.	W1K2573146L002756
Current Mileage(km.)	35371	Engine Capacity(cc.)	2000

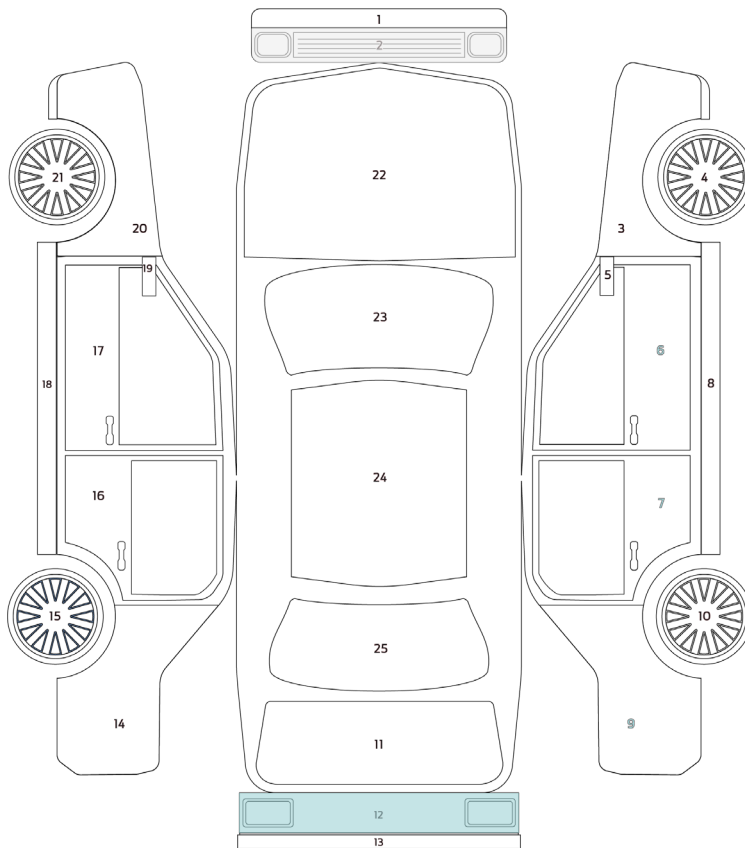
Exterior Inspection Points

1. Front Skirt	O	14. Left Skirt	O
2. Front Bumper	O (S1)	15. Left Wing Mirror	O
3. Front Right Fender	O	16. Front Windshield	O
4. Front Right Wheel	O	17. Roof	O
5. Front Left Fender	O	18. Rear Right Fender	O
6. Front Left Wheel	O	19. Rear Bonnet	O
7. Front Bonnet	O	20. Back Right Wheel	O
8. Right Wing Mirror	O	21. Rear Bumper	BP
9. Front Right Door	O	22. Rear Skirt	O
10. Rear Right Door	O	23. Rear Left Fender	O
11. Right Skirt	O	24. Back Left Wheel	O
12. Rear Left Door	O	25. Back Windshield	O
13. Front Left Door	O

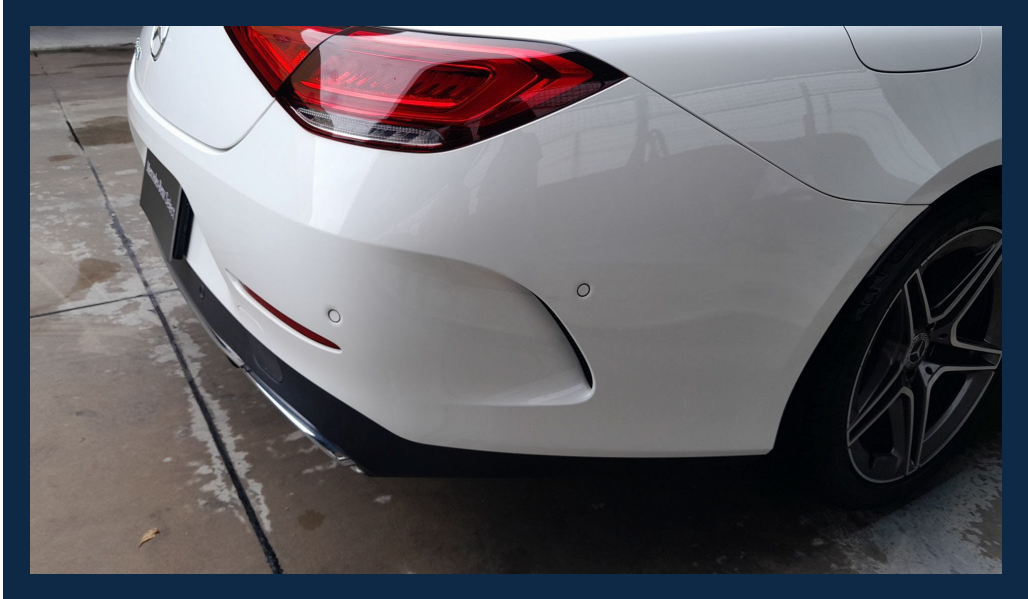
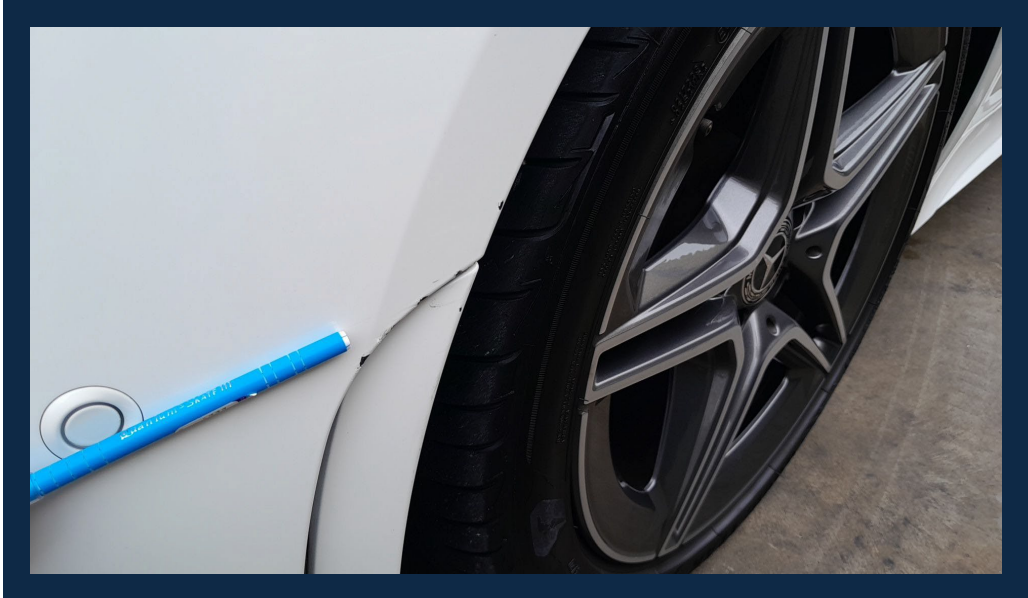
Vehicle Defect Notices

Inspector : ภายนอก(Exterior) : การตรวจสภาพภายนอกโดยรวมพบหลักฐานการซ่อมแซมทำสี กันชนหลัง กันชนหน้าเป็นรอยถลอก/ สภาพยางทั้ง4เส้น ปี 20 เสื่อมสภาพ ภายใน(Interior) : ภายใน เบาะหน้าขวาเป็นรอยถลอก สะอาดเรียบร้อย อุปกรณ์ไฟฟ้า แอร์ วิทยุFM ใช้งานได้สมบูรณ์ครบปกติ เครื่องยนต์(Engine) : เครื่องยนต์ทำงานได้ปกติ 5 เครื่องมีปัญหาด้วยเครื่อง OBDII ไม่พบสิ่งผิดปกติ (ไม่ได้ทดสอบขับขี่) โครงสร้าง(Frame) : อุบัติเหตุไม่มี โครงสร้างหลักปกติ ไม่มีการซ่อมแซมโครงสร้างหรือมีการชนถึงโครงสร้าง

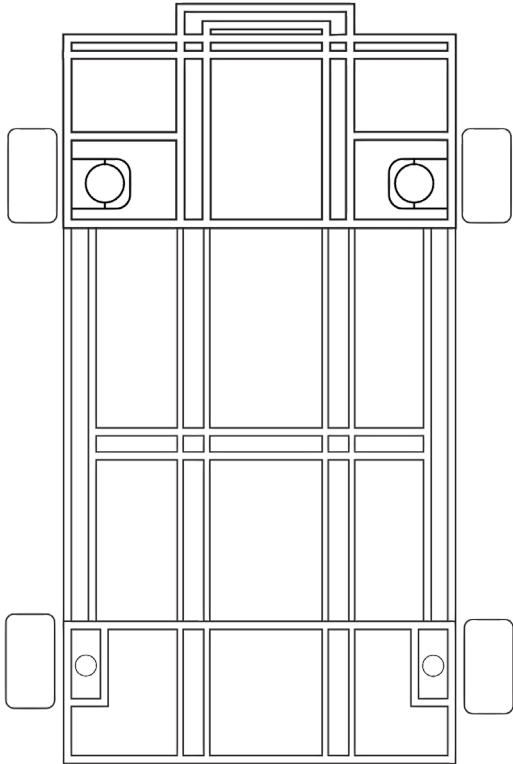
Chassis Report

No dent in the under carriage (th)	PASS
No deform chassis or chassis frame (th)	PASS
No visible corrosion on the chassis or chassis frame (th)	PASS
No missing part on the chassis frame (th)	PASS
Half cut Analysis (th)	PASS
Chassis Damage Level	No Damage
