Preowned Vehicle Inspection Report

Premium Inspection Analysis

Customer Name : MERCEDES-BENZ MOBILITY (THAILAND) CO., LTD. Inspection Date : 2024-06-26
Tel. : Lemon Inspection ID : LEMON24060289
Inspector : ไชยมงคล เบิร์ด ไพโรเลี้ยง Approved By : Sakulpong S

Brand	MERCEDES BENZ	Model year	2019
Model	GLA250	Engine Code - No.	27092031892712
Sub-model	AMG Dynamic	Registration year	2020-03-02
Registration No.		Chassis No.	WDC1569446L013402
Current Mileage(km.)	86508	Engine Capacity(cc.)	2000

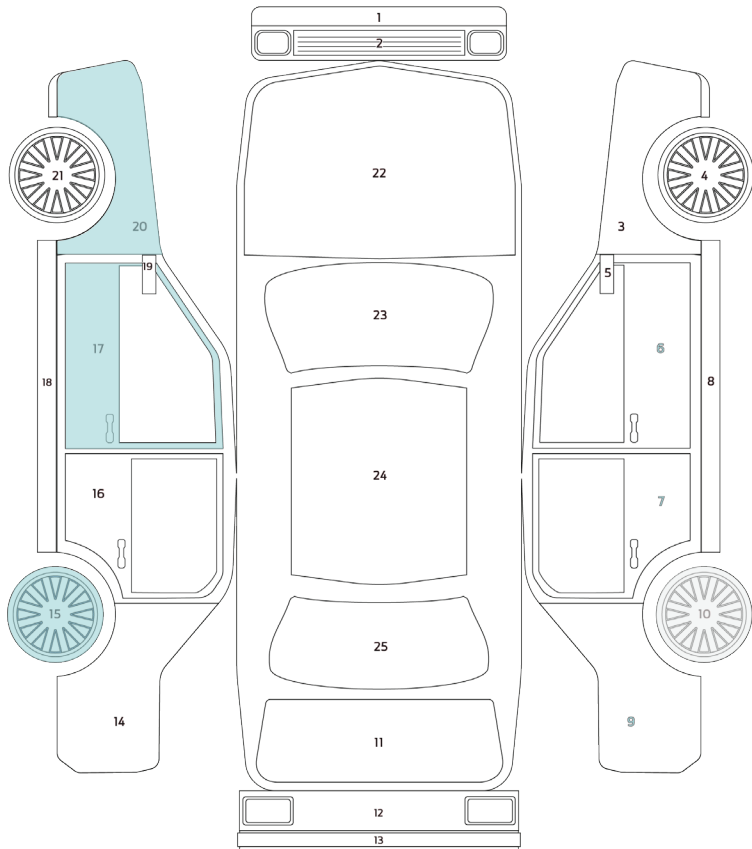
Exterior Inspection Points

1. Front Skirt	O	14. Left Skirt	O
2. Front Bumper	O	15. Left Wing Mirror	O
3. Front Right Fender	O	16. Front Windshield	O
4. Front Right Wheel	O	17. Roof	O
5. Front Left Fender	BP	18. Rear Right Fender	O
6. Front Left Wheel	O	19. Rear Bonnet	O
7. Front Bonnet	O	20. Back right wheel	O (S1)
8. Right Wing Mirror	O	21. Rear Bumper	O
9. Front Right Door	O	22. Rear Skirt	O
10. Rear Right Door	O	23. Rear Left Fender	O
11. Right Skirt	O	24. Back left wheel	BP (S1)
12. Rear Left Door	O	25. Back Windshield	O
13. Front left door	BP

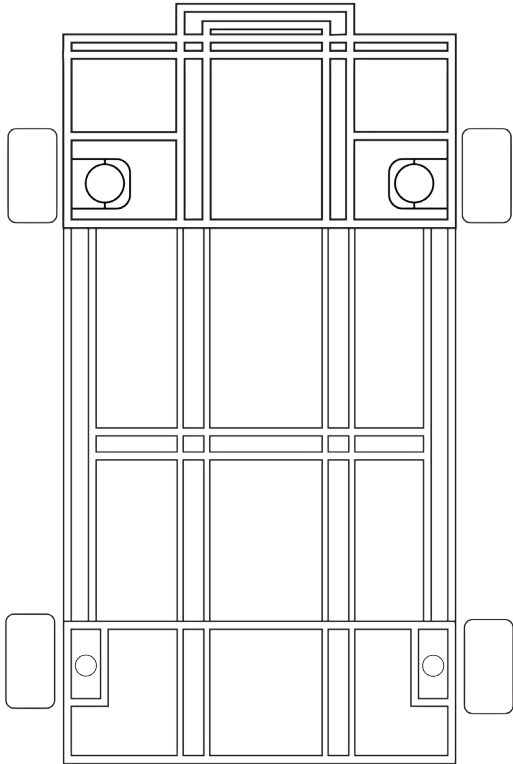
Chassis Report

No dent in the under carriage (th)	PASS
No deform chassis or chassis frame (th)	PASS
No visible corrosion on the chassis or chassis frame (th)	PASS
No missing part on the chassis frame (th)	PASS
Half cut Analysis (th)	PASS

Chassis Damage Level	No Damage
----------------------	-----------
