Preowned Vehicle Inspection Report

Premium Inspection Analysis

Customer Name : MERCEDES-BENZ MOBILITY (THAILAND) CO., LTD. Inspection Date : 2024-06-27
 Tel. : Lemon Inspection ID : LEMON24060290
 Inspector : แทนรัก ทอย ทิพย์อินทร์ Approved By : Chaimongkol C

Brand	MERCEDES BENZ	Model year	2019
Model	C220	Engine Code - No.	65492080382744
Sub-model	d Avantgarde	Registration year	2020-01-17
Registration No.		Chassis No.	WDD2050146L048183
Current Mileage(km.)	74700	Engine Capacity(cc.)	2000

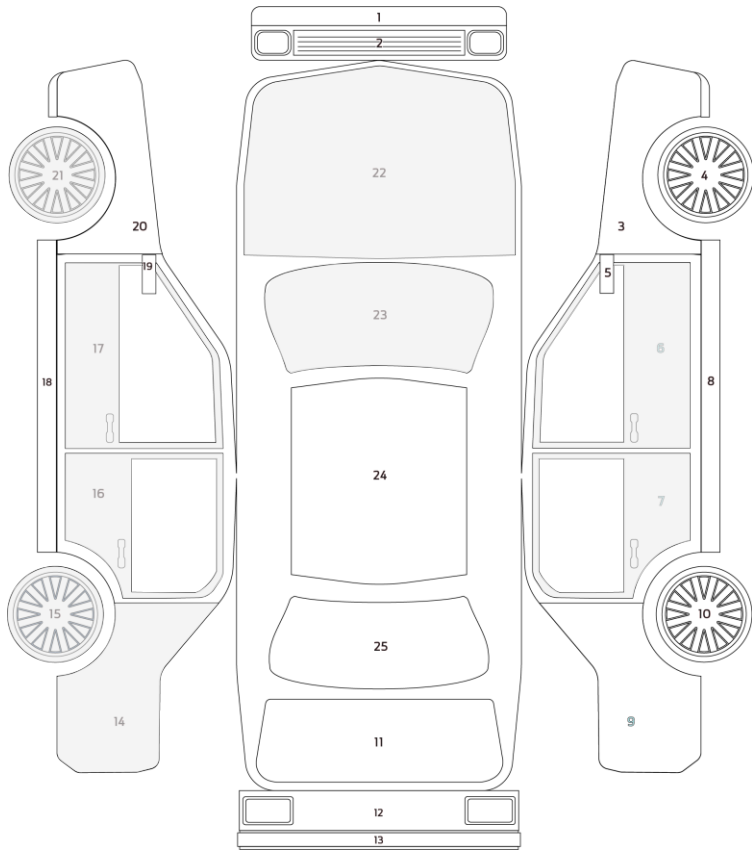
Exterior Inspection Points

1. Front Skirt	O	14. Left Skirt	O
2. Front Bumper	O	15. Left Wing Mirror	O
3. Front Right Fender	O	16. Front windshield	O (G1)
4. Front Right Wheel	O	17. Roof	O
5. Front Left Fender	O	18. Rear Right Fender	O
6. Front Left Wheel	O (S1)	19. Rear Bonnet	O
7. Front bonnet	O (G1)	20. Back Right Wheel	O
8. Right Wing Mirror	O	21. Rear Bumper	O
9. Front right door	O (S1)	22. Rear Skirt	O
10. Rear right door	O (S1)	23. Rear left fender	O (S1)
11. Right Skirt	O	24. Back left wheel	O (S1)
12. Rear Left door	O (S1)	25. Back Windshield	O
13. Front left door	O (S1)

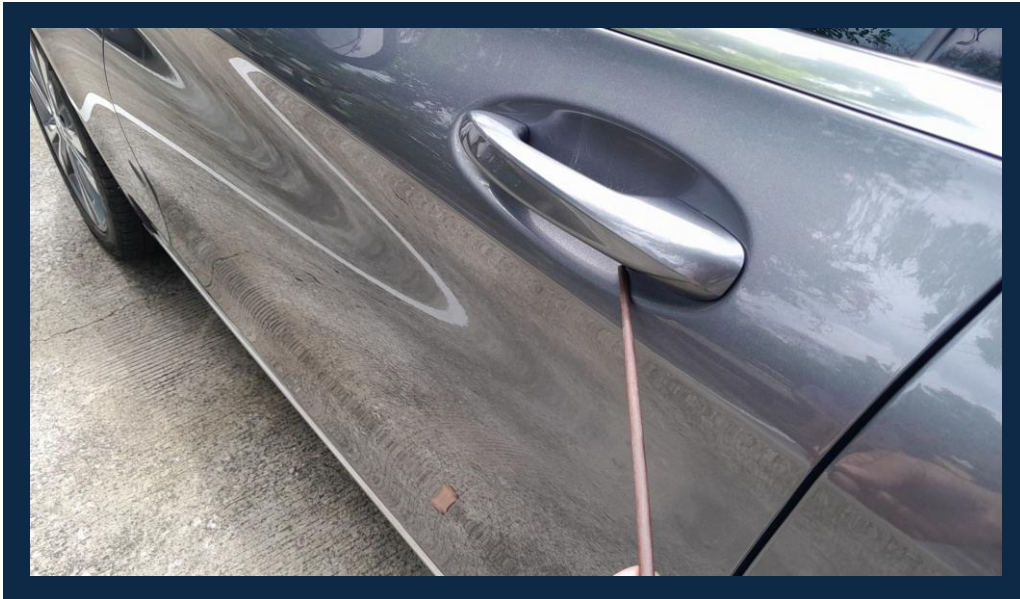
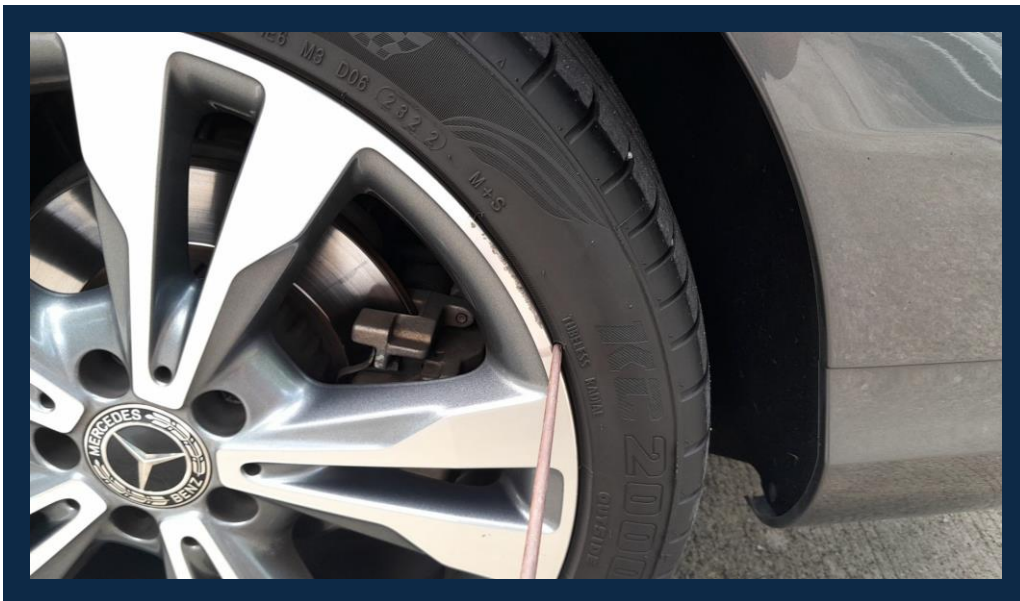
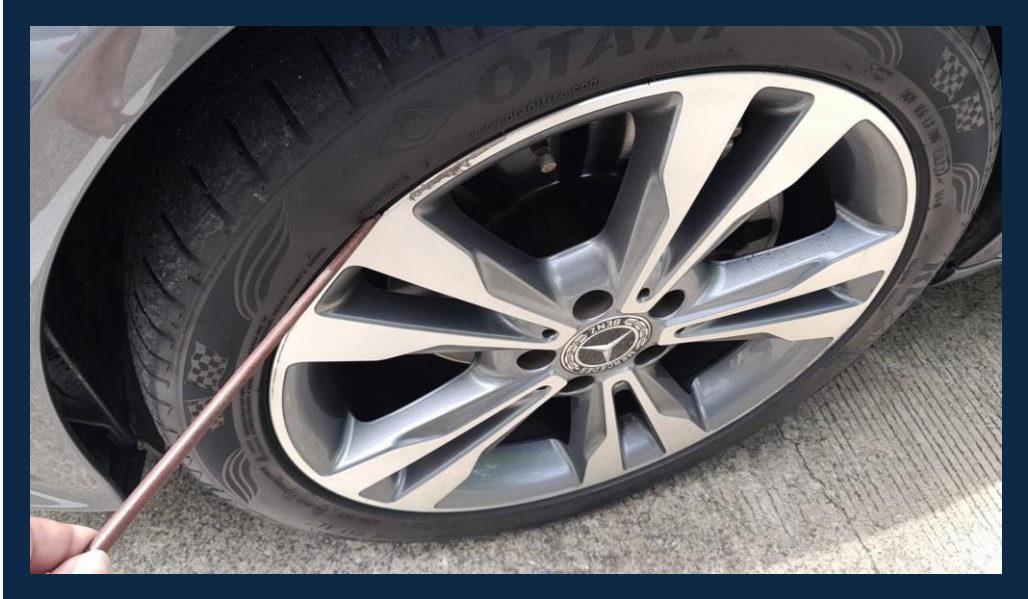
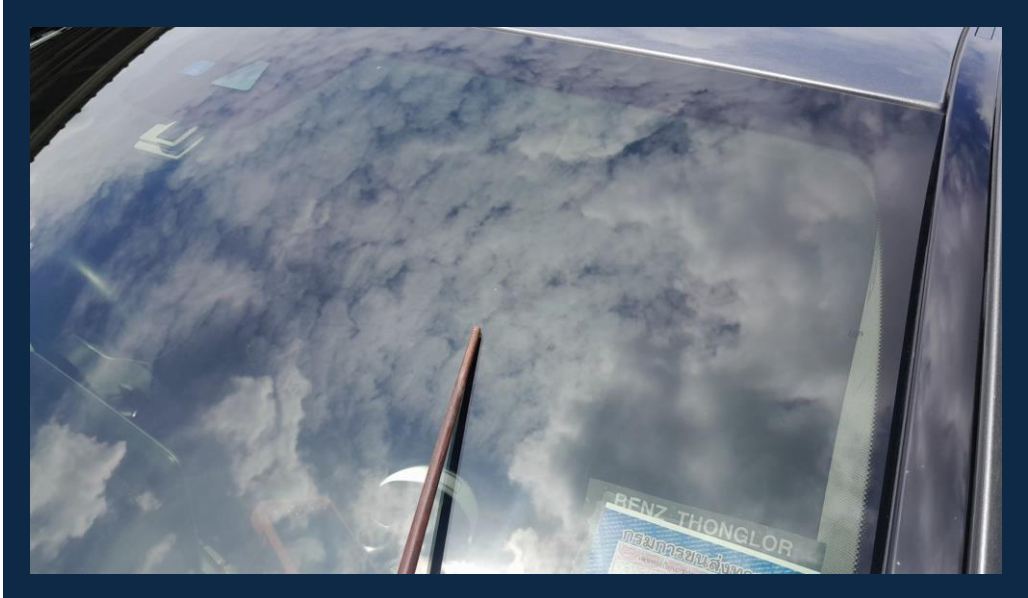
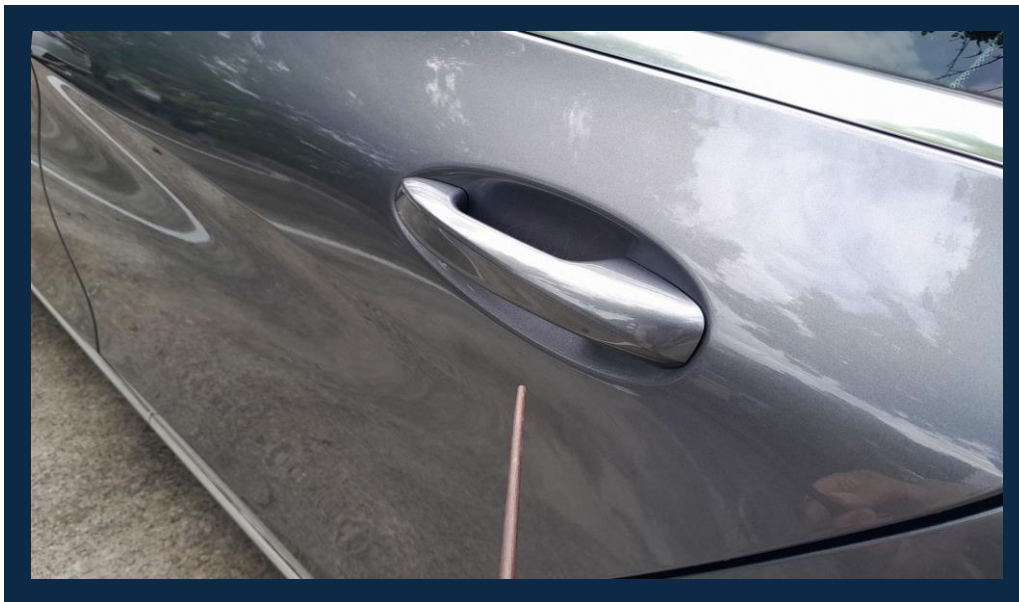
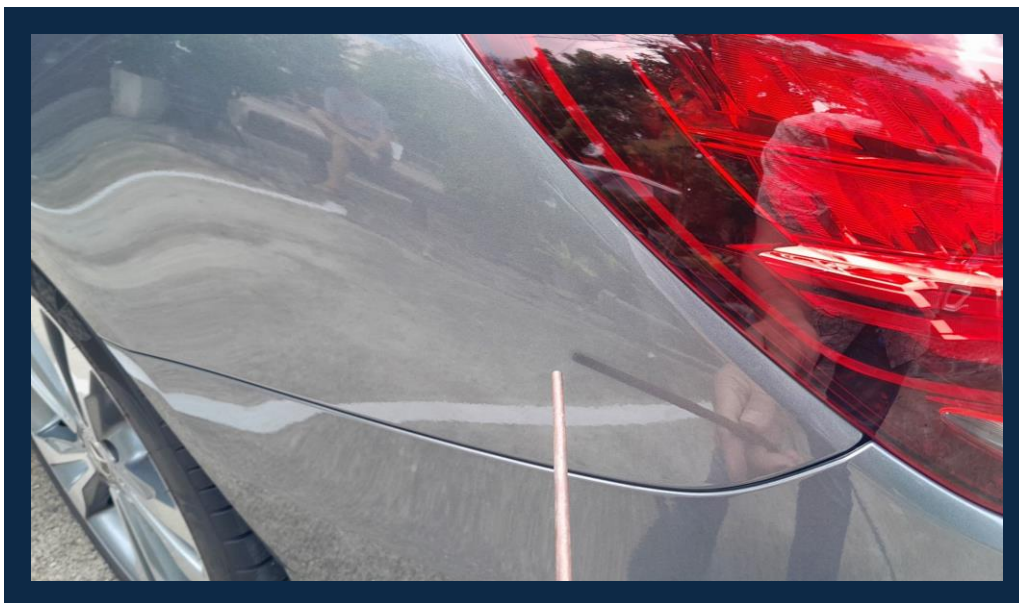
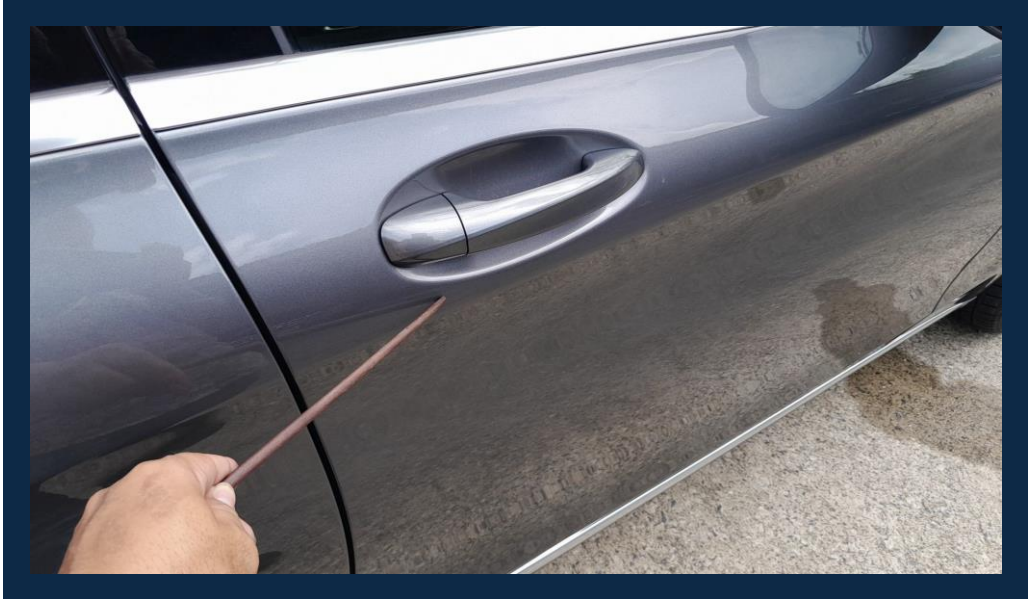
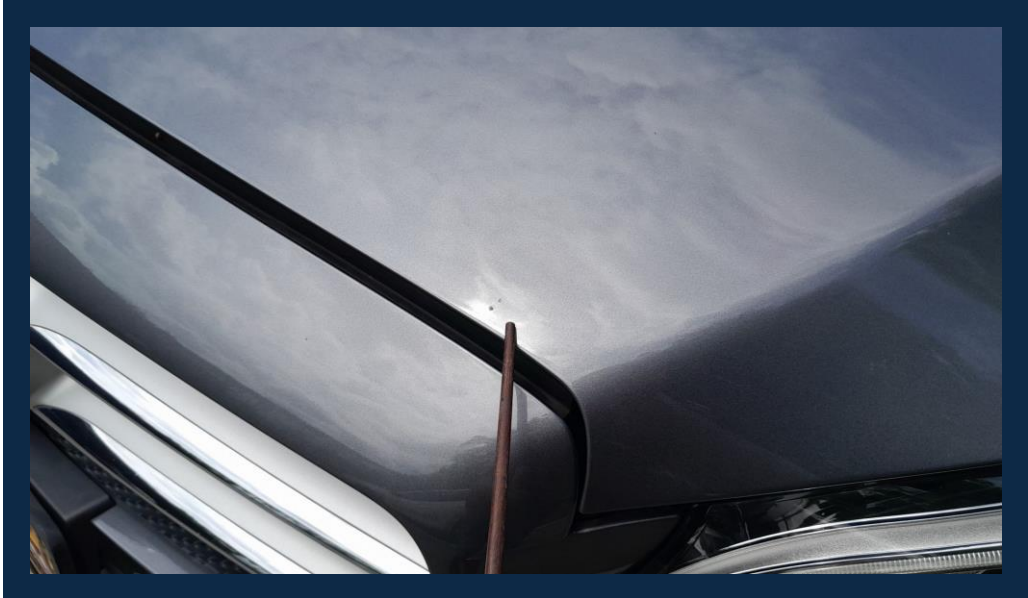
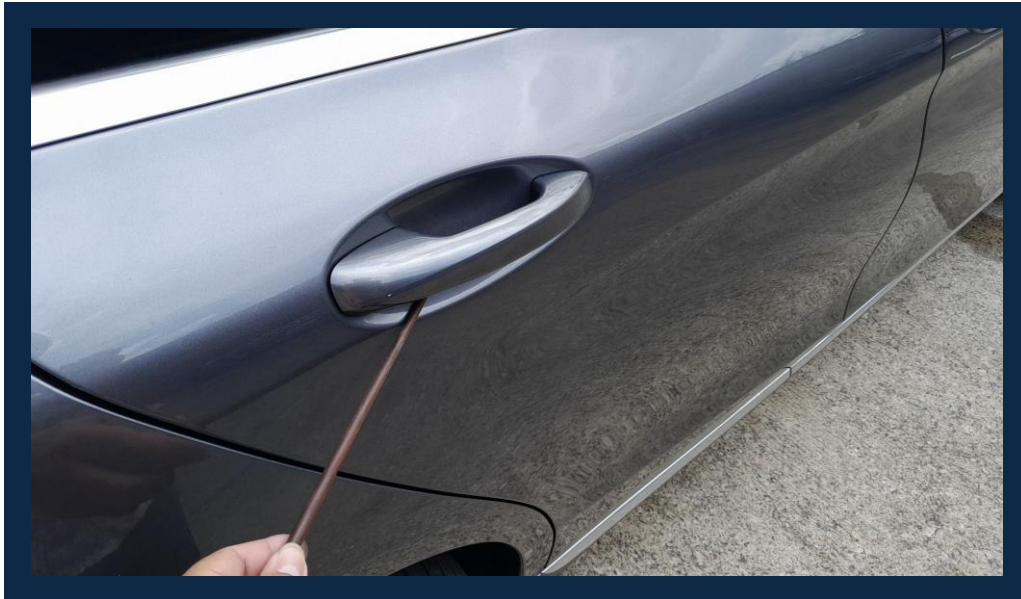
Vehicle Defect Notices

Inspector : ภายนอก(Exterior) : การตรวจสอบสภาพภายนอกโดยรวมไม่พบหลักฐานการซ่อมแซมทำสี มีริ้วรอยรอบคันเล็กน้อย / สภาพยางปกติทั้ง4เส้น ป 22 แม็กเปอรอยดลอก ภายใน(Interior) : ภายใน เบาะหนาขวาเปอรอยดลอก พานบุหลังคาเปอรอยย่น/ฟลัมเปอรอยพอง สะอาดเรียบร้อย อุปกรณ์ไฟฟ้า แอร์ วิทยุFM ใช้งานได้สมบูรณ์ครบปกติ เครื่องยนต์(Engine) : เครื่องยนต์ทำงานได้ปกติ วิเคราะห์ปัญหาด้วยเครื่อง OBDII ไม่พบสิ่งผิดปกติ (ไม่ได้ทดสอบ ขับขี่) โครงสร้าง(Frame) : อุบัติเหตุไม่มี โครงสร้างหลักปกติ ไม่มีการซ่อมแซมโครงสร้างหรือมีการชนถึงโครงสร้าง

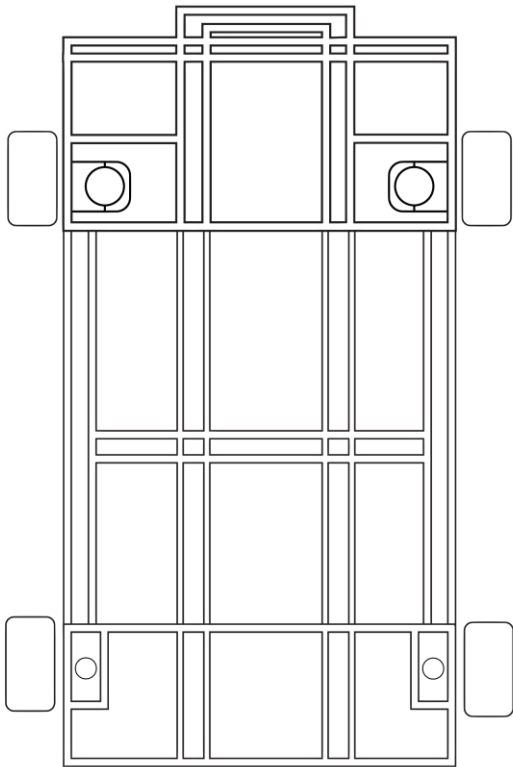
Chassis Report

No dent in the under carriage (th)	PASS
No deform chassis or chassis frame (th)	PASS
No visible corrosion on the chassis or chassis frame (th)	PASS
No missing part on the chassis frame (th)	PASS
Half cut Analysis (th)	PASS
Chassis Damage Level	No Damage
