# Preowned Vehicle Inspection Report

Premium Inspection Analysis

**Vehicle :** MERCEDES BENZ E350

**Inspection date :** 2024-07-01

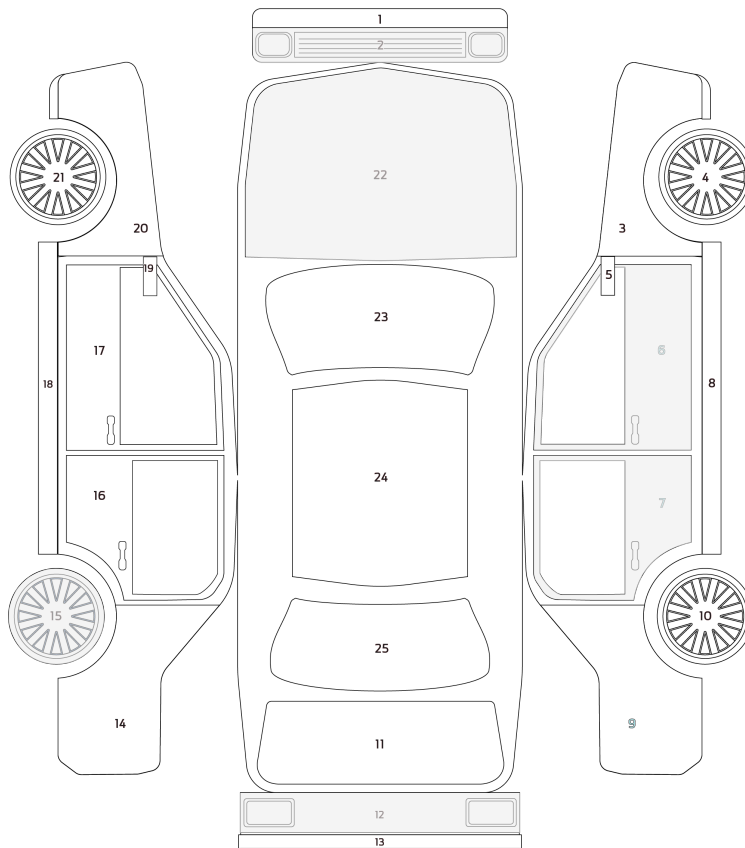
**Exterior Inspection Points**

1. Front Skirt	O	14. Left Skirt	O
2. Front Bumper	O (S1)	15. Left Wing Mirror	O
3. Front Right Fender	O	16. Front Windshield	O
4. Front Right Wheel	O	17. Roof	O
5. Front Left Fender	O	18. Rear Right Fender	O
6. Front Left Wheel	O	19. Rear Bonnet	O
7. Front bonnet	O (S1)	20. Back Right Wheel	O
8. Right Wing Mirror	O	21. Rear Bumper	O (S1)
9. Front right door	O (S1)	22. Rear Skirt	O
10. Rear right door	O (S1)	23. Rear Left Fender	O
11. Right Skirt	O	24. Back left wheel	O (S2)
12. Rear Left Door	O	25. Back Windshield	O
13. Front Left Door	O
