# Preowned Vehicle Inspection Report

Customer Name	: MERCEDES-BENZ MOBILITY (THAILAND) CO., LTD.	Inspection Date	: 2024-06-28
Tel.	:	Lemon Inspection ID	: LEMON24060325
Inspector	: ไชยมงคล เบิร์ด ไพโรเลียยง	Approved By	: Tanrak T

Brand	MERCEDES BENZ	Model year	2019
Model	C220	Engine Code - No.	65492080323141
Sub-model	d Avantgarde	Registration year	2019-12-17
Registration No.		Chassis No.	WDD2050146L044153
Current Mileage(km.)	86554	Engine Capacity(cc.)	2000

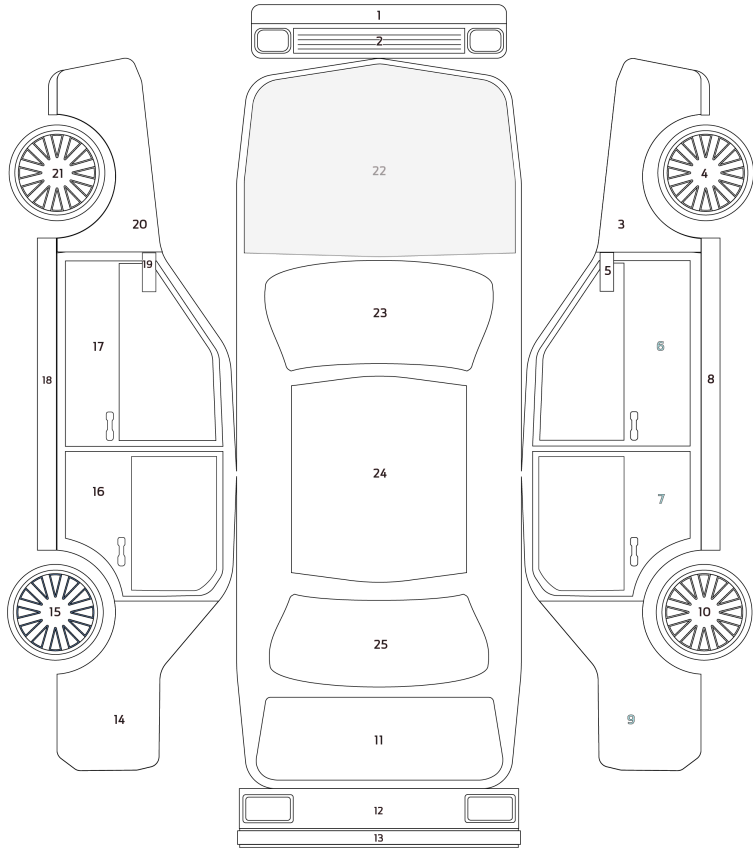
**Exterior Inspection Points**

1. Front Skirt	O	14. Left Skirt	O
2. Front Bumper	O	15. Left Wing Mirror	O
3. Front Right Fender	O	16. Front Windshield	O
4. Front Right Wheel	O	17. Roof	O
5. Front Left Fender	O	18. Rear Right Fender	O
6. Front Left Wheel	O	19. Rear Bonnet	O
7. Front bonnet	O	20. Back Right Wheel	O
8. Right Wing Mirror	O	21. Rear Bumper	O
9. Front Right Door	O	22. Rear Skirt	O
10. Rear Right Door	O	23. Rear Left Fender	O
11. Right Skirt	O	24. Back Left Wheel	O
12. Rear Left Door	O	25. Back Windshield	O
13. Front Left Door	O

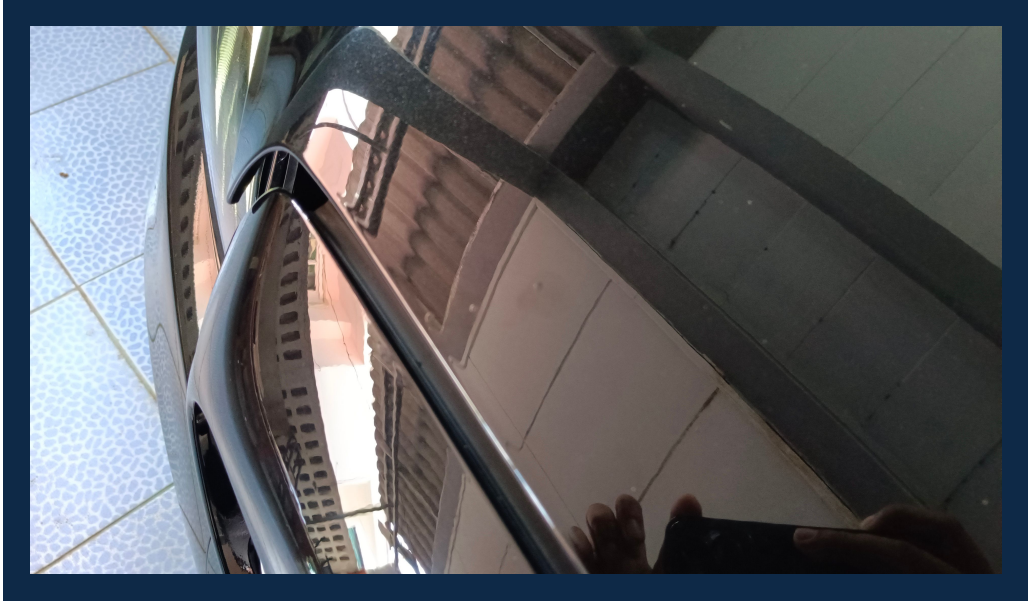
**Vehicle Defect Notices**

**Inspector :** ภายนอก(Exterior) : การตรวจสภาพภายนอกโดยรวมไม่พบหลักฐานการซ่อมแซมทำสี /พบฝากระโปรงหน้ามีรอยแต่มสี/ สภาพยางปกติทั้ง4เส้น ปี21 ภายใน(Interior) : ภายในปกติ เบาะหน้าขวาหนังลอก/สะอาดเรียบร้อย อุปกรณ์ไฟฟ้า แอร์ วิทยุFM ใช้งานได้สมบูรณ์ครบปกติ เครื่องยนต์(Engine) : เครื่องยนต์ทำงานได้ปกติ วิเคราะห์ปัญหาด้วยเครื่อง OBDII ไม่พบสิ่งผิดปกติ (ไม่ได้ทดสอบขับขี) โครงสร้าง(Frame) : อุบัติเหตุไม่มี โครงสร้างหลักปกติ ไม่มีการซ่อมแซมโครงสร้างหรือมีการชนถึงโครงสร้าง

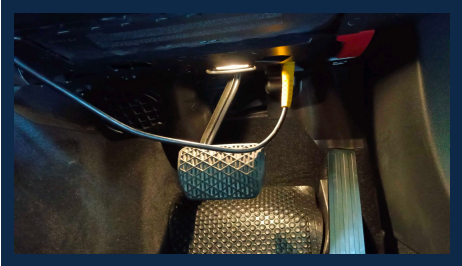
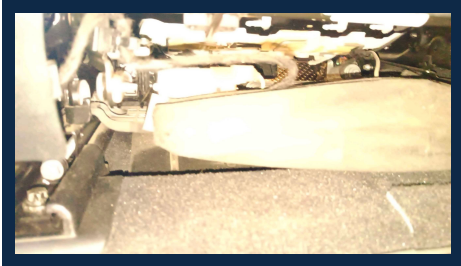
**Flood Report**

Evidence of Flood	No
-------------------	----

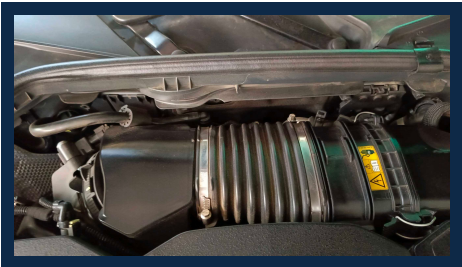
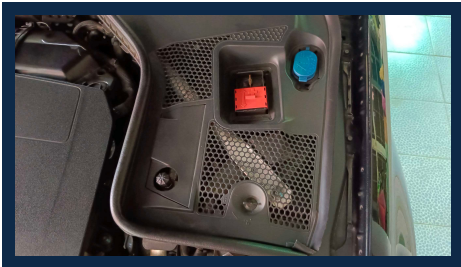
**Fire Report**

Evidence of Fire	No
------------------	----
