# Preowned Vehicle Inspection Report

Customer Name	: MERCEDES-BENZ MOBILITY (THAILAND) CO., LTD.	Inspection Date	: 2024-07-02
Tel.		Lemon Inspection ID	: LEMON24070016
Inspector	: สุวัฒน์ วัฒน ทองพิมพ์	Approved By	: Chaimongkol C

Brand	MERCEDES BENZ	Model year	2019
Model	C220	Engine Code - No.	65492080382790
Sub-model	d Avantgarde	Registration year	2019-10-11
Registration No.		Chassis No.	WDD205016L048229
Current Mileage(km.)	35786	Engine Capacity(cc.)	2000

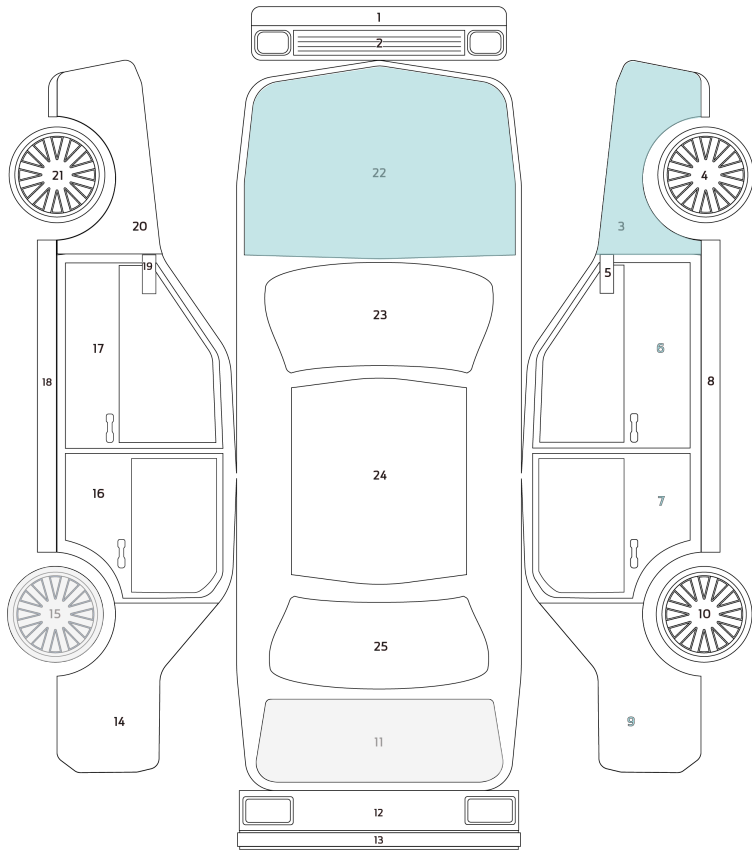
**Exterior Inspection Points**

1. Front Skirt	O	14. Left Skirt	O
2. Front Bumper	O	15. Left Wing Mirror	O
3. Front Right Fender	BP	16. Front Windshield	O
4. Front Right Wheel	O	17. Roof	O
5. Front Left Fender	O	18. Rear Right Fender	O
6. Front Left Wheel	O	19. Rear Bonnet	O
7. Front bonnet	BP	20. Back Right Wheel	O
8. Right Wing Mirror	O	21. Rear Bumper	O
9. Front Right Door	O	22. Rear Skirt	O
10. Rear Right Door	O	23. Rear Left Fender	O
11. Right Skirt	O	24. Back left wheel	O (S1)
12. Rear Left Door	O	25. Back Windshield	O
13. Front Left Door	O

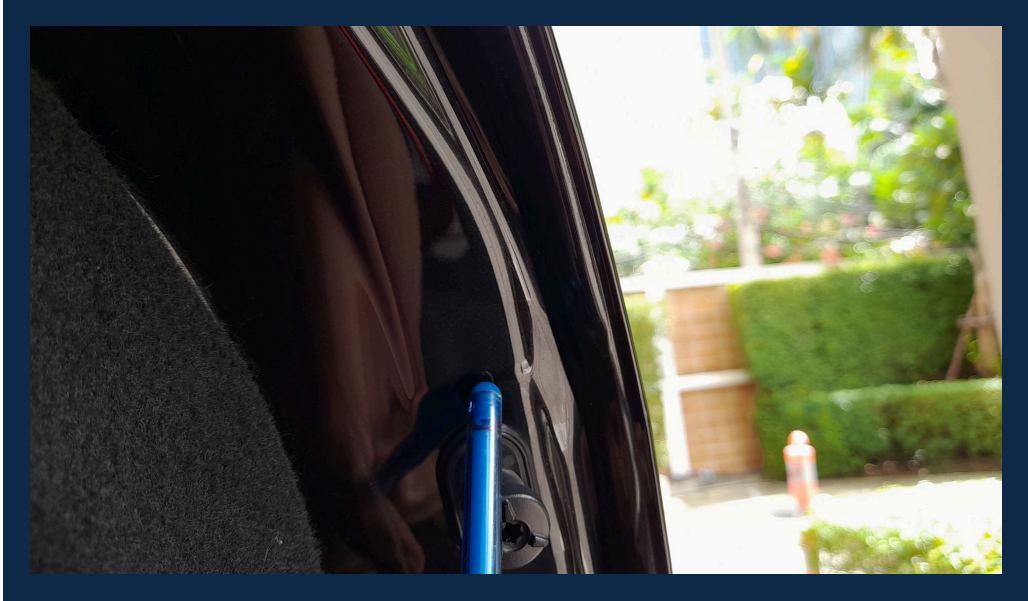
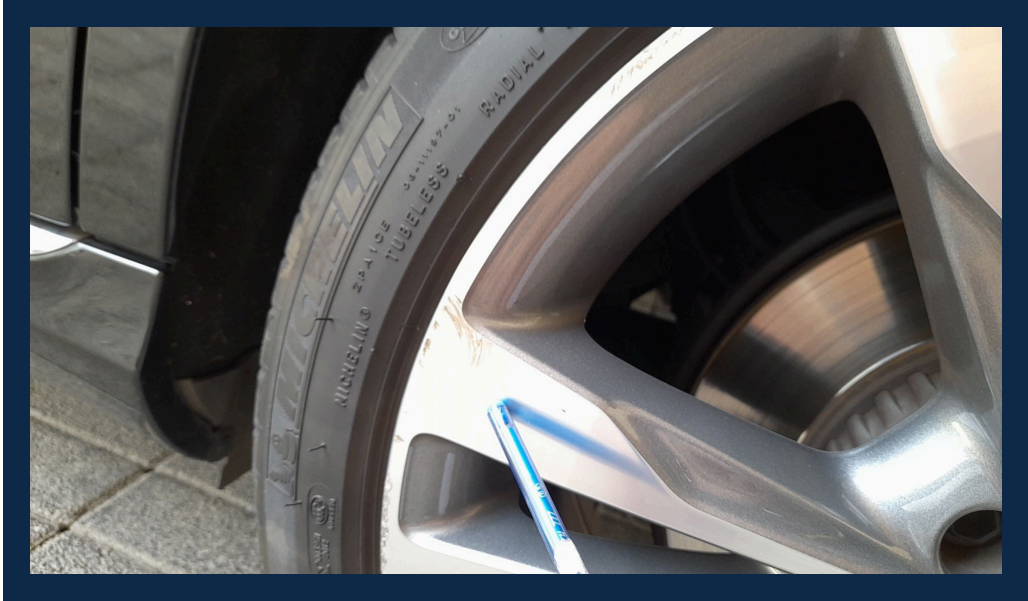
**Vehicle Defect Notices**

**Inspector :** หมายเหตุ\* ภายนอก(Exterior) : การตรวจสภาพภายนอกโดยรวมพบหลักฐานการซ่อมแซมทำสี ฝากระโปรงหน้า บังโคลนหน้าขวา ฝาท้ายถอดซ่อมสี ล้อหลังฝั่งซ้ายครูด สภาพยางเสื่อมทั้ง4เส้น ปี18 ภายใน(Interior) : ภายในปกติไม่มีความเสียหาย สะอาดเรียบร้อย อุปกรณ์ไฟฟ้า แอร์ วิทยุFM ใช้งานได้สมบูรณ์ครบปกติ เครื่องยนต์(Electric) : เครื่องยนต์ทำงานได้ปกติ วิเคราะห์ปัญหาด้วยเครื่อง OBDII ไม่พบสิ่งผิดปกติ (ไม่ได้ทดสอบขั้วขี้) โครงสร้าง(Frame) : อุบัติเหตุไม่มี โครงสร้างหลักปกติ ไม่มีการซ่อมแซมโครงสร้างหรือมีการชนถึงโครงสร้าง
