Preowned Vehicle Inspection Report

Customer Name	: MERCEDES-BENZ MOBILITY (THAILAND) CO., LTD.	Inspection Date	: 2024-07-06
Tel.		Lemon Inspection ID	: LEMON24070107
Inspector	: ไซยมงคล ไพโรสัยง	Approved By	: แทนรัก ทิพย์อินทร์

Brand	MERCEDES BENZ	Model year	2019
Model	E350	Engine Code - No.	27492031706069
Sub-model	e AMG Dynamic	Registration year	2022-07-26
Registration No.		Chassis No.	WDD2130506L023244
Current Mileage(km.)	87822	Engine Capacity(cc.)	2000

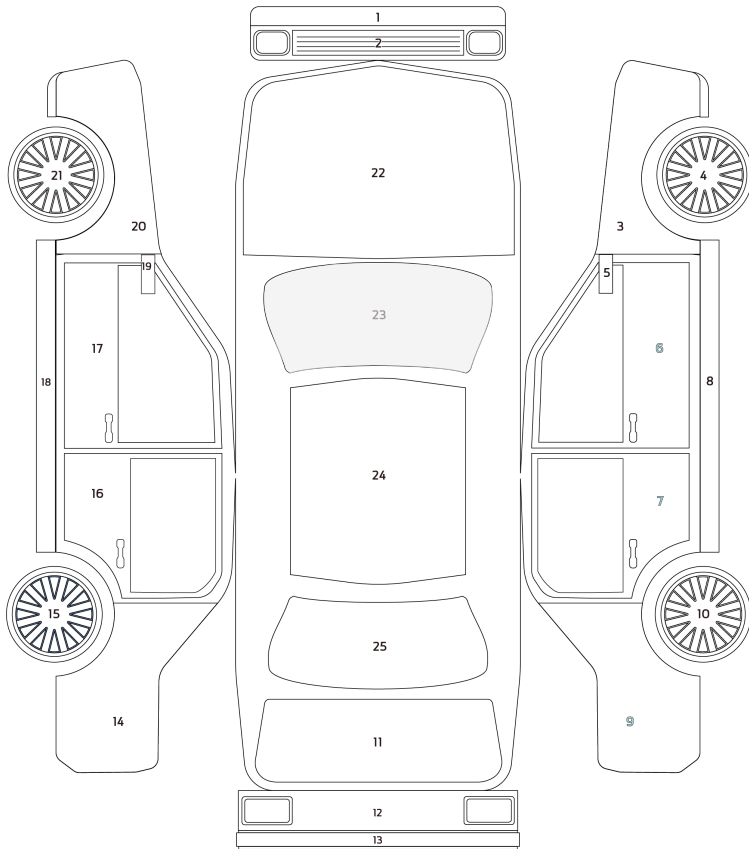
Exterior Inspection Points

1. Front Skirt	O	14. Left Skirt	O
2. Front Bumper	O	15. Left Wing Mirror	O
3. Front Right Fender	O	16. Front windshield	O (G1)
4. Front Right Wheel	O	17. Roof	O
5. Front Left Fender	O	18. Rear Right Fender	O
6. Front Left Wheel	O	19. Rear Bonnet	O
7. Front Bonnet	O	20. Back Right Wheel	O
8. Right Wing Mirror	O	21. Rear Bumper	O
9. Front Right Door	O	22. Rear Skirt	O
10. Rear Right Door	O	23. Rear Left Fender	O
11. Right Skirt	O	24. Back Left Wheel	O
12. Rear Left Door	O	25. Back Windshield	O
13. Front Left Door	O

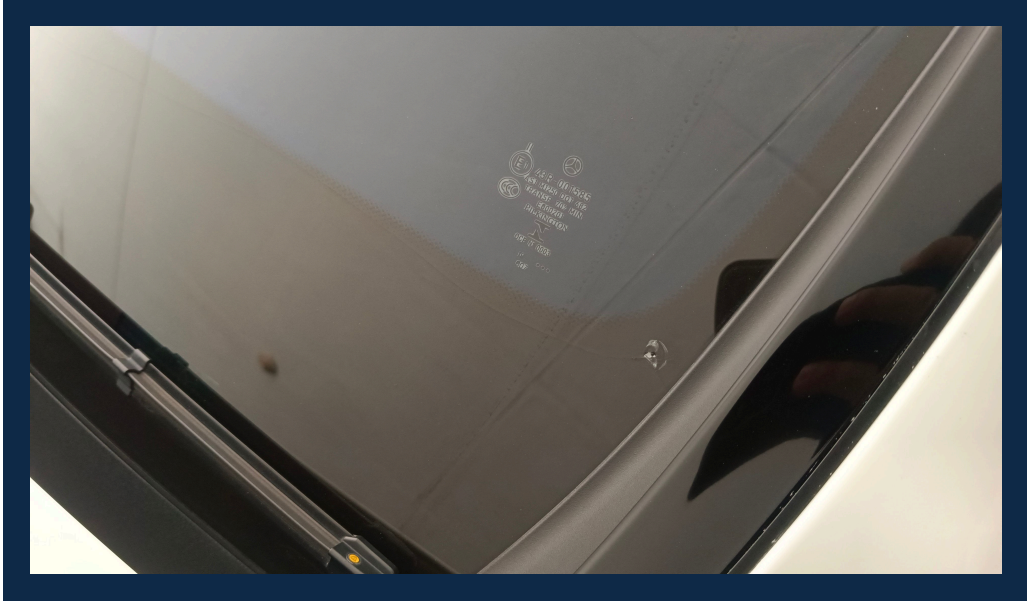
Vehicle Defect Notices

Inspector : ภายนอก(Exterior) : การตรวจสภาพภายนอกโดยรวมพบหลักฐานการเก็บสีมารอบคัน/บันไดฝั่งซ้ายคลูดยาว/กระจกบังลมหน้าแตกจุด สภาพยางปกติทั้ง4เส้น ปี22 หลังซ้ายแถมฉีก ภายใน(Interior) : เบาะหน้าขวาหนังลอก สะอาดเรียบร้อย อุปกรณ์ไฟฟ้า แอร์ วิทยุFM ใช้งานได้สมบูรณ์ครบปกติ เครื่องยนต์(Engine) : เครื่องยนต์ทำงานได้ปกติ วิเคราะห์ปัญหาด้วยเครื่อง OBDII พบสิ่งผิดปกติคือไฟไม่โชว์ แนะนำเข้าศูนย์ตรวจเช็ค (ไม่ได้ทดสอบขับขี) โครงสร้าง(Frame) : อุบัติเหตุไม่มี โครงสร้างหลักปกติ ไม่มีการซ่อมแซมโครงสร้างหรือมีการชนถึงโครงสร้าง พบการถอดคานหมอน้ำบนเพื่อเปลี่ยนอะไหล่

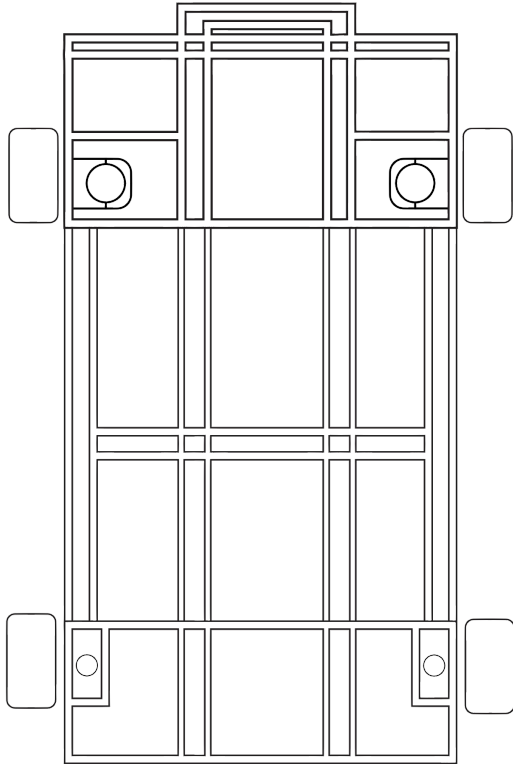
Chassis Report

No dent in the under carriage (th)	PASS
No deform chassis or chassis frame (th)	PASS
No visible corrosion on the chassis or chassis frame (th)	PASS
No missing part on the chassis frame (th)	PASS
Half cut Analysis (th)	PASS

Chassis Damage Level	No Damage
----------------------	-----------
