Vehicle : MERCEDES BENZ GLC220

Chassis number : WDC2539056L023770

Inspection date : 2024-07-08

Vehicle Certification : Pass the inspection standard of SCHIC INSPECTION BY LEMON-AIDE

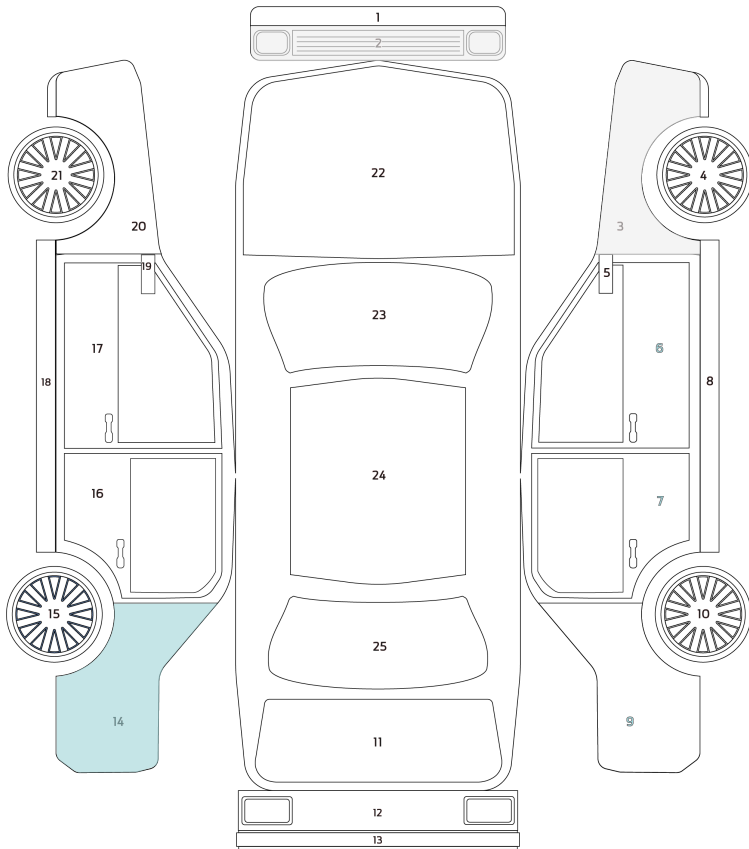
Exterior Inspection Points

1. Front Skirt	O	14. Left Skirt	O
2. Front Bumper	O (S1)	15. Left Wing Mirror	O
3. Front Right Fender	O (S2)	16. Front Windshield	O
4. Front Right Wheel	O	17. Roof	O
5. Front Left Fender	O	18. Rear Right Fender	O
6. Front Left Wheel	O	19. Rear Bonnet	O
7. Front Bonnet	O	20. Back Right Wheel	O
8. Right Wing Mirror	O	21. Rear Bumper	O
9. Front Right Door	O	22. Rear Skirt	O
10. Rear Right Door	O	23. Rear left fender	BP
11. Right Skirt	O	24. Back Left Wheel	O
12. Rear Left Door	O	25. Back Windshield	O
13. Front Left Door	O

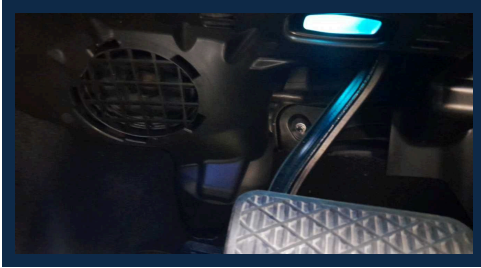
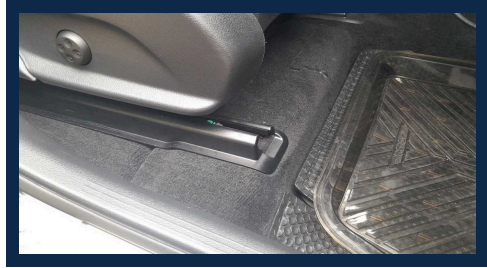
Flood Report

Evidence of Flood	No
-------------------	----

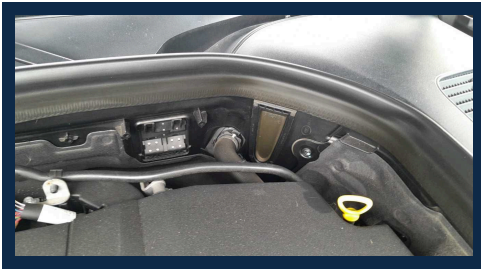
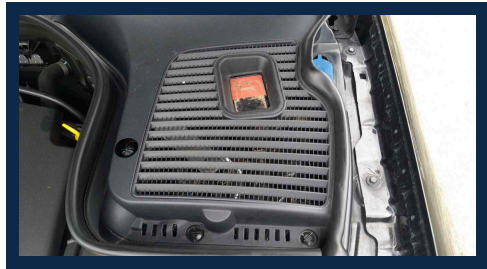
Fire Report

Evidence of Fire	No
------------------	----
