Preowned Vehicle Inspection Report

Premium Inspection Analysis

Inspector Note**Vehicle :** MERCEDES BENZ GLC250**Chassis number :** WDC2539096L022138**Inspection date :** 2024-07-10

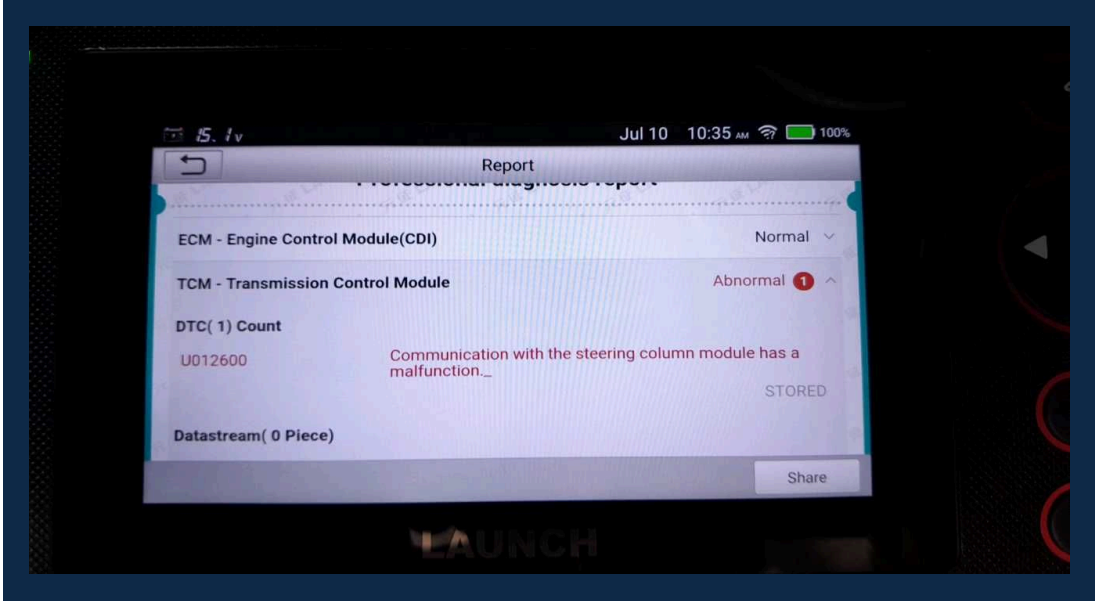
OBD Vehicle Health Analysis

Inspector : ภายนอก(Exterior) : ภายนอกโดยรวมไม่พบหลักฐานการซ่อมแซมทำสี รื้อรอยบุบถลอกเล็กน้อย / สภาพยางปกติทั้ง 4 เส้น ปี 22 ภายใน(Interior) : ภายในปกติ สะอาดเรียบร้อย , อุปกรณ์ไฟฟ้า แอร์ วิทยุ ใช้งานได้ครบปกติ เครื่องยนต์(Engine) : เครื่องยนต์ทำงานได้ปกติ ,วิเคราะห์ปัญหาด้วยเครื่อง OBDII พบสิ่งผิดปกติ แนะนำตรวจเช็คศูนย์บริการ (ไม่ได้ทดสอบขับ) โครงสร้าง(Frame) : อุบัติเหตุไม่มี ,โครงสร้างหลักปกติ ไม่มีการซ่อมแซมโครงสร้าง หรือมีการชนถึงโครงสร้าง

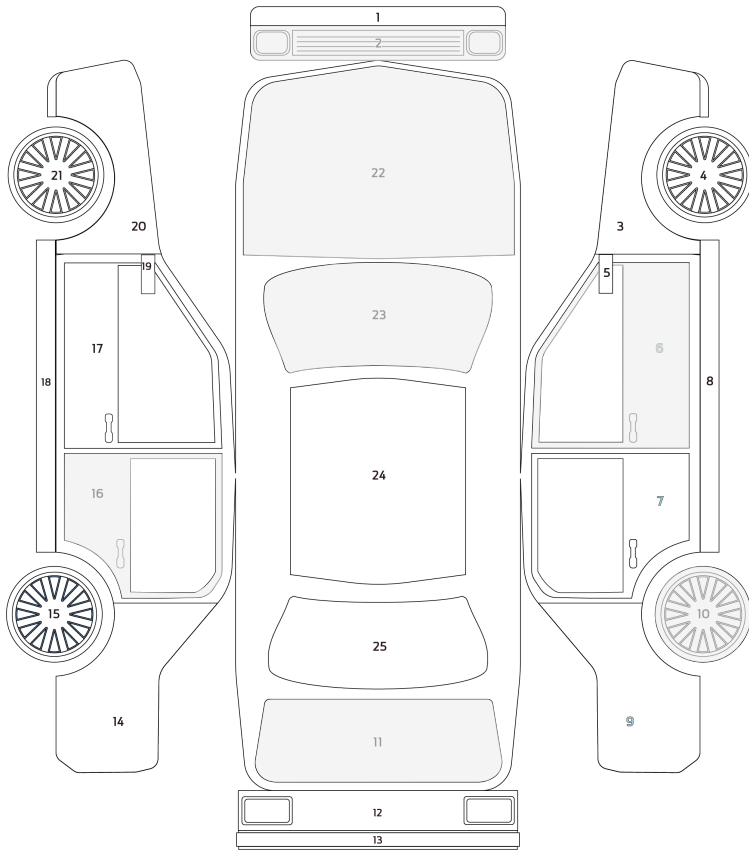
Exterior Inspection Points

1. Front Skirt	O	14. Left Skirt	O
2. Front Bumper	O (S1)	15. Left Wing Mirror	O
3. Front Right Fender	O	16. Front windshield	O (G1)
4. Front Right Wheel	O	17. Roof	O
5. Front Left Fender	O	18. Rear Right Fender	O
6. Front Left Wheel	O	19. Rear Bonnet	O (S2)
7. Front bonnet	O (S2)	20. Back right wheel	O (S1)
8. Right Wing Mirror	O	21. Rear Bumper	O
9. Front right door	O (S1)	22. Rear Skirt	O
10. Rear Right Door	O	23. Rear Left Fender	O
11. Right Skirt	O	24. Back Left Wheel	O
12. Rear Left door	O (D2)	25. Back Windshield	O
13. Front Left Door	O
