# Preowned Vehicle Inspection Report

Premium Inspection Analysis

Brand	MERCEDES BENZ	Model year	2018
Model	CLA200	Engine Code - No.	27091031694759
Sub-model	URBAN	Registration year	2019-09-03
Registration No.		Chassis No.	WDD1173436L010551
Current Mileage(km.)	113382	Engine Capacity(cc.)	1600

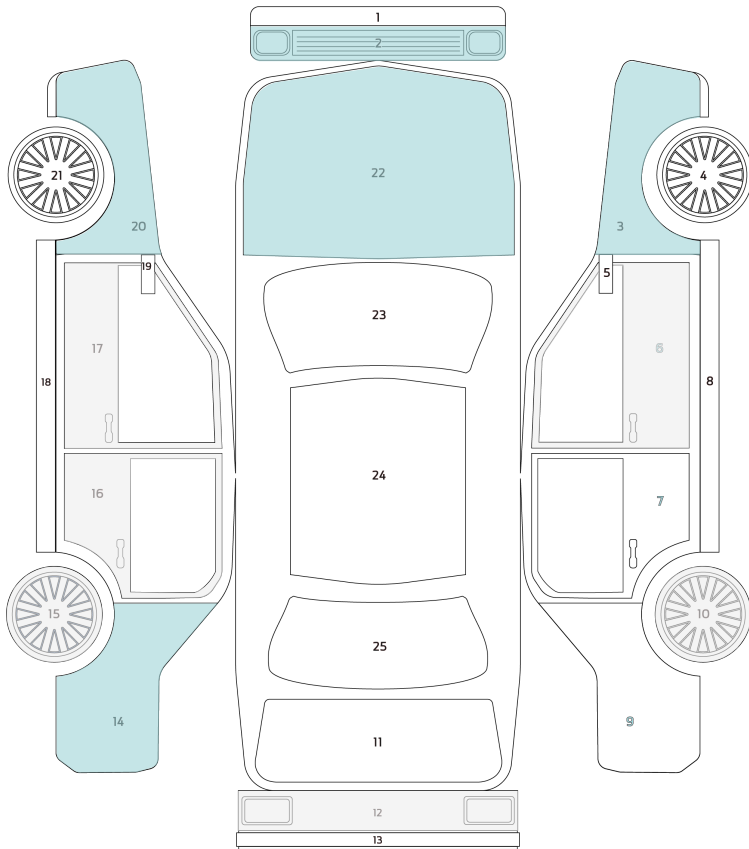
1. Front Skirt	O	14. Left Skirt	O
2. Front Bumper	BP (S2)	15. Left Wing Mirror	O
3. Front Right Fender	BP	16. Front Windshield	O
4. Front Right Wheel	O	17. Roof	O
5. Front Left Fender	BP	18. Rear Right Fender	O
6. Front Left Wheel	O	19. Rear Bonnet	O
7. Front bonnet	BP (D1)	20. Back right wheel	O (S2)
8. Right Wing Mirror	O	21. Rear Bumper	O (S1)
9. Front right door	O (G1)	22. Rear Skirt	O
10. Rear Right Door	O	23. Rear left fender	BP
11. Right Skirt	O	24. Back left wheel	O (S1)
12. Rear Left door	O (D1)	25. Back Windshield	O
13. Front left door	O (S1)

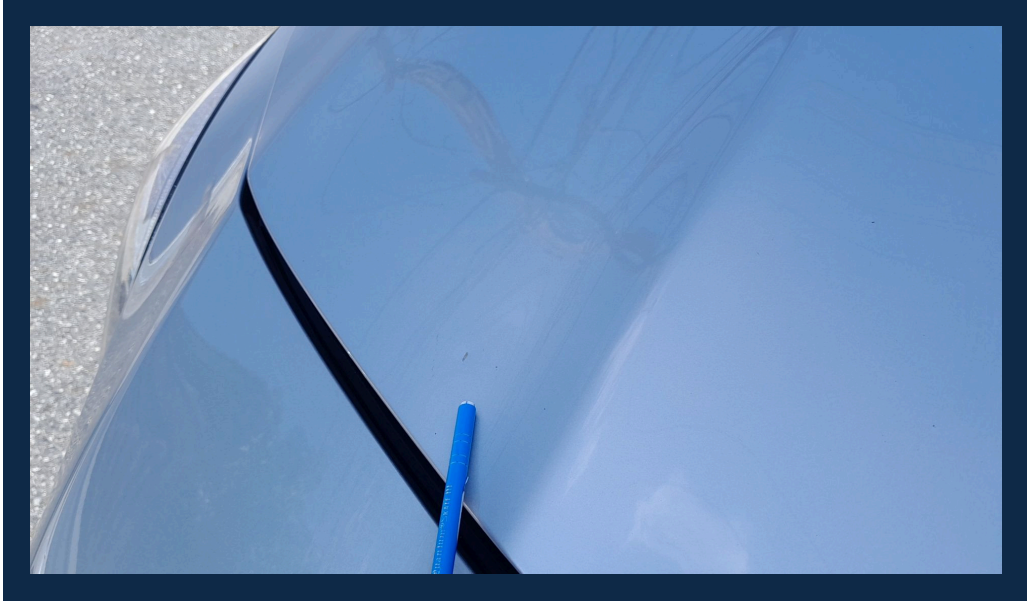
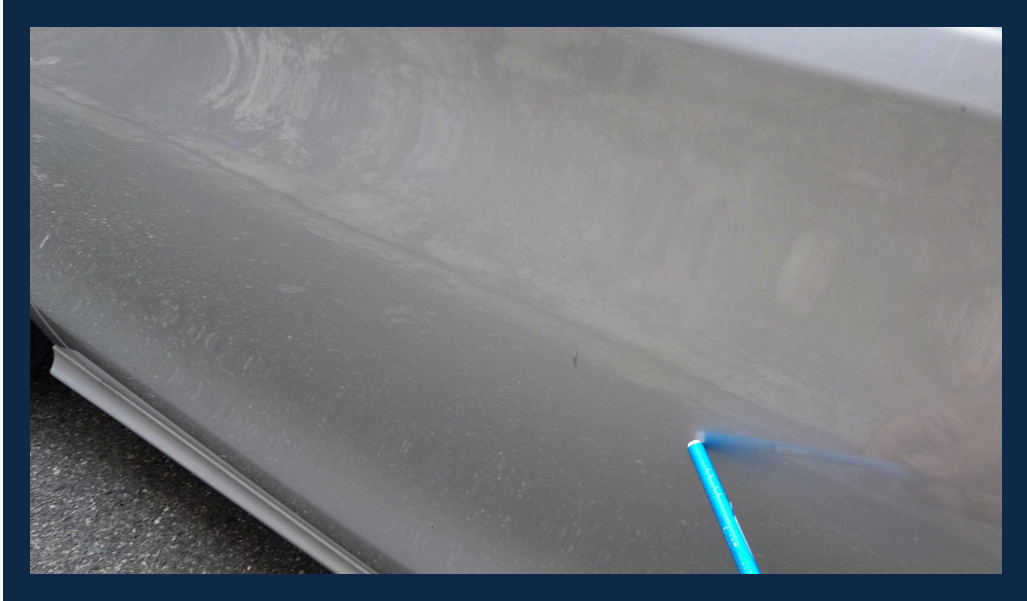
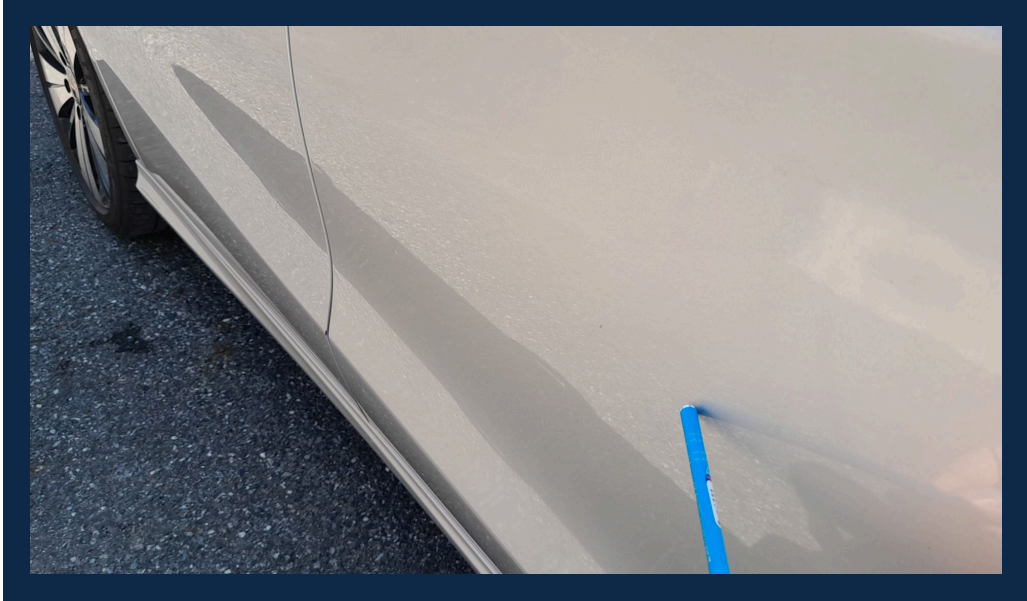
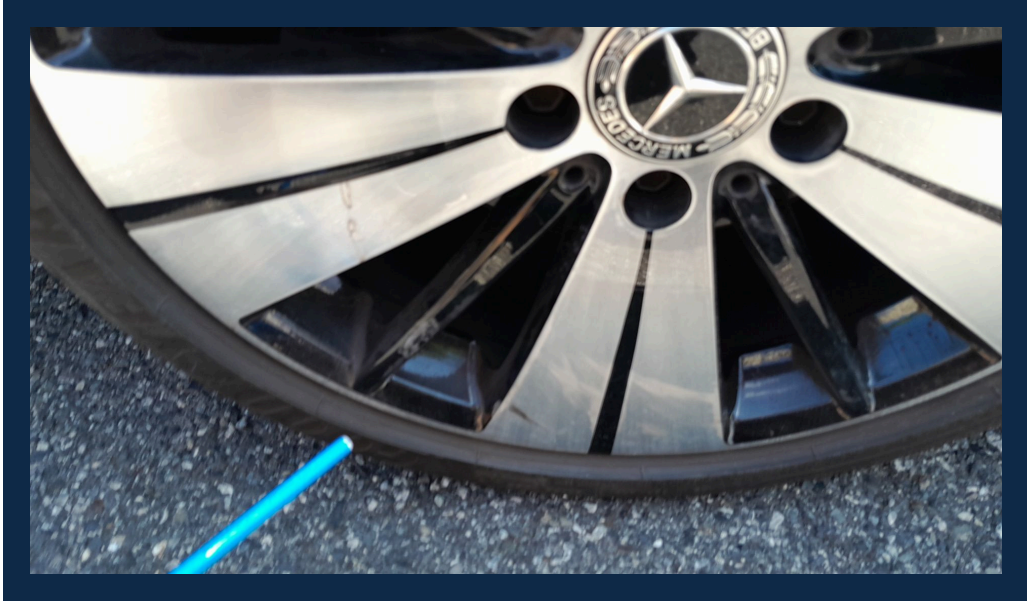
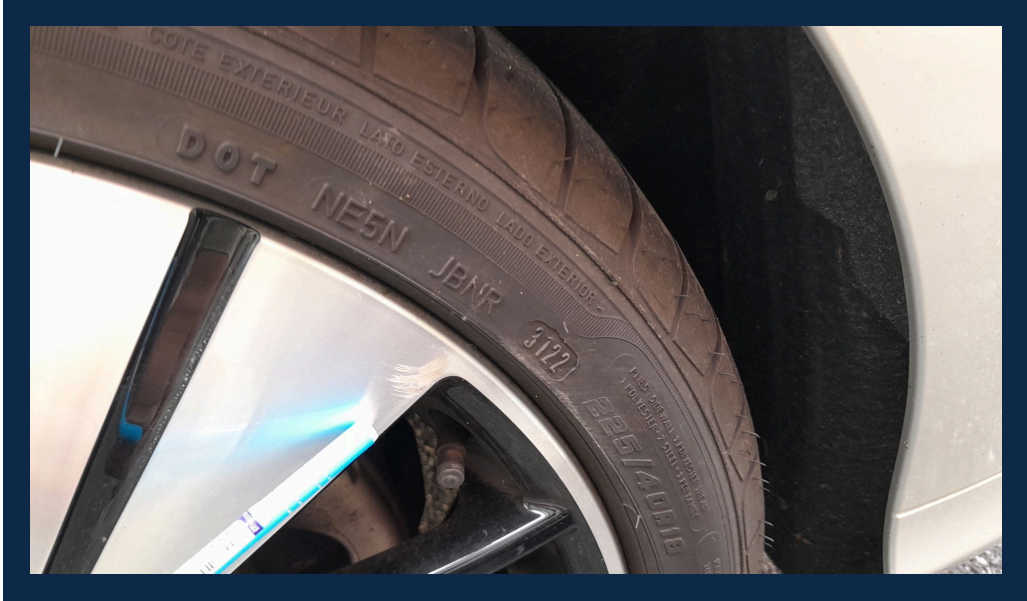
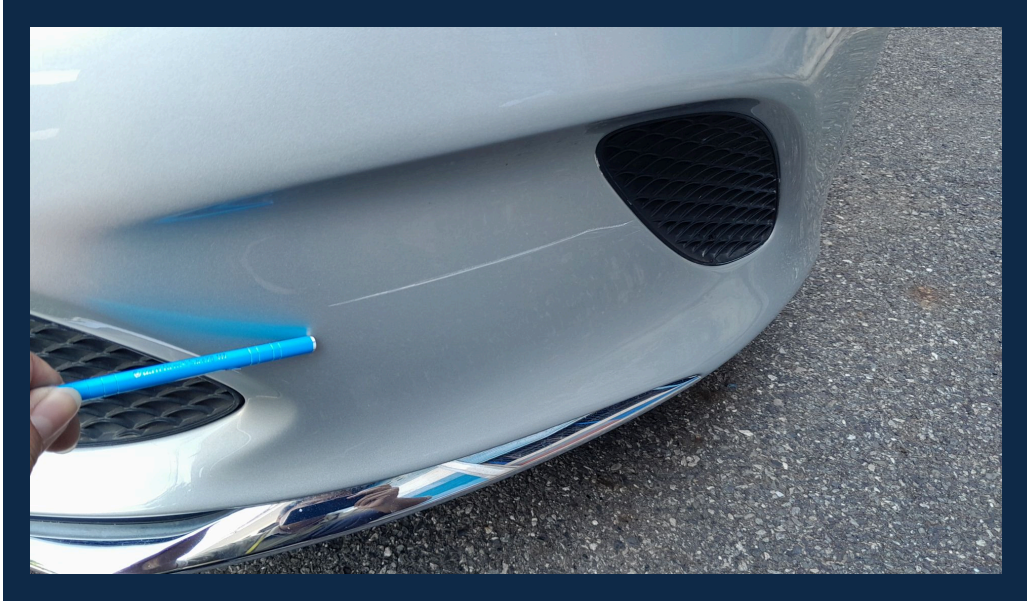
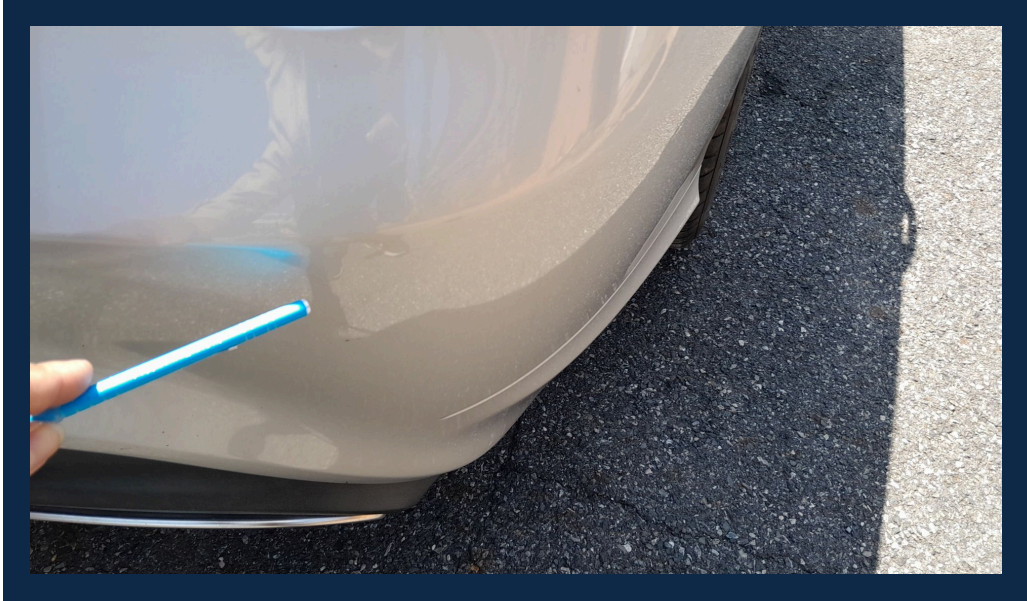
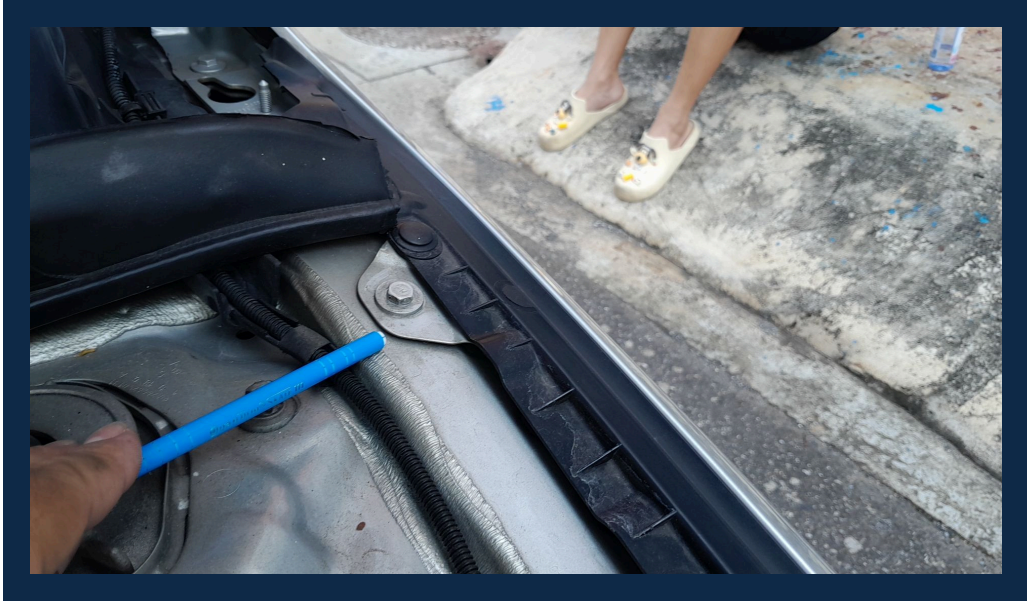
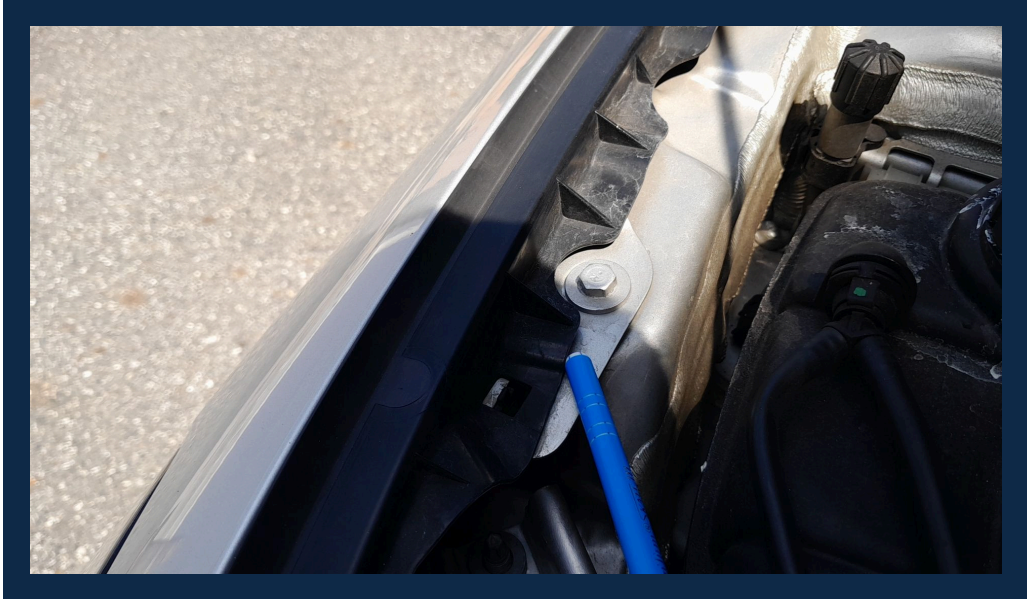
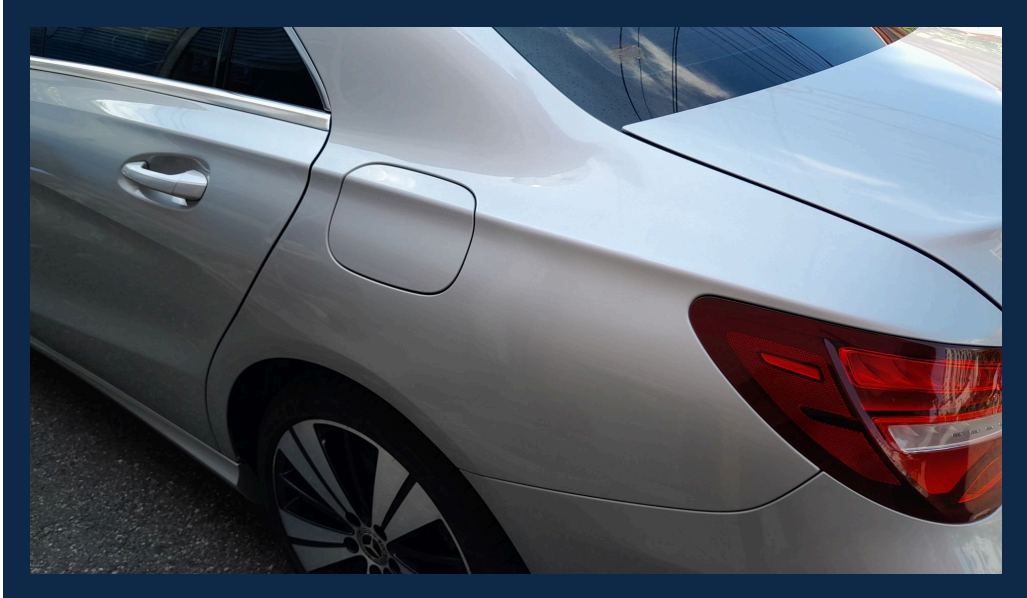
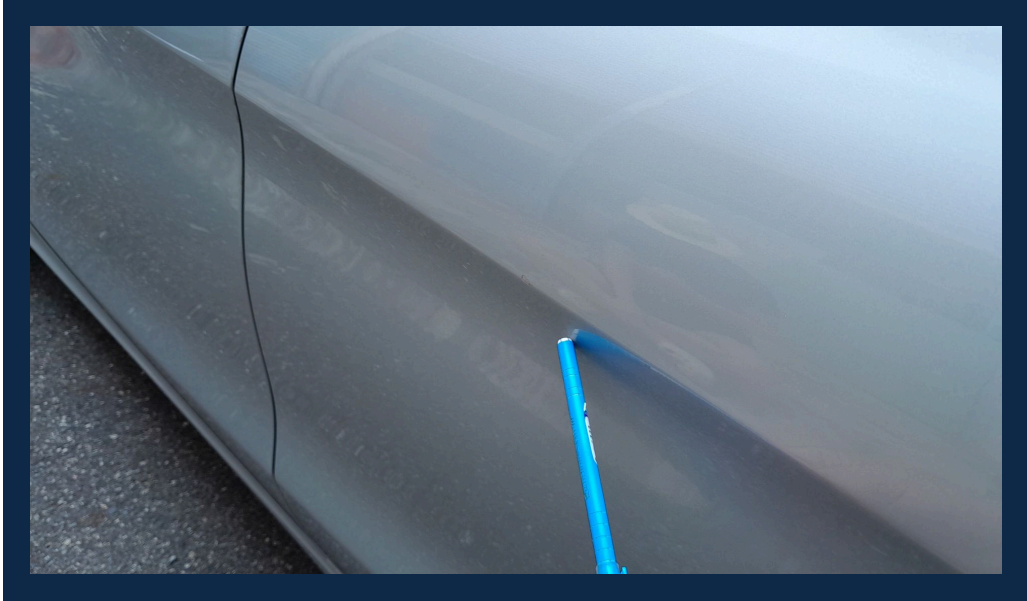
**Vehicle Defect Notices**

**Inspector :** ภายนอก(Exterior) : การตรวจสภาพภายนอกโดยรวมพบหลักฐานการซ่อมแซมทำสีบ้างชิ้น แก้มหน้าซ้าย ขวาทอดทำสี รั้วรอยถลอกรอบคันเล็กน้อย/ สภาพยางปกติทั้ง3เส้น ปี 22 ยางหลังขวาเสื่อมสภาพ ล้อแม็กรอยถลอก ภายใน(Interior) : ภายในเบาะเป็นรอยขาด ยางขอบประตูขวาเป็นรอยขาด สะอาดเรียบร้อย ,อุปกรณ์ไฟฟ้า แอร์ วิทยุFM ใช้งานได้สมบูรณ์ครบปกติ เครื่องยนต์(Engine) : เครื่องยนต์ทำงานได้ปกติ ,วิเคราะห์ปัญหาด้วยเครื่อง OBDII ไม่พบสิ่งผิดปกติ (ไม่ได้ทดสอบขั้วขี้) โครงสร้าง(Frame) : อุบัติเหตุไม่มี ,โครงสร้างหลักปกติ ไม่มีการซ่อมแซม โครงสร้างหรือมีการชนถึงโครงสร้าง

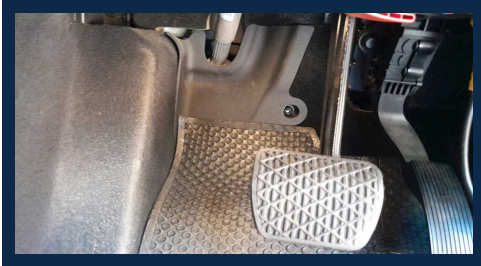
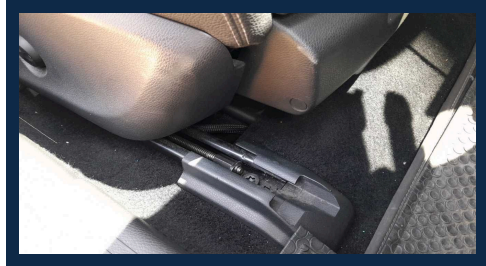
**Flood Report**

Evidence of Flood	No
-------------------	----

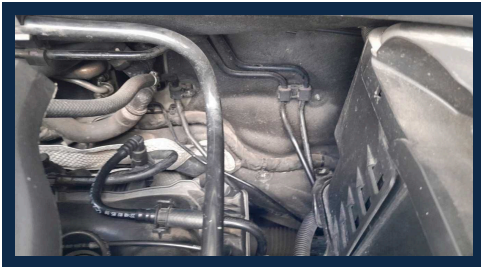
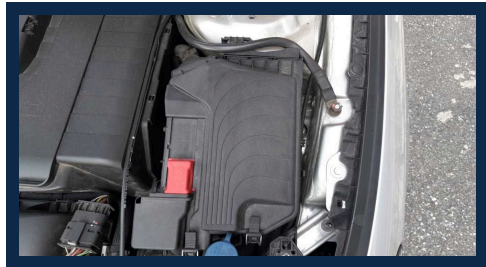
**Fire Report**

Evidence of Fire	No
------------------	----
