# Preowned Vehicle Inspection Report

Premium Inspection Analysis

**Vehicle :** MERCEDES BENZ C250

**Inspection date :** 2024-07-08

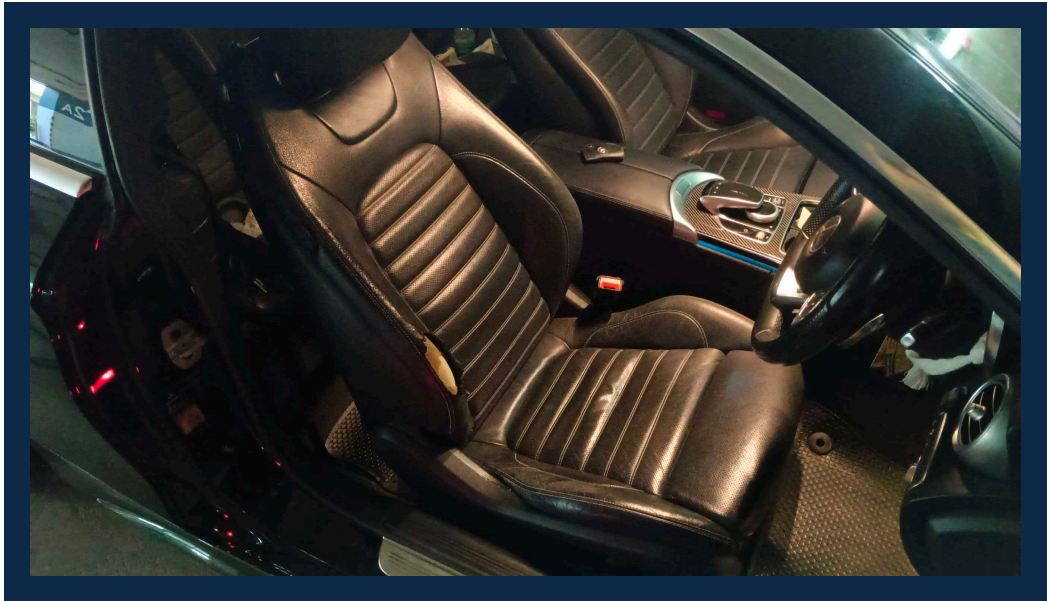
Passenger Front Seat Image

**Inspector :** ภายนอก(Exterior) : การตรวจสอบสภาพภายนอกโดยรวมพบหลักฐานการเก็บสีรอบคัน แก้มหน้าซ้ายถอดทำสี / สภาพยางปกติทั้ง4เส้น ปี 23 ภายใน(Interior) : ภายในสะอาดเรียบร้อย/เบาะหน้าขวาฉีกขาด,อุปกรณ์ไฟฟ้า แอร์ วิทยุFM ใช้งานได้สมบูรณ์ครบปกติ เครื่องยนต์(Engine) : เครื่องยนต์ทำงานได้ปกติ ,วิเคราะห์ปัญหาด้วยเครื่อง OBDII ไม่พบสิ่งผิดปกติ (ไม่ได้ทดสอบขับเคลื่อน) โครงสร้าง(Frame) : อุบัติเหตุไม่มี ,โครงสร้างหลักปกติ ไม่มีการซ่อมแซมโครงสร้างหรือมีการชนถึงโครงสร้าง
