Preowned Vehicle Inspection Report

Customer Name	: MERCEDES-BENZ MOBILITY (THAILAND) CO., LTD.	Inspection Date	: 2024-07-12
Tel.	:	Lemon Inspection ID	: LEMON24070177
Inspector	: แทนรัก ทิพย์อินทร์	Approved By	: ไชยมงคล ไพโรเลียง

Brand	MERCEDES BENZ	Model year	2018
Model	E350	Engine Code - No.	27492031551814
Sub-model	e Avantgarde	Registration year	2019-09-03
Registration No.		Chassis No.	WDD2130506L018979
Current Mileage(km.)	122733	Engine Capacity(cc.)	2000

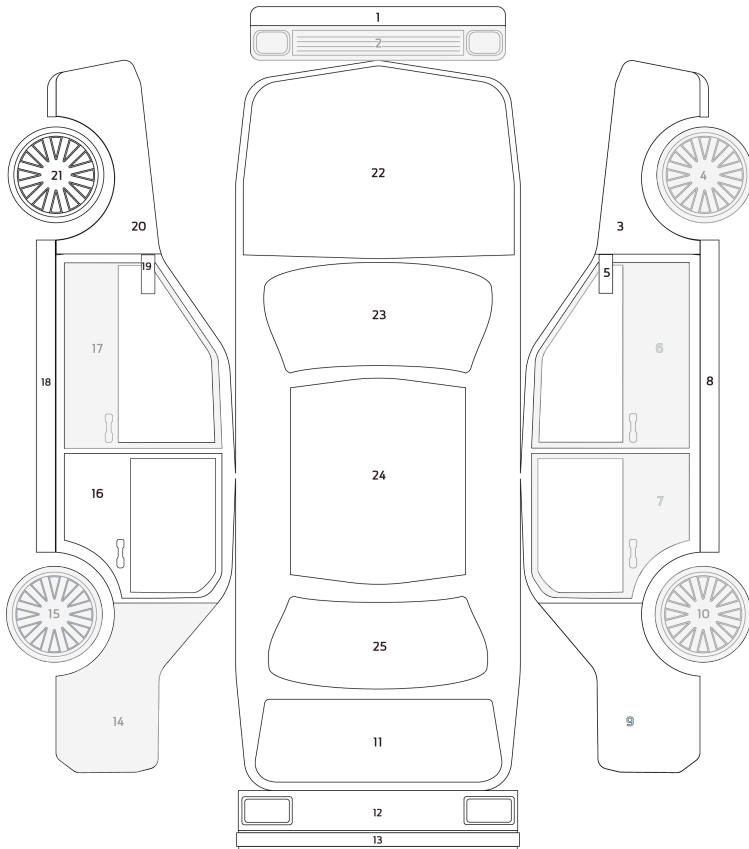
Exterior Inspection Points

1. Front Skirt	O	14. Left Skirt	O
2. Front Bumper	O (S2)	15. Left Wing Mirror	O
3. Front Right Fender	O	16. Front Windshield	O
4. Front Right Wheel	O (S1)	17. Roof	O
5. Front Left Fender	O	18. Rear Right Fender	O
6. Front Left Wheel	O	19. Rear Bonnet	O
7. Front Bonnet	O	20. Back right wheel	O (S2)
8. Right Wing Mirror	O	21. Rear Bumper	O
9. Front right door	O (S1)	22. Rear Skirt	O
10. Rear right door	O (S1)	23. Rear left fender	O (S1)
11. Right Skirt	O	24. Back left wheel	O (S2)
12. Rear Left Door	O	25. Back Windshield	O
13. Front left door	O (S1)

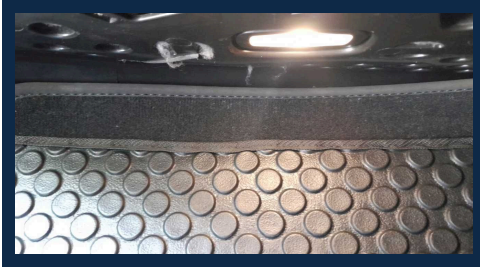
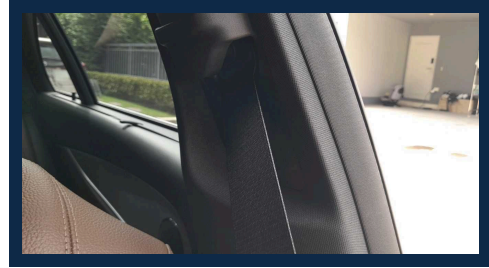
Flood Report

Evidence of Flood

No

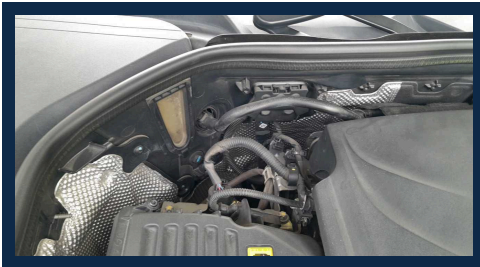
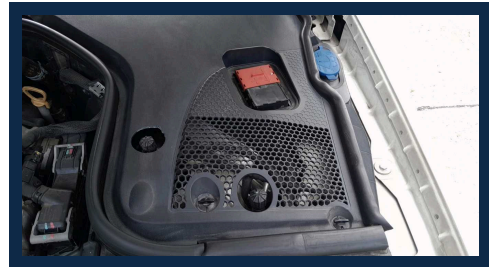
Fire Report

Evidence of Fire

No
