# Preowned Vehicle Inspection Report

Premium Inspection Analysis

**Vehicle :** MERCEDES BENZ E300 ปียแดง

**Chassis number :** W1K2130536L034836

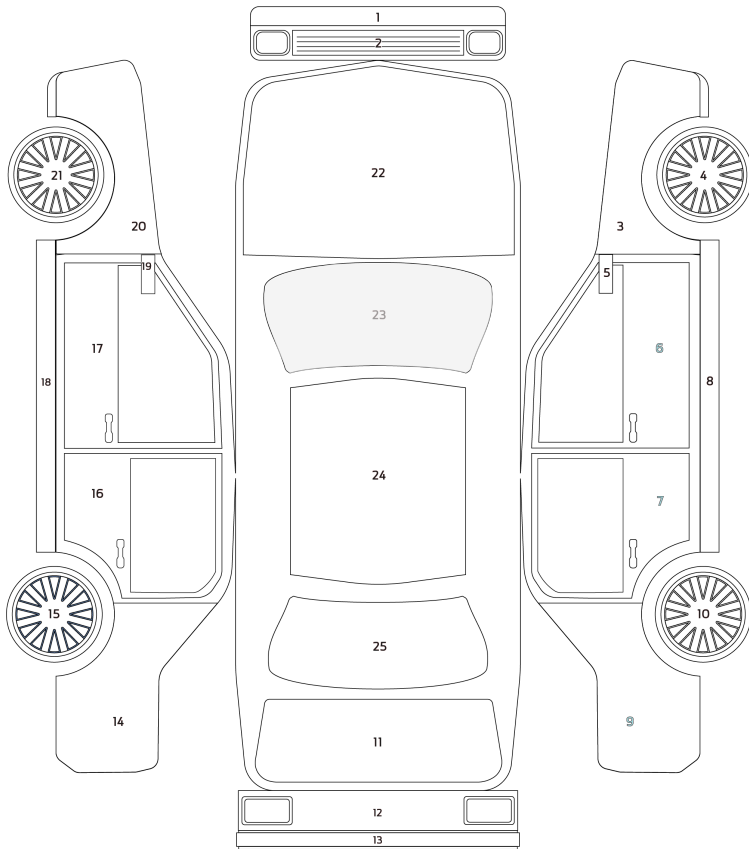
### Exterior Inspection Points

1. Front Skirt	O	14. Left Skirt	O
2. Front Bumper	O	15. Left Wing Mirror	O
3. Front Right Fender	O	16. Front windshield	O (G1)
4. Front Right Wheel	O	17. Roof	O
5. Front Left Fender	O	18. Rear Right Fender	O
6. Front Left Wheel	O	19. Rear Bonnet	O
7. Front Bonnet	O	20. Back Right Wheel	O
8. Right Wing Mirror	O	21. Rear Bumper	O
9. Front Right Door	O	22. Rear Skirt	O
10. Rear Right Door	O	23. Rear Left Fender	O
11. Right Skirt	O	24. Back Left Wheel	O
12. Rear Left Door	O	25. Back Windshield	O
13. Front Left Door	O

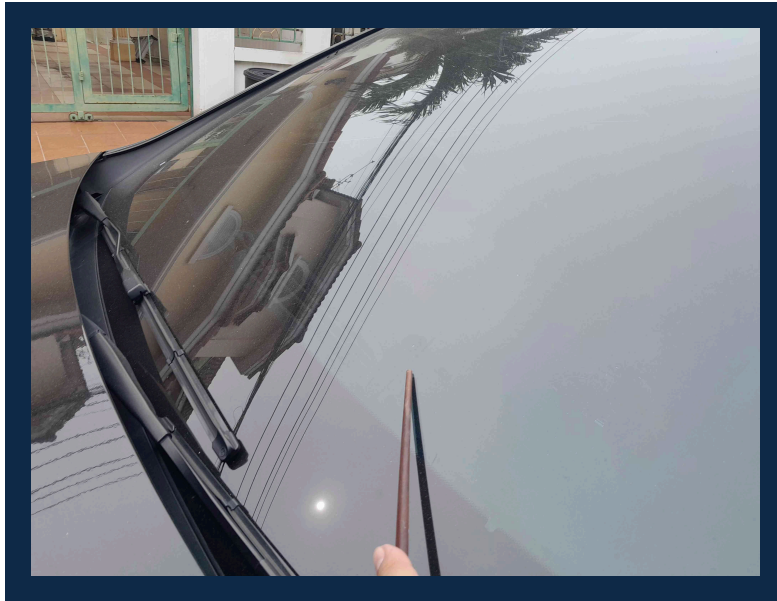
**Vehicle Defect Notices**

**Inspector :** ภายนอก(Exterior) : การตรวจสอบสภาพภายนอกโดยรวมไม่พบหลักฐานการซ่อมแซมทำสี กระจกหน้าเป็นรอยสะเก็ดหิน / สภาพยาง4เส้น ปี 20 เสื่อมสภาพ ภายใน(Interior) : ภายในปกติ สะอาดเรียบร้อย อุปกรณ์ไฟฟ้า แอร์ วิทยุFM ใช้งานได้สมบูรณ์ครบปกติ เครื่องยนต์(Engine) : เครื่องยนต์ทำงานได้ปกติ วิเคราะห์ปัญหาด้วยเครื่อง OBDII พบสิ่งผิดปกติ แนะนำตรวจเช็คศูนย์บริการ (ไม่ได้ทดสอบขับขี) โครงสร้าง(Frame) : อุบัติเหตุไม่มี โครงสร้างหลักปกติ ไม่มีการซ่อมแซมโครงสร้างหรือมีการชนถึงโครงสร้าง
