# Preowned Vehicle Inspection Report

Customer Name	: MERCEDES-BENZ MOBILITY (THAILAND) CO., LTD.	Inspection Date	: 2024-07-11
Tel.	:	Lemon Inspection ID	: LEMON24070164
Inspector	: ไชยมงคล ไพโรลีง	Approved By	: แทนรัก ทิพย์อินทร์

Brand	MERCEDES BENZ	Model year	2019
Model	E350	Engine Code - No.	27492031826643
Sub-model	e Avantgarde	Registration year	2020-03-25
Registration No.		Chassis No.	WDD2130506L026973
Current Mileage(km.)	63140	Engine Capacity(cc.)	2000

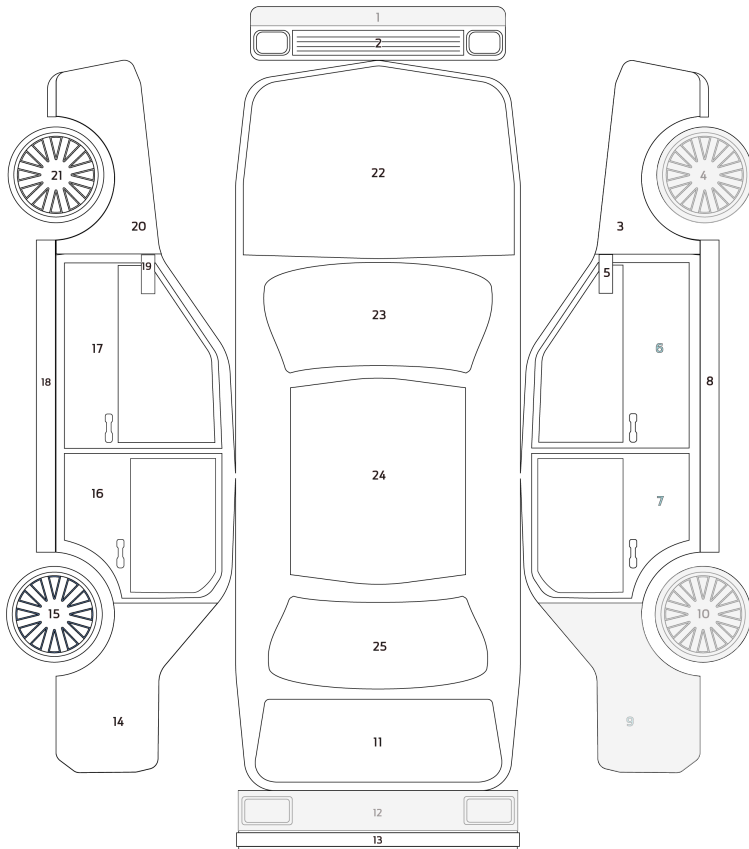
### Exterior Inspection Points

1. Front Skirt	O (S1)	14. Left Skirt	O
2. Front Bumper	O	15. Left Wing Mirror	O
3. Front Right Fender	O	16. Front Windshield	O
4. Front Right Wheel	O (S1)	17. Roof	O
5. Front Left Fender	O	18. Rear right fender	O
6. Front Left Wheel	O	19. Rear Bonnet	O
7. Front Bonnet	O	20. Back right wheel	O (S1)
8. Right Wing Mirror	O	21. Rear Bumper	O
9. Front Right Door	O	22. Rear Skirt	O
10. Rear Right Door	O	23. Rear Left Fender	O
11. Right Skirt	O	24. Back Left Wheel	O
12. Rear Left Door	O	25. Back Windshield	O
13. Front Left Door	O

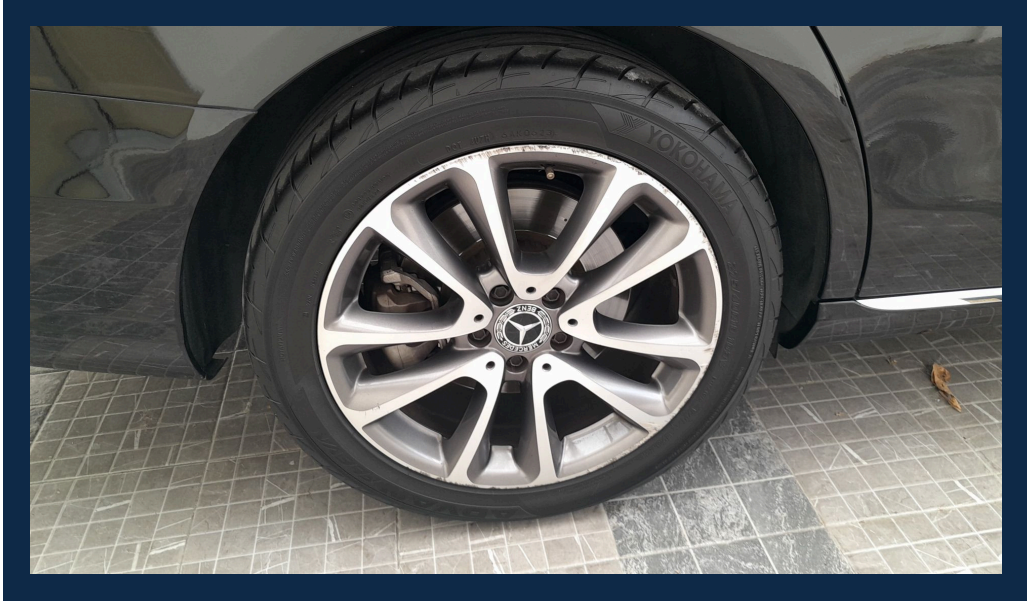
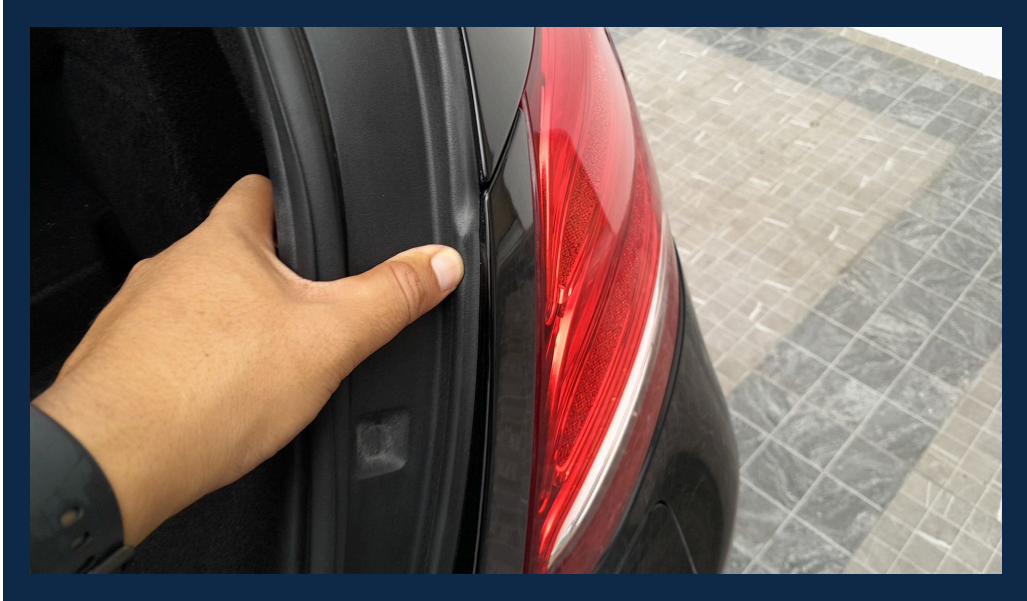
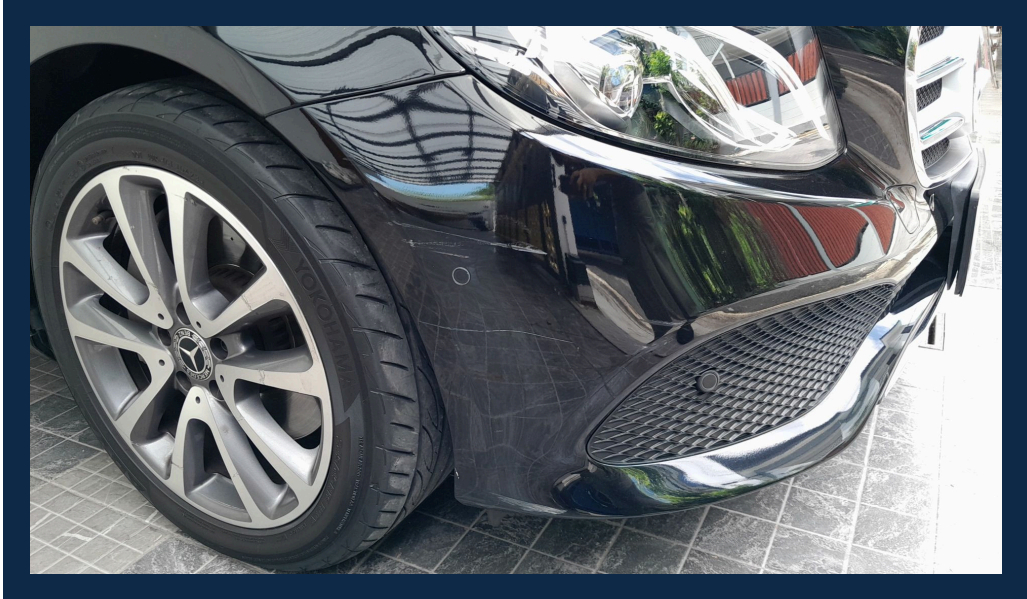
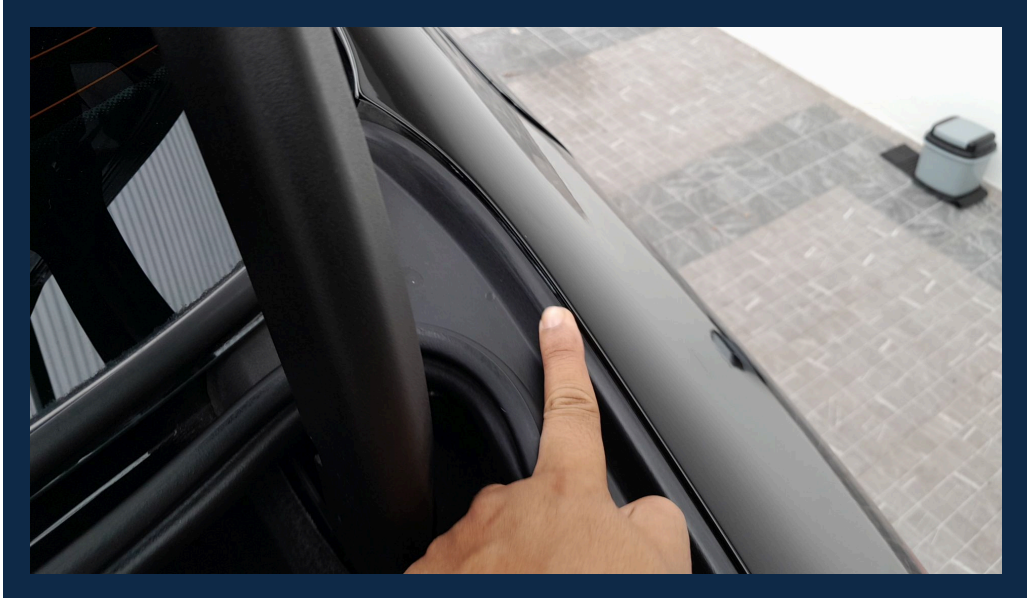
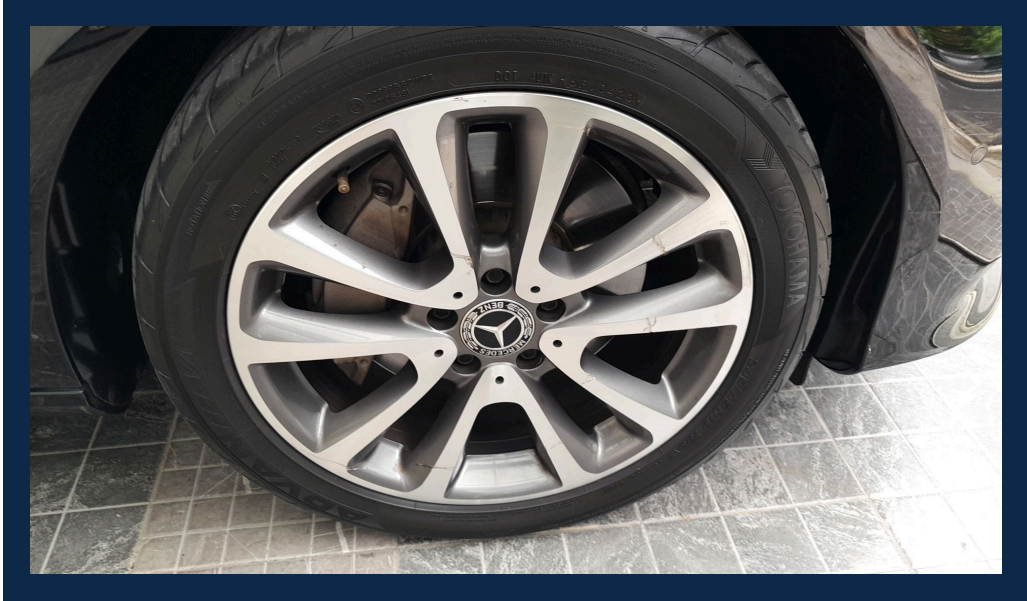
**Vehicle Defect Notices**

**Inspector :** ภายนอก(Exterior) : ภายนอกโดยรวมพบหลักฐานการซ่อมแซมทำสี 2 ชั้น / ล้อแม็กหน้าหลังขวามีรอยถลอก / กันชนหน้าถลอก / สภาพยางปกติทั้ง4เส้น ปี23 ภายใน(Interior) : ภายในปกติ / เบาะหน้าขวาหนังลอก / อุปกรณ์ไฟฟ้า แอร์ วิทยุ ใช้งานได้ปกติ เครื่องยนต์(Engine) : เครื่องยนต์ทำงานได้ปกติ / วิเคราะห์ปัญหาด้วยเครื่อง OBDII ไม่พบสิ่งผิดปกติ (ไม่ได้ทดสอบขั้วขี้) โครงสร้าง(Frame) : อุบัติเหตุไม่มี / โครงสร้างหลักปกติ / ไม่มีการซ่อมแซมโครงสร้างหรือมีการชนถึงโครงสร้าง
