Customer Name	: MERCEDES-BENZ MOBILITY (THAILAND) CO., LTD.	Inspection Date	: 2024-07-15
Tel.		Lemon Inspection ID	: LEMON24070233
Inspector	: ไชยมงคล ไพโรลีเยง	Approved By	: แทนรัก ทิพย์อินทร์

Brand	MERCEDES BENZ	Model year	2021
Model	GLA200	Engine Code - No.	28291430400081
Sub-model	AMG Dynamic	Registration year	2021-01-08
Registration No.		Chassis No.	W1N2477876L000077
Current Mileage(km.)	116220	Engine Capacity(cc.)	1300

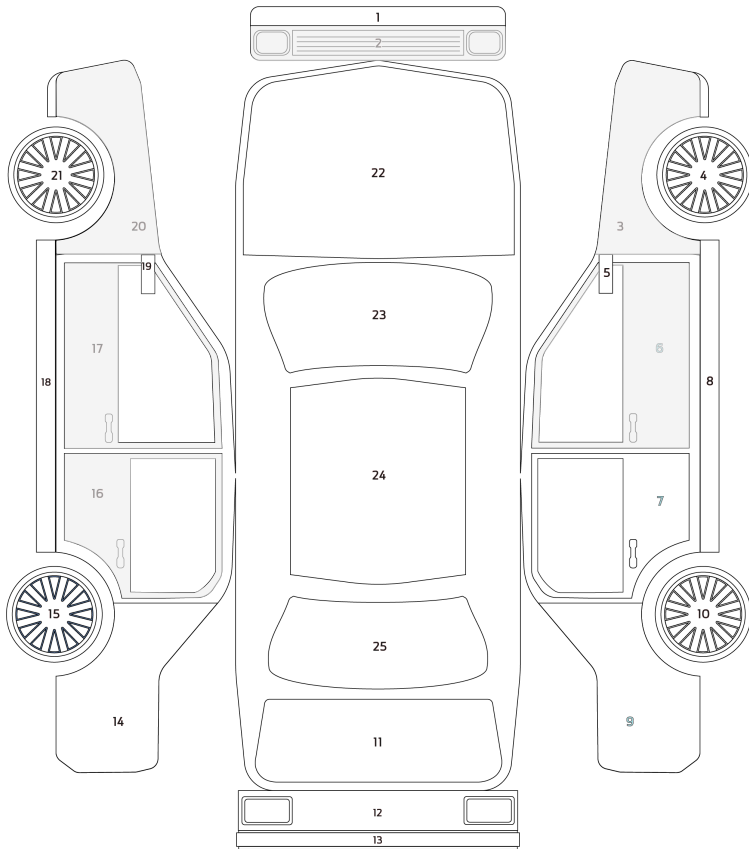
Exterior Inspection Points

1. Front Skirt	O	14. Left Skirt	O
2. Front Bumper	O (S2)	15. Left Wing Mirror	O
3. Front Right Fender	O (S2)	16. Front Windshield	O
4. Front Right Wheel	O	17. Roof	O
5. Front Left Fender	O (S1)	18. Rear Right Fender	O
6. Front Left Wheel	O	19. Rear Bonnet	O
7. Front Bonnet	O	20. Back Right Wheel	O
8. Right Wing Mirror	O	21. Rear Bumper	O
9. Front right door	O (S1)	22. Rear Skirt	O
10. Rear Right Door	O	23. Rear Left Fender	O
11. Right Skirt	O	24. Back Left Wheel	O
12. Rear Left door	O (S1)	25. Back Windshield	O
13. Front left door	O (S1)
