Vehicle : MERCEDES BENZ C220

Chassis number : W1K2060046L009729

Inspection date : 2024-07-15

Vehicle Certification : Pass the inspection standard of SCHIC INSPECTION BY LEMON-AIDE

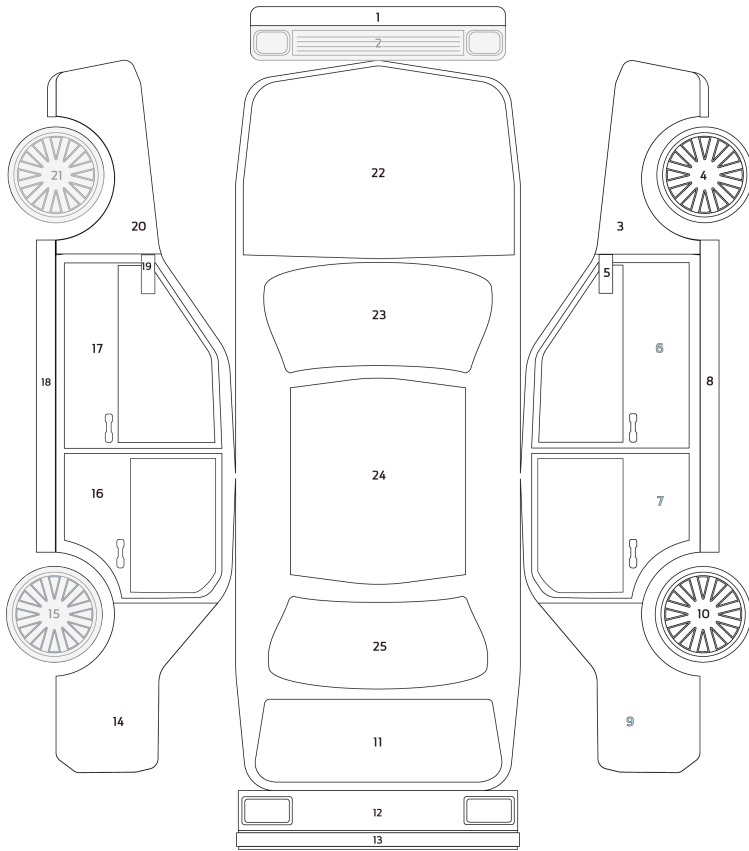
Exterior Inspection Points

1. Front Skirt	O	14. Left Skirt	O
2. Front Bumper	O (S2)	15. Left Wing Mirror	O
3. Front Right Fender	O	16. Front Windshield	O
4. Front Right Wheel	O	17. Roof	O
5. Front Left Fender	O	18. Rear Right Fender	O
6. Front Left Wheel	O (S2)	19. Rear Bonnet	O
7. Front Bonnet	O	20. Back Right Wheel	O
8. Right Wing Mirror	O	21. Rear Bumper	O
9. Front Right Door	O	22. Rear Skirt	O
10. Rear Right Door	O	23. Rear Left Fender	O
11. Right Skirt	O	24. Back left wheel	O (S2)
12. Rear Left Door	O	25. Back Windshield	O
13. Front Left Door	O

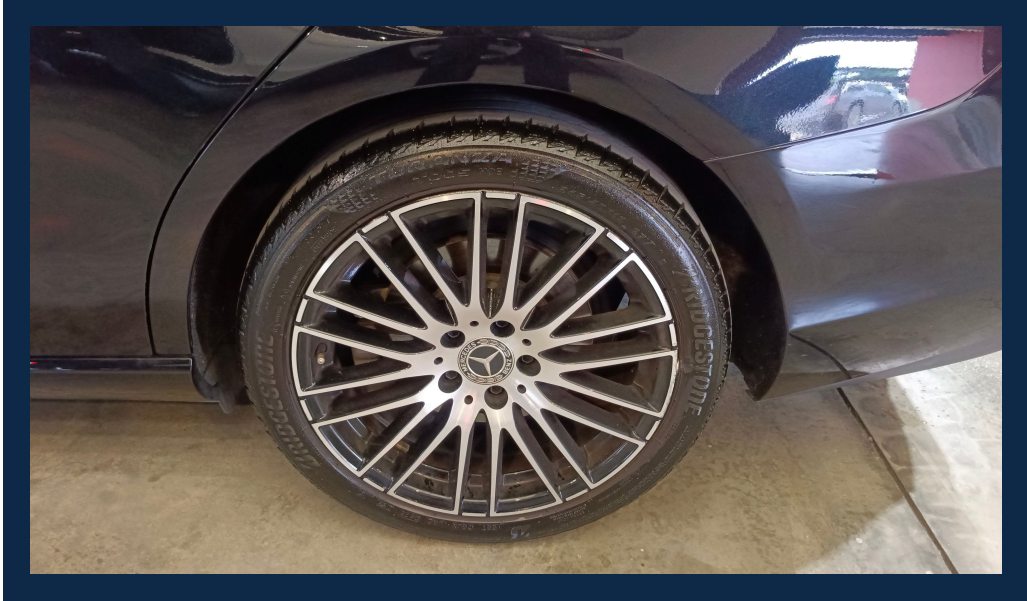
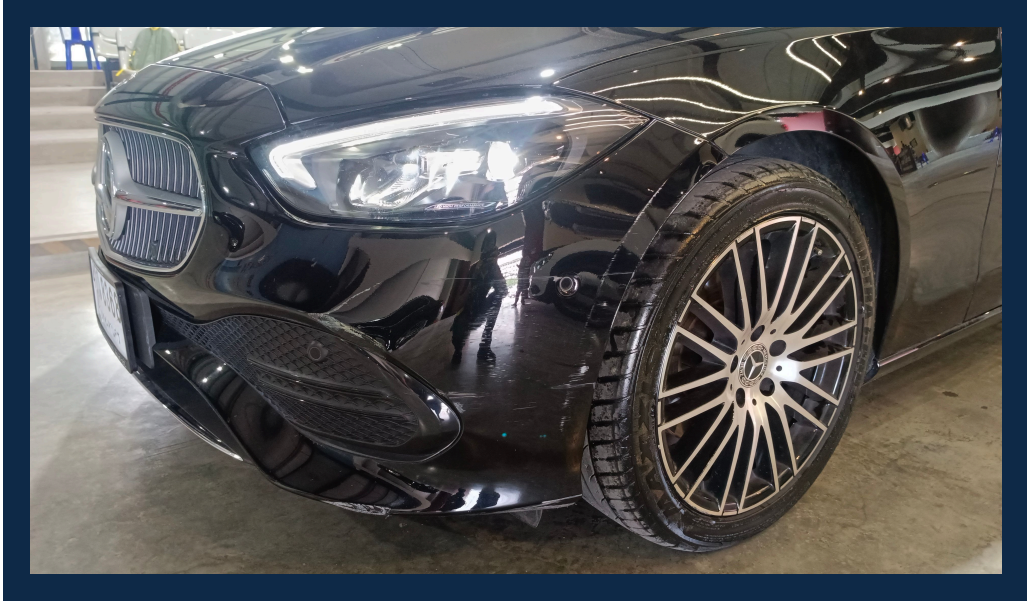
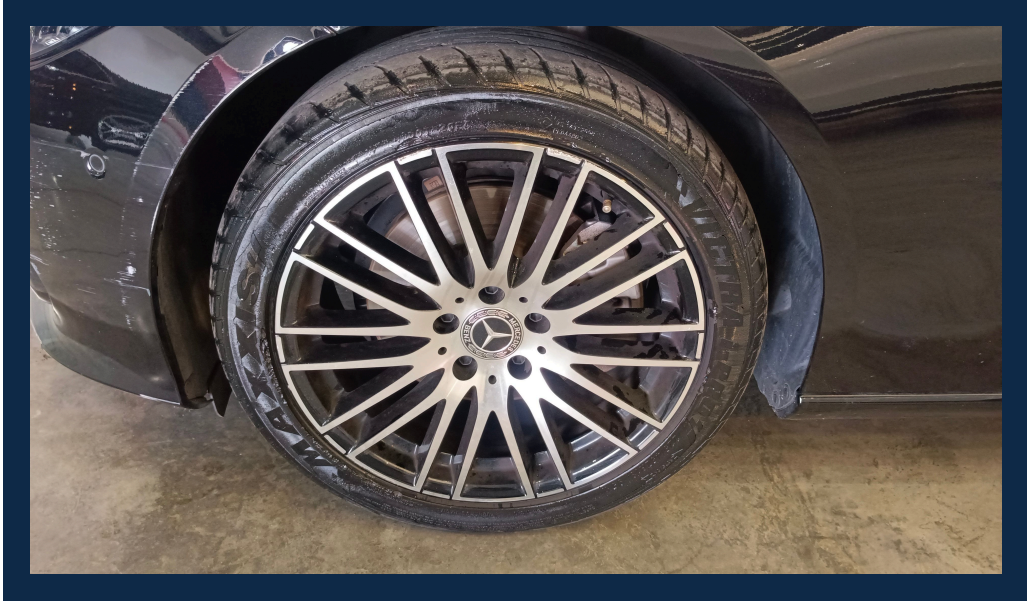
Vehicle Defect Notices

Conditions Report	Tire Status	Date Code	Tire Depth(mm)
1. Front Left Tire Condition	Tear	3922	5
2. Front Right Tire Condition	Normal	3622	5
3. Back Left Tire Condition	Tear	3922	5
4. Back Right Tire Condition	Normal	3622	5

Inspector : ภายนอก(Exterior) : การตรวจสภาพภายนอกโดยรวมไม่พบหลักฐานการซ่อมแซมทำสี / กัดชนหน้า
ถลอก/ สภาพยางทั้ง4เส้น ปี23 ยางหน้าหลังฝั่งซ้ายแก้มฉีกควรเปลี่ยน ภายใน(Interior) : ภายในปกติ สะอาด
เรียบร้อย , อุปกรณ์ไฟฟ้า แอร์ วิทยุFM ใช้งานได้สมบูรณ์ครบปกติ เครื่องยนต์(Engine) : เครื่องยนต์ทำงานได้ปกติ
,วิเคราะห์ปัญหาด้วยเครื่อง OBDII ไม่พบสิ่งผิดปกติ (ไม่ได้ทดสอบขับเคลื่อน) โครงสร้าง(Frame) : อุบัติเหตุไม่มี , โครงสร้าง
หลักปกติ ไม่มีการซ่อมแซมโครงสร้างหรือมีการชนถึงโครงสร้าง

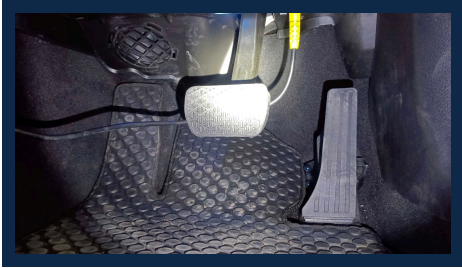
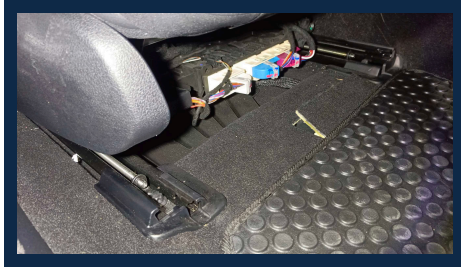
Flood Report

Evidence of Flood	No
-------------------	----

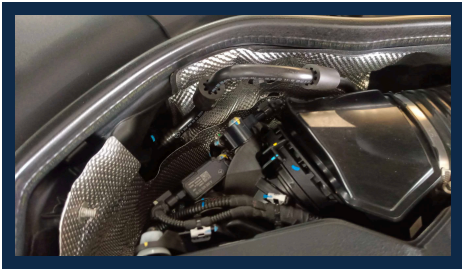
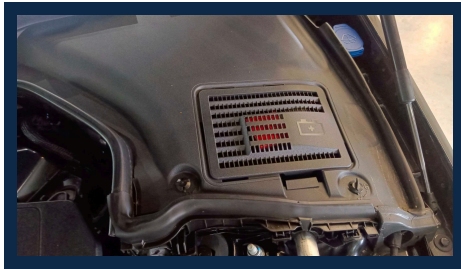
Fire Report

Evidence of Fire	No
------------------	----
