Vehicle : MERCEDES BENZ GLC220

Chassis number : W1N2539146L032284

Inspection date : 2024-07-15

Vehicle Certification : Pass the inspection standard of SCHIC INSPECTION BY LEMON-AIDE

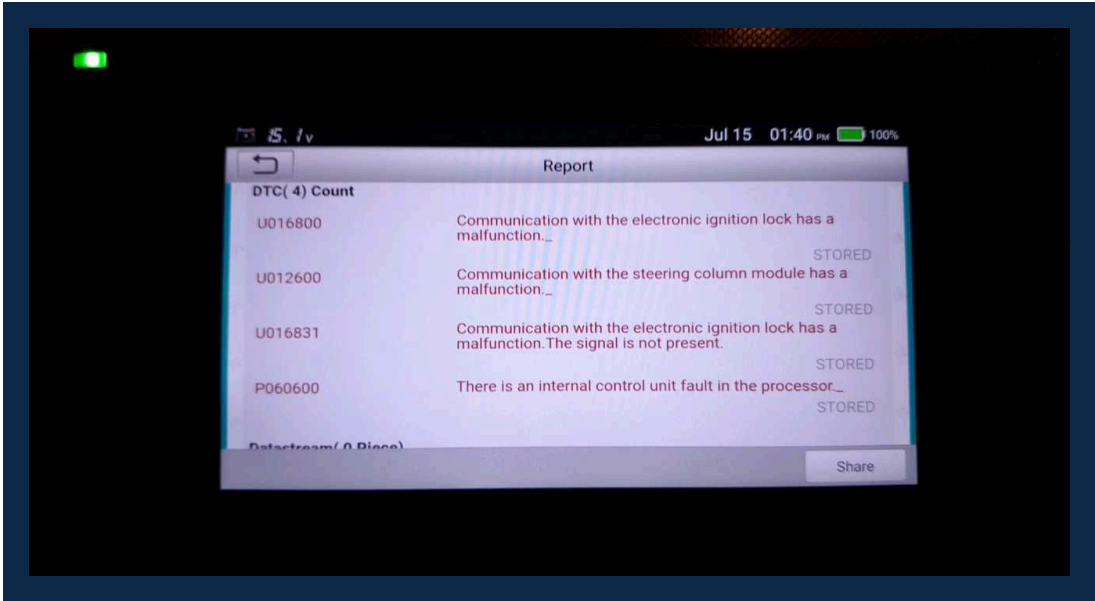
OBD Vehicle Health Analysis

1. Vehicle Engine Number Analysis (th)	PASS	14. Air Conditioning and Heating System (th)	PASS
2. Vehicle Chassis Number Analysis (th)	PASS	15. Front and Rear Suspension (th)	PASS
3. Vehicle Original OEM Color Analysis (th)	PASS	16. Drive Axle (th)	PASS
4. Engine System (th)	PASS	17. High Tech (th)	PASS
5. Transmission System (th)	PASS	18. Passenger Comfort (th)	PASS
6. Electrical System (th)	PASS	19. Security System (th)	PASS
7. Brake System (th)	PASS	20. Safety Active (th)	PASS
8. Steering System (th)	PASS	21. Safety Passive (th)	PASS
9. Fuel System (th)	PASS	22. Original Mileage Analysis (th)	PASS
10. Four-wheel Drive (th)	PASS	23. Overall Chassis Analysis (th)	PASS
11. Turbocharger/Supercharger (th)	PASS	24. Overall Exterior Analysis (th)	PASS
12. Fuel Injection and Engine Management System (th)	PASS	25. Overall Interior Analysis (th)	PASS
13. Engine Cooling System (th)	PASS

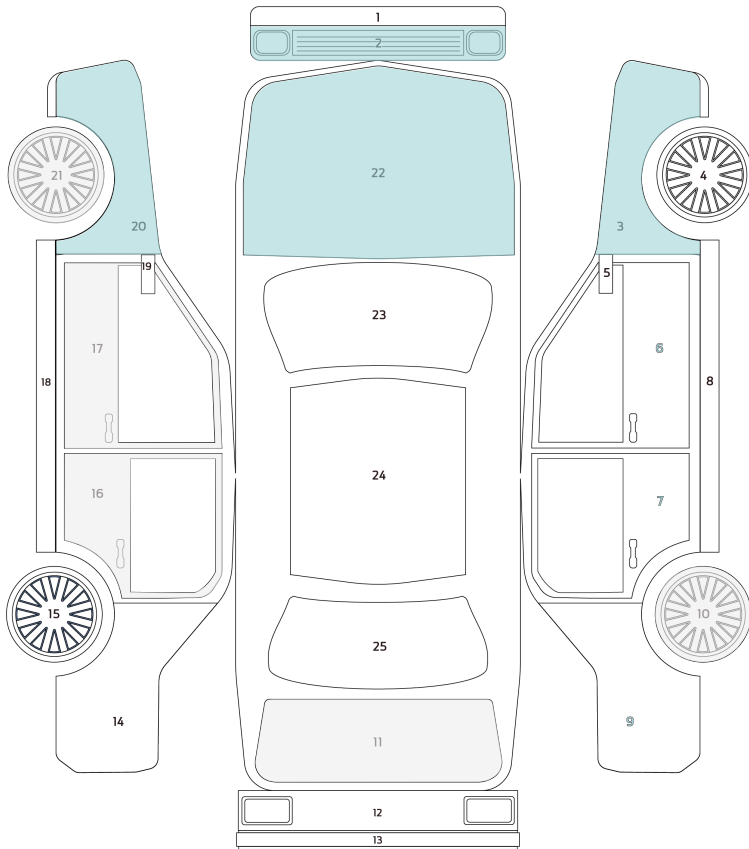
Exterior Inspection Points

1. Front Skirt	O	14. Left Skirt	O
2. Front Bumper	BP	15. Left Wing Mirror	O
3. Front Right Fender	BP	16. Front Windshield	O
4. Front Right Wheel	O	17. Roof	O
5. Front Left Fender	BP	18. Rear Right Fender	O
6. Front Left Wheel	O (S1)	19. Rear Bonnet	O (S1)
7. Front bonnet	BP	20. Back right wheel	O (S2)
8. Right Wing Mirror	O	21. Rear Bumper	O
9. Front Right Door	O	22. Rear Skirt	O
10. Rear Right Door	O	23. Rear Left Fender	O
11. Right Skirt	O	24. Back Left Wheel	O
12. Rear Left door	O (S1)	25. Back Windshield	O
13. Front left door	O (S1)

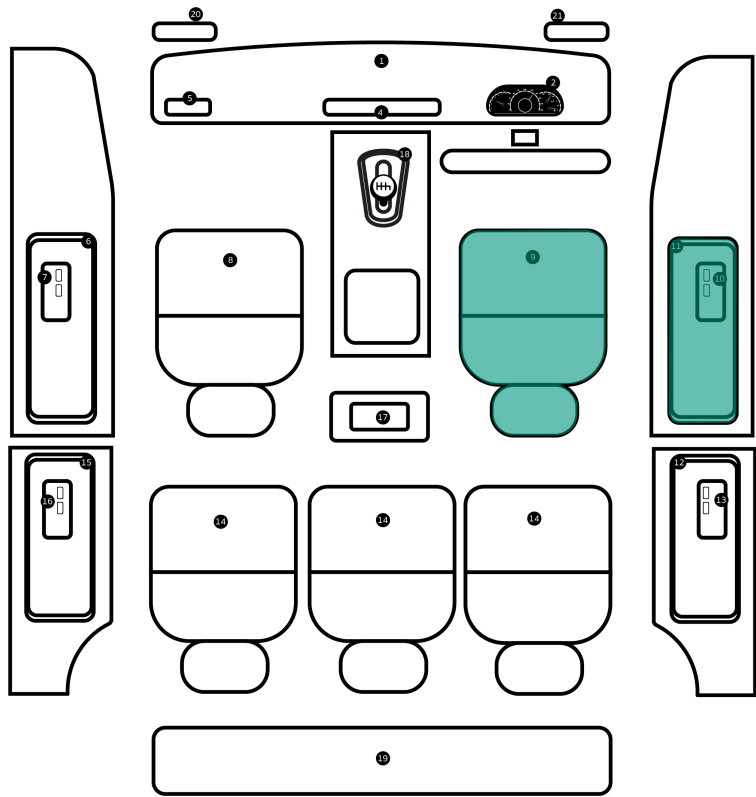
Interior Inspection Points

Inspector : ภายนอก(Exterior) : การตรวจสภาพภายนอกโดยรวมพบหลักฐานการซ่อมแซมทำสีบางชิ้น ฝากระโปรงหน้าเปลี่ยนทำสี / สภาพยางทั้ง4เส้น หน้าปี 20 เสื่อมสภาพ หลังปี 22 ภายใน(Interior) : ภายใน คอนโซลสา B หน้าหุ้มถลอก ผ้าบุหลังคามีรอยจิม สะอาดเรียบร้อย , อุปกรณ์ไฟฟ้า แอร์ วิทยุFM ใช้งานได้สมบูรณ์ครบปกติ
เครื่องยนต์(Engine) : เครื่องยนต์ทำงานได้ปกติ วิเคราะห์ปัญหาด้วยเครื่อง OBDII พบสิ่งผิดปกติ แนะนำตรวจเช็คศูนย์บริการ (ไม่ได้ทดสอบขับขี) **โครงสร้าง(Frame) :** โครงสร้างหลักปกติ ไม่มีการซ่อมแซมโครงสร้างหรือมีการชนถึงโครงสร้าง / คานบนหมอน้ำมีการถอดซ่อม

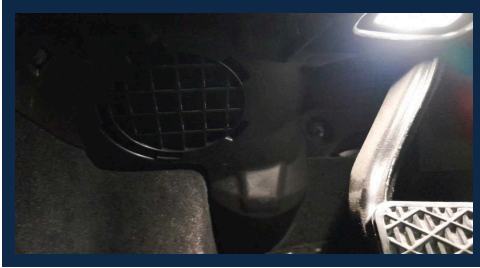
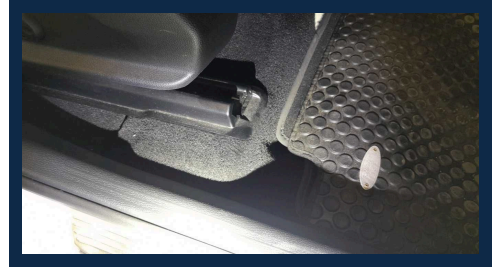
Flood Report

Evidence of Flood

No

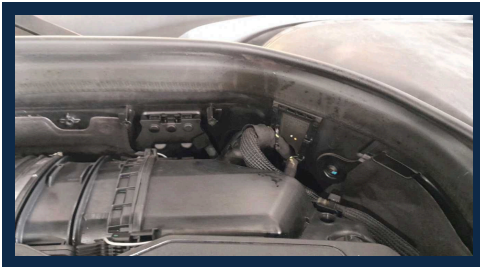
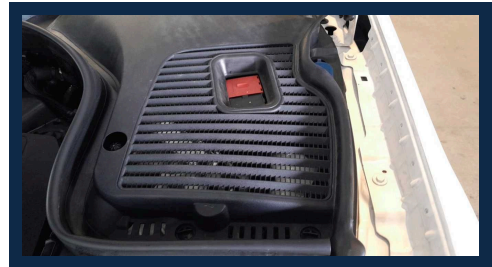
Fire Report

Evidence of Fire

No
