Vehicle : MERCEDES BENZ GLC250

Chassis number : WDC2539096L016417

Inspection date : 2024-07-15

Vehicle Certification : Pass the inspection standard of SCHIC INSPECTION BY LEMON-AIDE

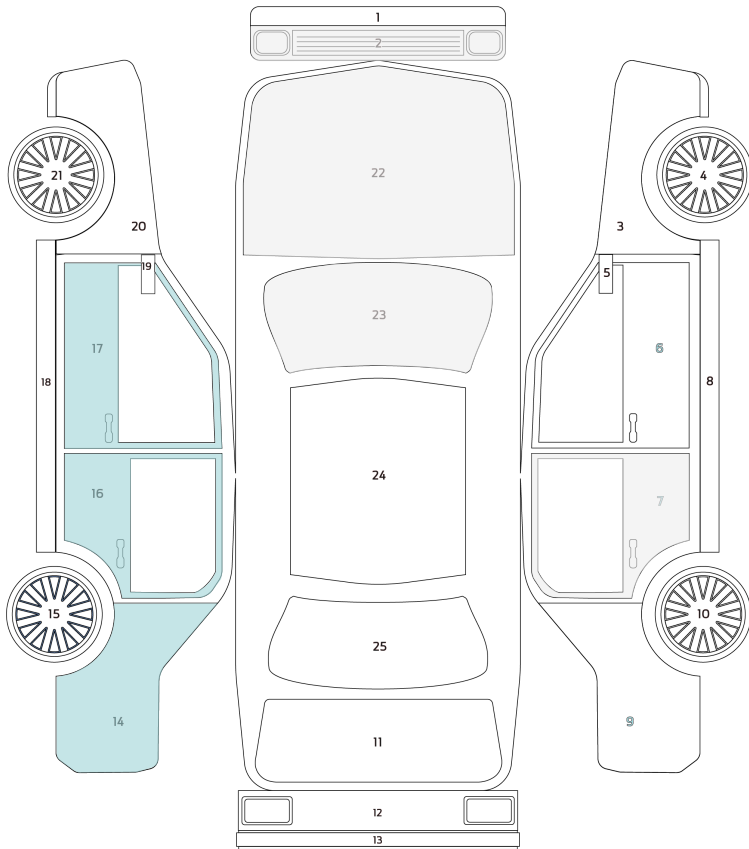
Exterior Inspection Points

| 2. Front Bumper | O (S1) | 15. Left Wing Mirror | O |
| 3. Front Right Fender | O | 16. Front windshield | O (G1) |
| 7. Front bonnet | O (S1) | 20. Back Right Wheel | O |
| 10. Rear right door | O (S1) | 23. Rear left fender | BP |
| 12. Rear Left door | BP | 25. Back Windshield | O |
| 13. Front left door | BP | | |

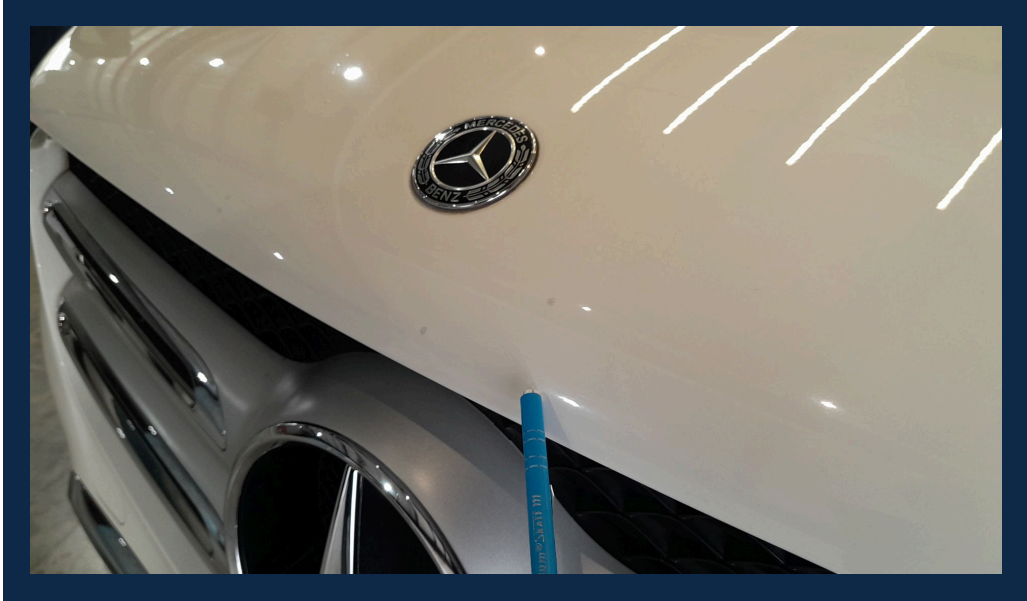
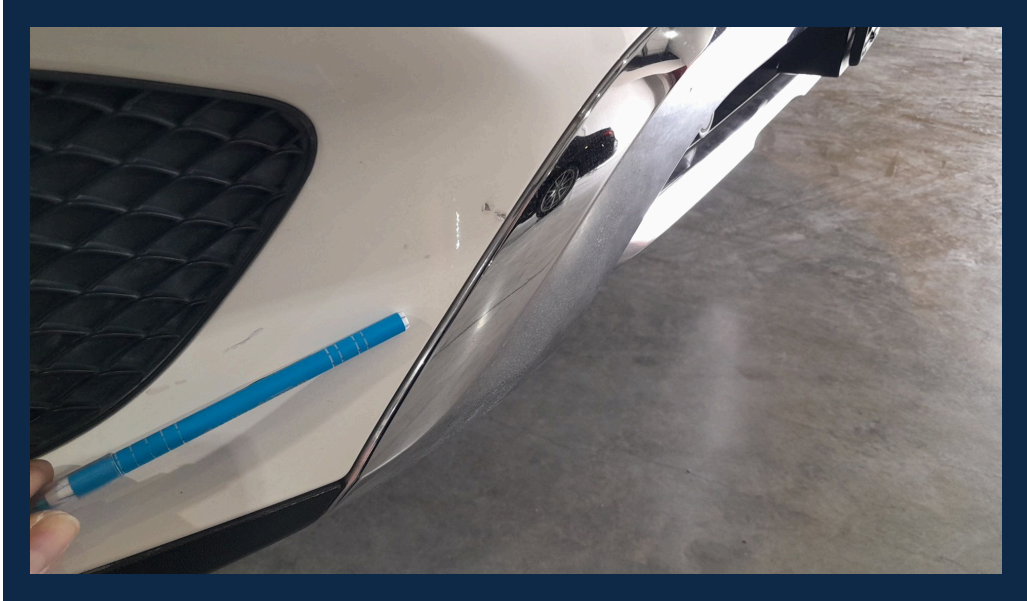
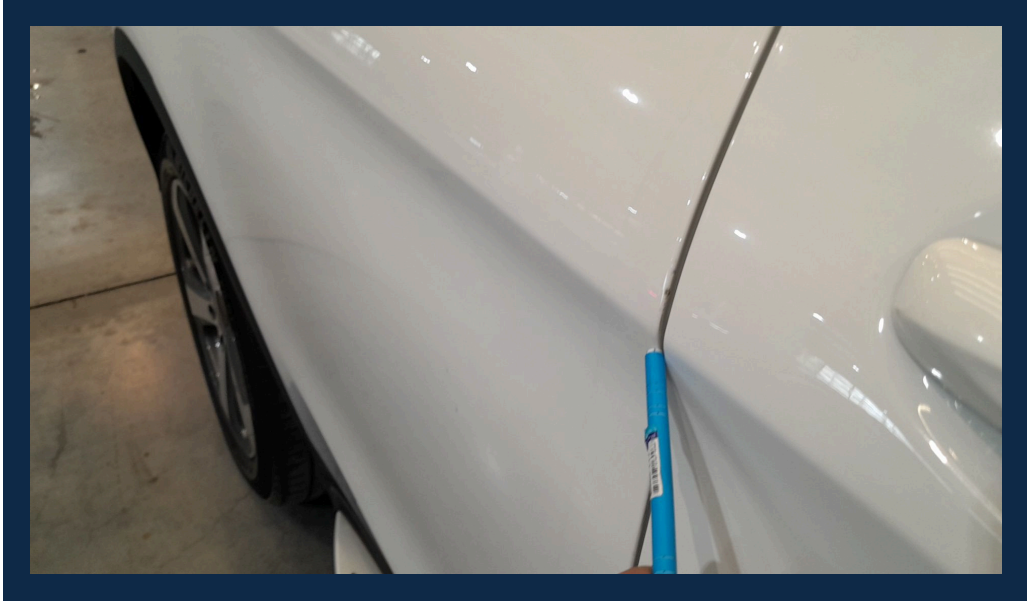
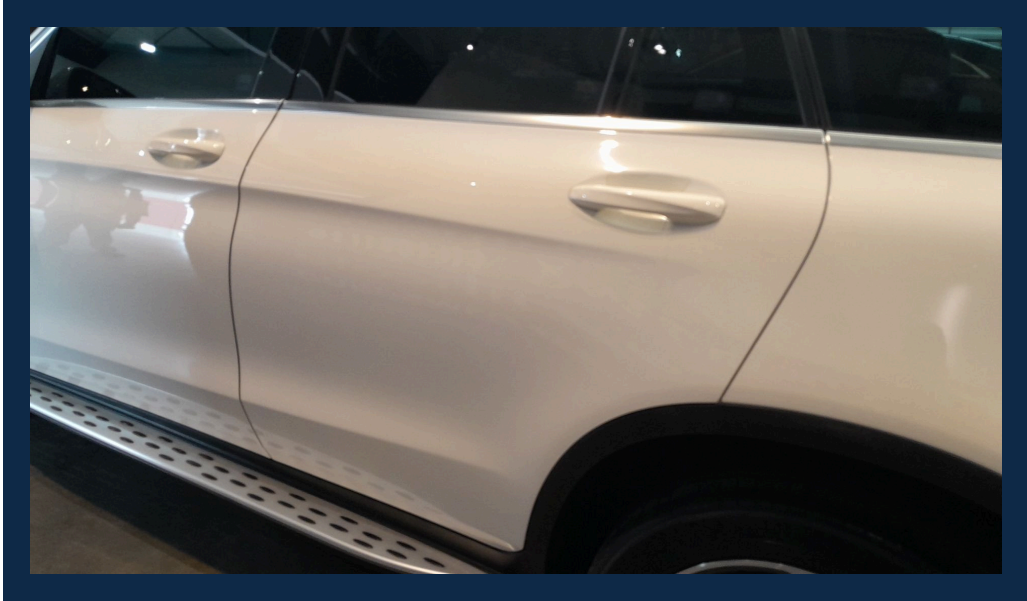
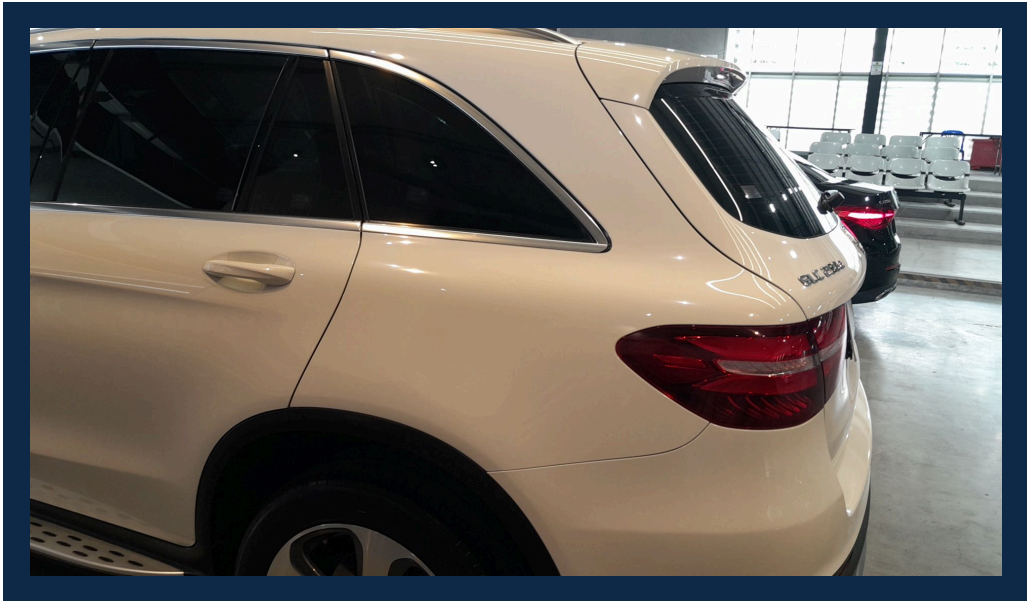
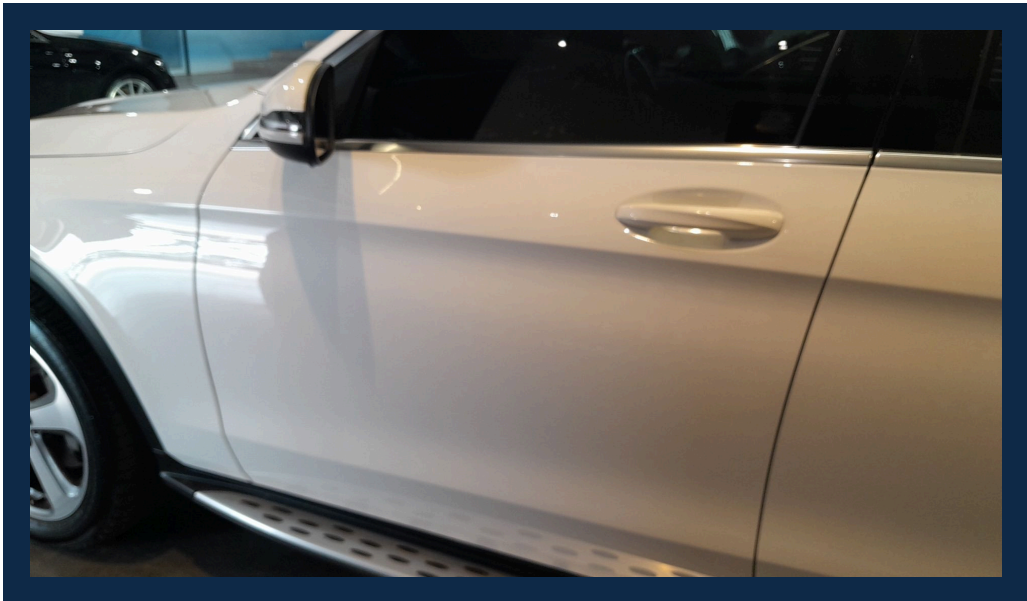
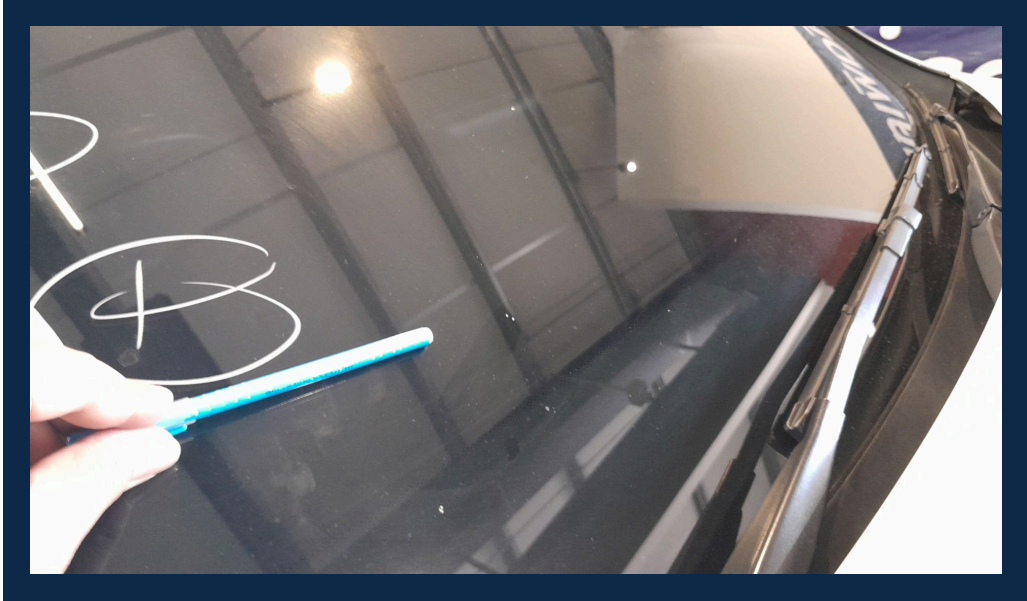
Vehicle Defect Notices

Inspector : ภายนอก(Exterior) : การตรวจสภาพภายนอกโดยรวมพบหลักฐานการซ่อมแซมทำสีมาบ้างชิ้น รื้อรอยรอบคันเล็กน้อย กระจกเป็นรอยสะเก็ดหิน / สภาพยาง4เส้น หน้าปี 22 หลังปี 21 เสื่อมสภาพ ภายใน(Interior) : ภายในปกติ สะอาดเรียบร้อย , อุปกรณ์ไฟฟ้า แอร์ วิทยุFM ใช้งานได้สมบูรณ์ครบปกติ เครื่องยนต์(Engine) : เครื่องยนต์ทำงานได้ปกติ ,วิเคราะห์ปัญหาด้วยเครื่อง OBDII พบสิ่งผิดปกติ แนะนำเข้าตรวจเช็คศูนย์บริการ (ไม่ได้ทดสอบขับ) โครงสร้าง(Frame) : อุบัติเหตุไม่มี ,โครงสร้างหลักปกติ ไม่มีการซ่อมแซมโครงสร้างหรือมีการชนถึงโครงสร้าง

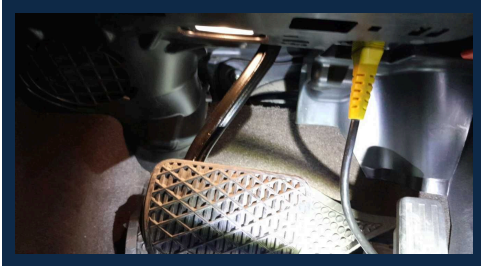
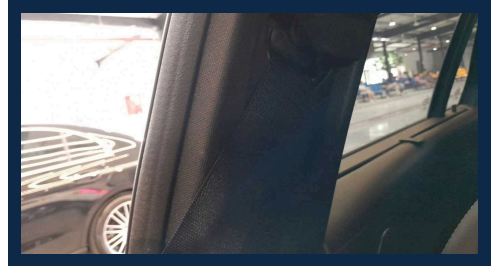
Flood Report

| Evidence of Flood | No |

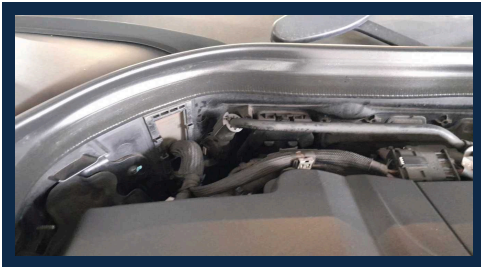
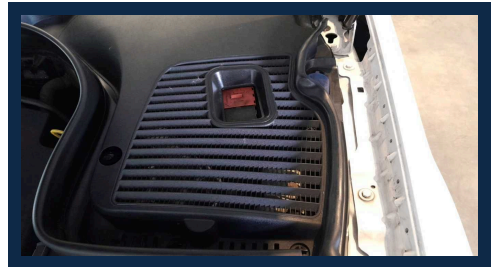
Fire Report

| Evidence of Fire | No |
