Customer Name : MERCEDES-BENZ MOBILITY (THAILAND) CO., LTD. Inspection Date : 2024-07-15  
Tel. : \_\_\_\_\_ Lemon Inspection ID : LEMON24070223  
Inspector : ไชยมงคล ไพร์เลียย Approved By : แทนรัก ทิพย์อินทร์

Brand	MERCEDES BENZ	Model year	2021
Model	E300	Engine Code - No.	27492031947499
Sub-model	e AMG Dynamic	Registration year	2023-05-29
Registration No.		Chassis No.	W1K2130536LO34714
Current Mileage(km.)	78601	Engine Capacity(cc.)	2000

This vehicle has been inspected by the SCHIC INSPECTION BY LEMON-AIDE inspection service.

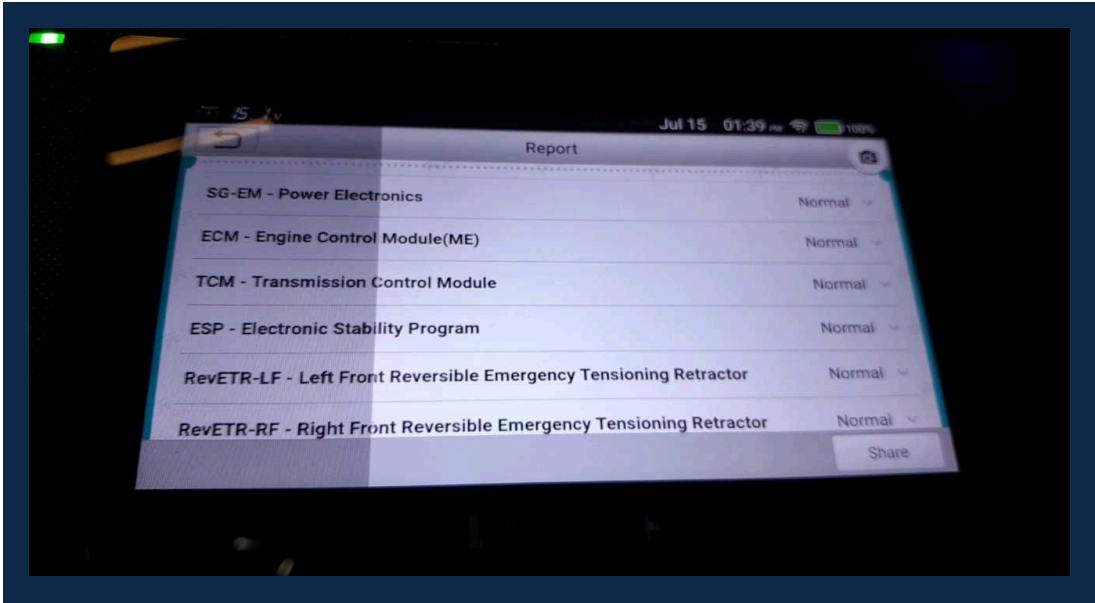
**OBD Vehicle Health Analysis**

เครื่องยนต์(Engine) : เครื่องยนต์ทำงานได้ปกติ , วิเคราะห์ปัญหาด้วยเครื่อง OBDII ไม่พบสิ่งผิดปกติ (ไม่ได้ทดสอบขับขี) โครงสร้าง(Frame) : อุบัติเหตุไม่มี , โครงสร้างหลักปกติ ไม่มีการซ่อมแซมโครงสร้างหรือมีการชนถึงโครงสร้าง

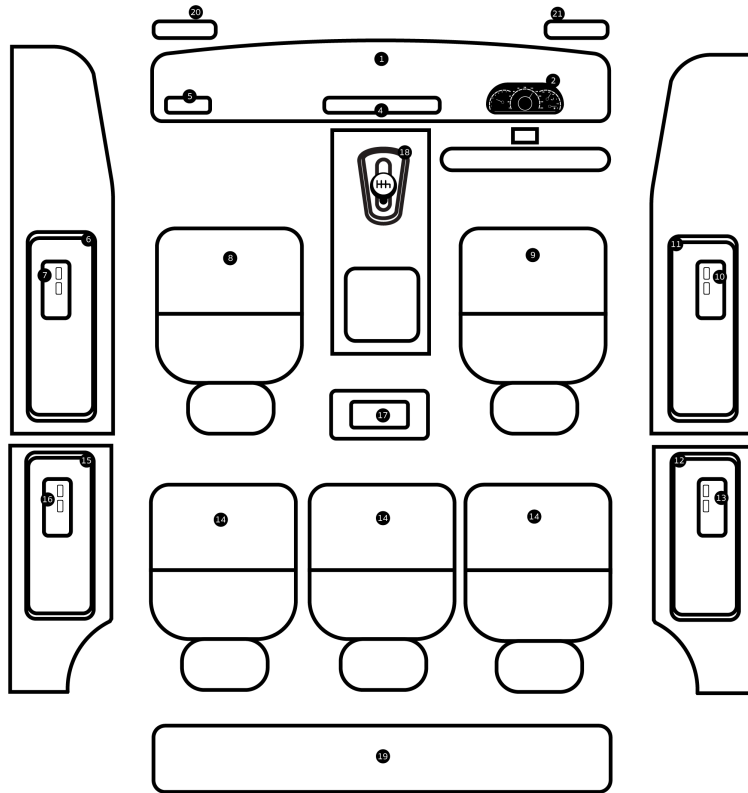
**Interior Inspection Points**

ภายใน(Interior) : ภายในปกติ สะอาดเรียบร้อย , อุปกรณ์ไฟฟ้า แอร์ วิทยุFM ใช้งานได้ตามบูรณ์ครบปกติ

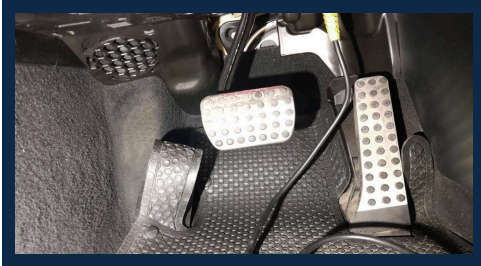
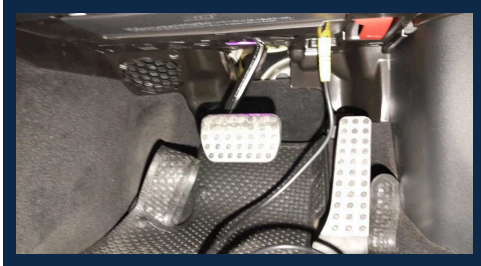
**Flood Report**

Evidence of Flood	No
-------------------	----

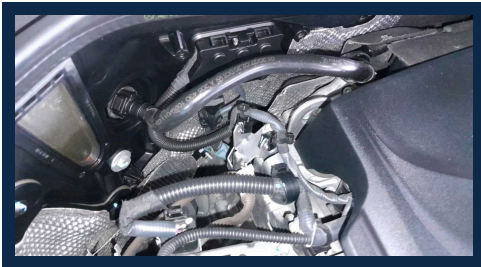
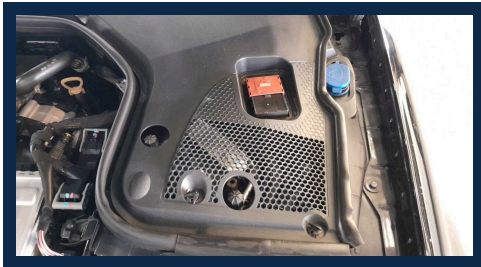
**Fire Report**

Evidence of Fire	No
------------------	----
