Vehicle : MERCEDES BENZ C350

Chassis number : W1K2060546L006857

Inspection date : 2024-07-15

Vehicle Certification : Pass the inspection standard of SCHIC INSPECTION BY LEMON-AIDE

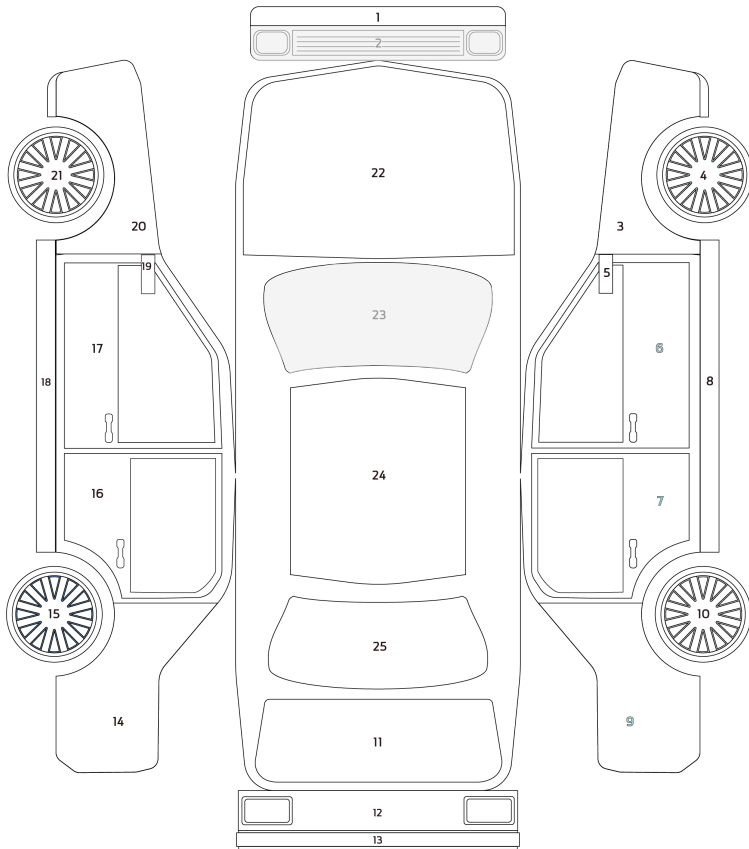
Exterior Inspection Points

1. Front Skirt	O	14. Left Skirt	O
2. Front Bumper	O (S2)	15. Left Wing Mirror	O
3. Front Right Fender	O	16. Front windshield	O (G1)
4. Front Right Wheel	O	17. Roof	O
5. Front Left Fender	O	18. Rear Right Fender	O
6. Front Left Wheel	O	19. Rear Bonnet	O
7. Front Bonnet	O	20. Back Right Wheel	O
8. Right Wing Mirror	O	21. Rear Bumper	O
9. Front Right Door	O	22. Rear Skirt	O
10. Rear Right Door	O	23. Rear Left Fender	O
11. Right Skirt	O	24. Back Left Wheel	O
12. Rear Left Door	O	25. Back Windshield	O
13. Front Left Door	O

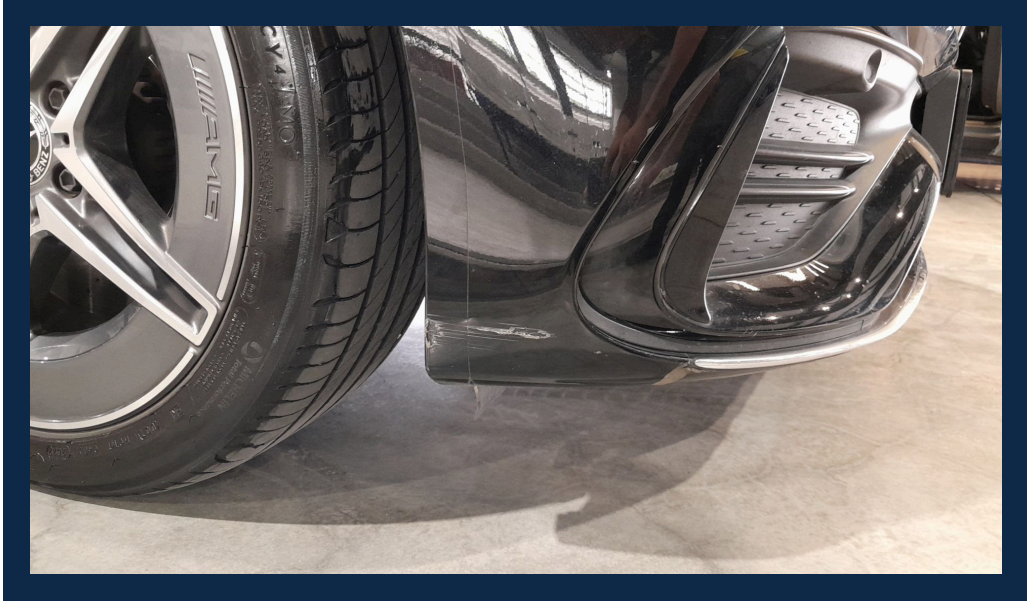
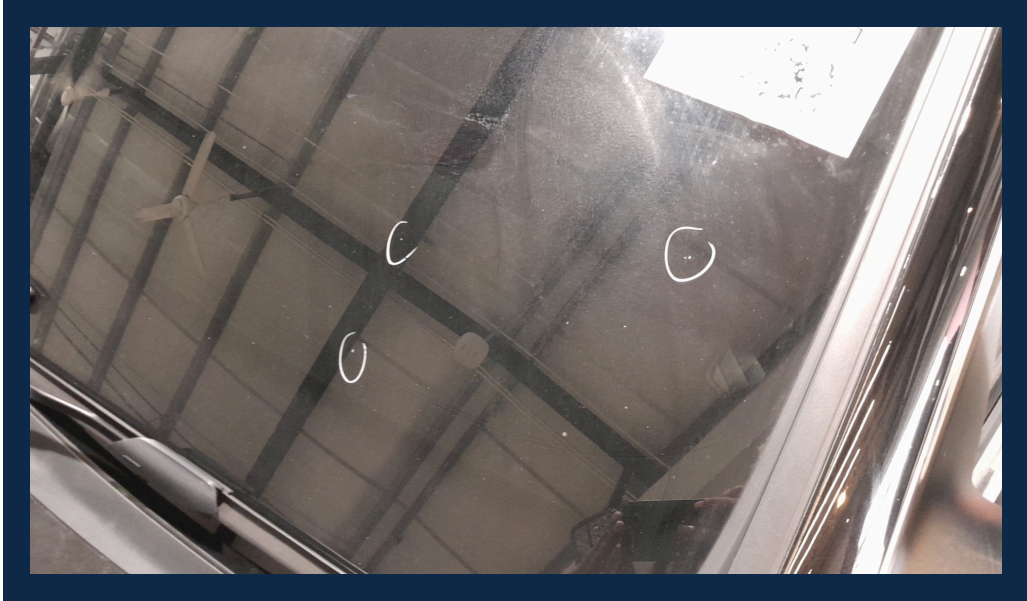
Vehicle Defect Notices

Inspector : ภายนอก(Exterior) : การตรวจสภาพภายนอกโดยรวมไม่พบหลักฐานการซ่อมแซมทำสี / ก้นชนหน้า
ถลอก / กระจกบังลมหน้ากระเทาะ / สภาพยางปกติทั้ง4เส้น ปี23 ภายใน(Interior) : ภายในปกติ สะอาดเรียบร้อย
อุปกรณ์ไฟฟ้า แอร์ วิทยุFM ใช้งานได้สมบูรณ์ครบปกติ เครื่องยนต์(Engine) : เครื่องยนต์ทำงานได้ปกติ ,วิเคราะห์
ปัญหาด้วยเครื่อง OBDII ไม่พบสิ่งผิดปกติ (ไม่ได้ทดสอบขับขี) โครงสร้าง(Frame) : อุบัติเหตุไม่มี ,โครงสร้างหลักปกติ
ไม่มีการซ่อมแซมโครงสร้างหรือมีการชนถึงโครงสร้าง

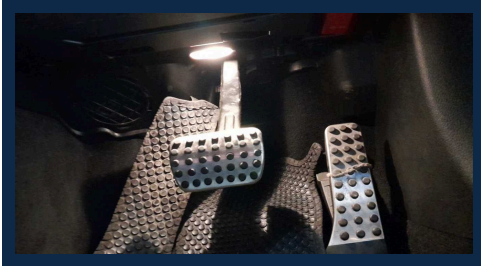
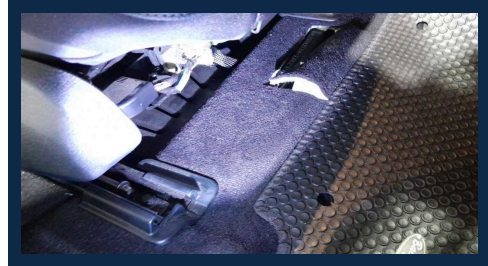
Flood Report

Evidence of Flood	No
-------------------	----

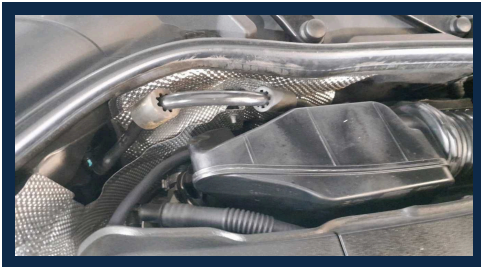
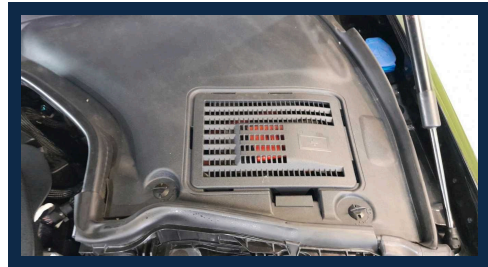
Fire Report

Evidence of Fire	No
------------------	----
