Preowned Vehicle Inspection Report

Premium Inspection Analysis

Customer Name : MERCEDES-BENZ MOBILITY (THAILAND) CO., LTD. Inspection Date : 2024-07-16
Tel. : Lemon Inspection ID : LEMON24070267
Inspector : แทนรัก ทิพย์อินทร์ Approved By : ไซยมงคล ไพริสัยง

Table with 4 columns: Brand, Model, Sub-model, Registration No., Current Mileage(km.), MERCEDES BENZ, GLE300, d 4MATIC AMG Dynamic, 1กย6996, 71689, Model year, Engine Code - No., Registration year, Chassis No., Engine Capacity(cc.), 2020, 65492080777076, 2022-11-08, W1N671196M001690, 2000

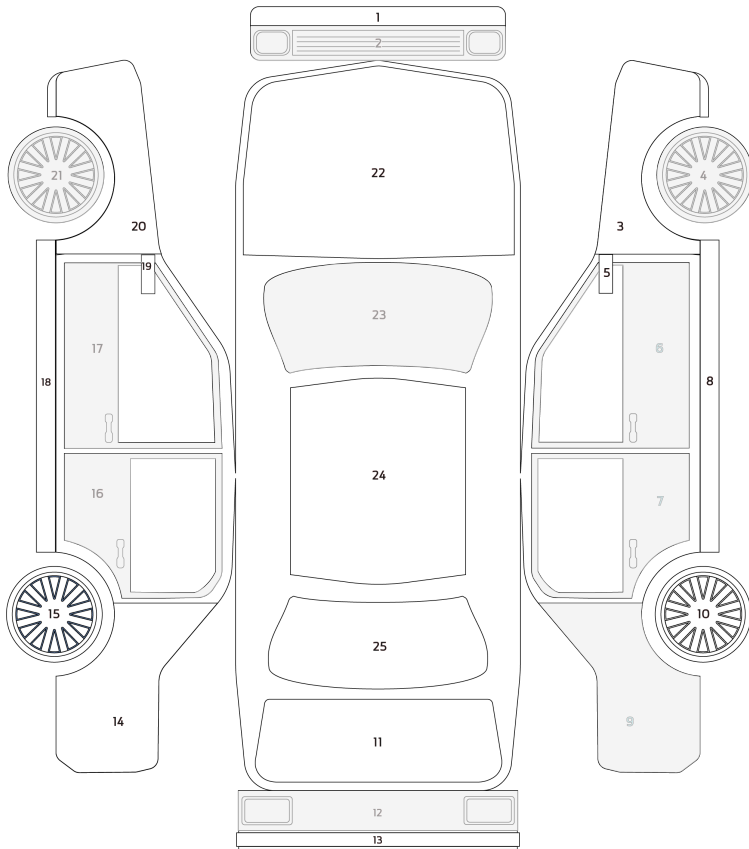
Exterior Inspection Points

1. Front Skirt	O	14. Left Skirt	O
2. Front Bumper	O (S3)	15. Left Wing Mirror	O
3. Front Right Fender	O	16. Front windshield	O (G1)
4. Front Right Wheel	O (S3)	17. Roof	O
5. Front Left Fender	O	18. Rear right fender	O (D1)
6. Front Left Wheel	O (S3)	19. Rear Bonnet	O
7. Front Bonnet	O	20. Back Right Wheel	O
8. Right Wing Mirror	O	21. Rear Bumper	O (S2)
9. Front right door	O (S1)	22. Rear Skirt	O
10. Rear right door	O (S1)	23. Rear Left Fender	O
11. Right Skirt	O	24. Back Left Wheel	O
12. Rear Left door	O (S1)	25. Back Windshield	O
13. Front left door	O (S1,D1)

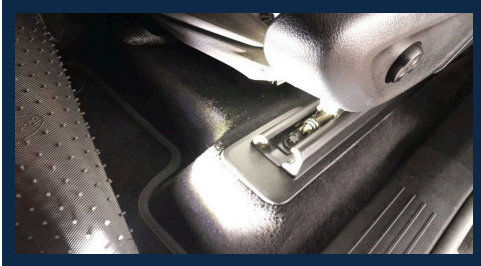
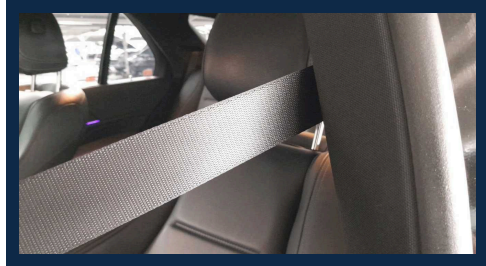
Flood Report

Evidence of Flood	No
-------------------	----

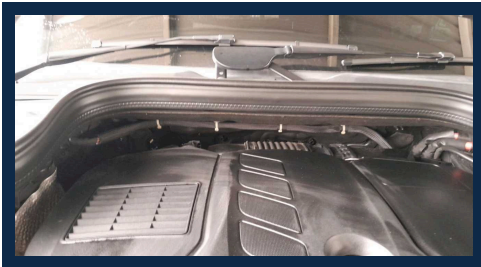
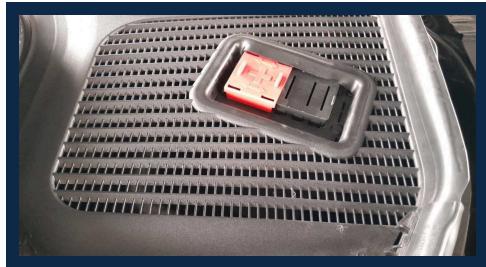
Fire Report

Evidence of Fire	No
------------------	----
