# Preowned Vehicle Inspection Report

Customer Name	: MERCEDES-BENZ MOBILITY (THAILAND) CO., LTD.	Inspection Date	: 2024-07-16
Tel.	:	Lemon Inspection ID	: LEMON24070263
Inspector	: อนุรัก ทิพย์อินทร์	Approved By	: ไซมมกค ไพริสัยง

Brand	MERCEDES BENZ	Model year	2019
Model	C200	Engine Code - No.	26491530043514
Sub-model	COUPE AMG DYNAMIC	Registration year	2019-10-04
Registration No.		Chassis No.	WDD2053776L043162
Current Mileage(km.)	53957	Engine Capacity(cc.)	1500

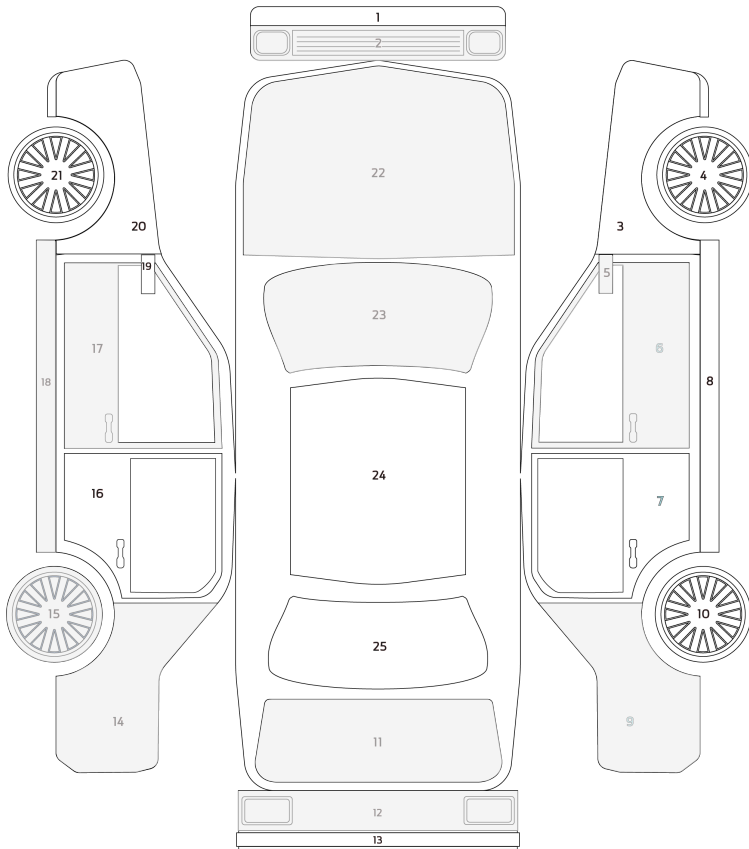
### Exterior Inspection Points

1. Front Skirt	O	14. Left skirt	O (S3)
2. Front Bumper	O (S2)	15. Left Wing Mirror	O
3. Front Right Fender	O	16. Front windshield	O (G1)
4. Front Right Wheel	O	17. Roof	O
5. Front Left Fender	O	18. Rear right fender	O (S1,D1)
6. Front Left Wheel	O	19. Rear Bonnet	O (D2)
7. Front bonnet	O (S1)	20. Back Right Wheel	O
8. Right wing mirror	O (S1)	21. Rear Bumper	O (S3)
9. Front right door	O (S1)	22. Rear Skirt	O
10. Rear Right Door	O	23. Rear left fender	O (S1)
11. Right Skirt	O	24. Back left wheel	O (S2)
12. Rear Left Door	O	25. Back Windshield	O
13. Front left door	O (S1)
