# Preowned Vehicle Inspection Report

Premium Inspection Analysis

**Vehicle :** MERCEDES BENZ CLS220

**Chassis number :** W1K2573146L004378

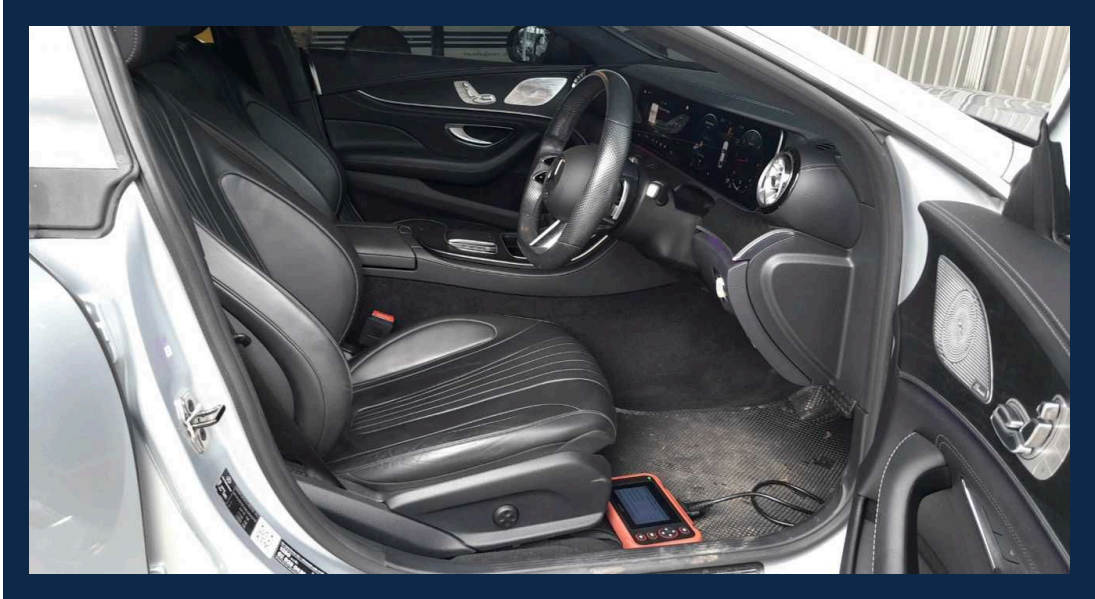
**Passenger Front Seat Image**

**Inspector :** ภายนอก(Exterior) : การตรวจสภาพภายนอกโดยรวมพบหลักฐานการซ่อมแซมทำสีฟาท้าย รีวตลอกเล็กน้อย / สภาพยางปกติทั้ง4เส้น ปี 21 ภายใน(Interior) : ภายในเบาะหน้าขวาเป็นรอยย่น สะอาดเรียบร้อย , อุปกรณ์ไฟฟ้าแอร์ วิทยุFM ใช้งานได้สมบูรณ์ครบปกติ เครื่องยนต์(Engine) : เครื่องยนต์ทำงานได้ปกติ , วิเคราะห์ปัญหาด้วยเครื่อง OBDII พบสิ่งผิดปกติ แนะนำตรวจเช็คศูนย์ (ไม่ได้ทดสอบขับ) โครงสร้าง(Frame) : อุบัติเหตุไม่มี , โครงสร้างหลักปกติ ไม่มีการซ่อมแซมโครงสร้างหรือมีการชนถึงโครงสร้าง

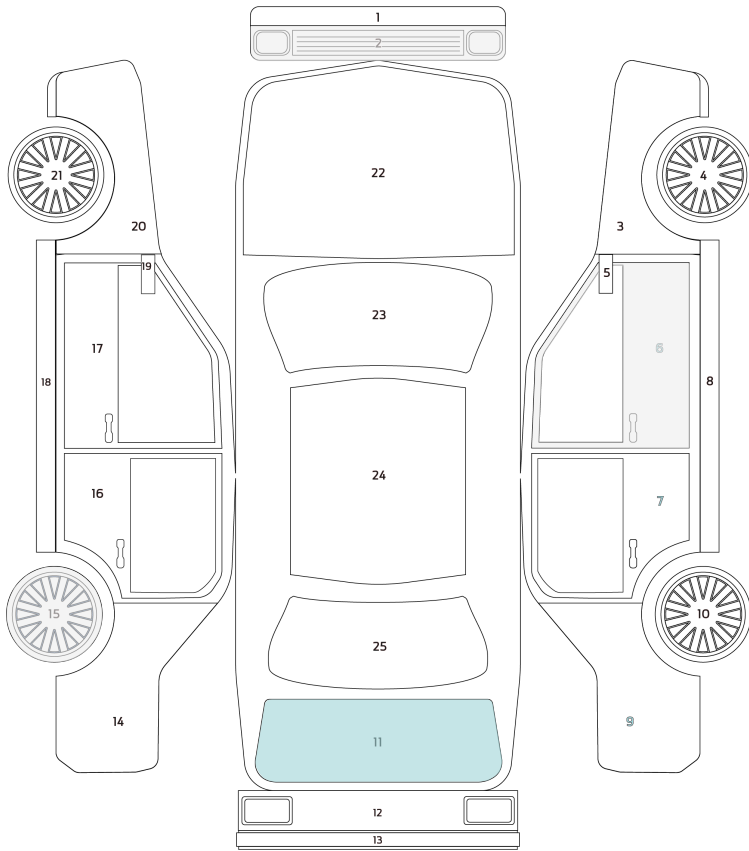
### Exterior Inspection Points

1. Front Skirt	O	14. Left Skirt	O
2. Front Bumper	O (S1)	15. Left Wing Mirror	O
3. Front Right Fender	O	16. Front Windshield	O
4. Front Right Wheel	O	17. Roof	O
5. Front Left Fender	O	18. Rear Right Fender	O
6. Front Left Wheel	O	19. Rear Bonnet	BP
7. Front Bonnet	O	20. Back Right Wheel	O
8. Right Wing Mirror	O	21. Rear Bumper	O
9. Front right door	O (D1)	22. Rear Skirt	O
10. Rear Right Door	O	23. Rear Left Fender	O
11. Right Skirt	O	24. Back left wheel	O (S2)
12. Rear Left Door	O	25. Back Windshield	O
13. Front Left Door	O

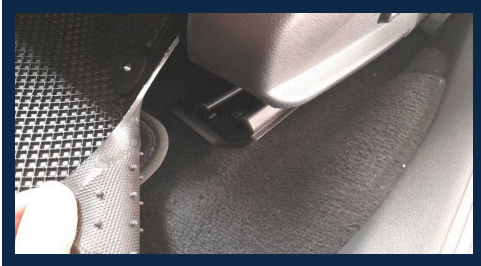
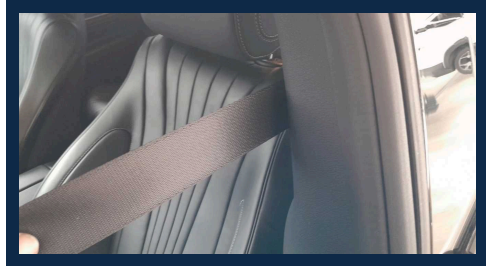
**Flood Report**

Evidence of Flood	No
-------------------	----

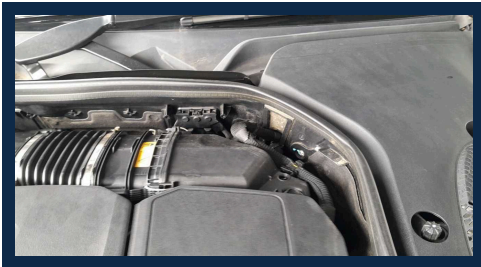
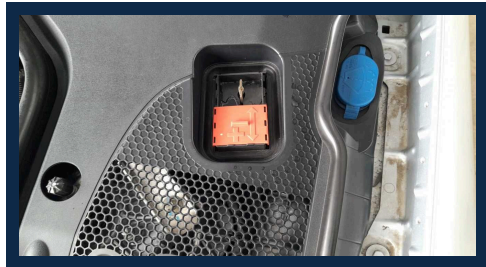
**Fire Report**

Evidence of Fire	No
------------------	----
