Preowned Vehicle Inspection Report

Premium Inspection Analysis

Inspector Note**Vehicle :** MERCEDES BENZ GLC250**Chassis number :** WDC2533466L021067**Inspection date :** 2024-07-18

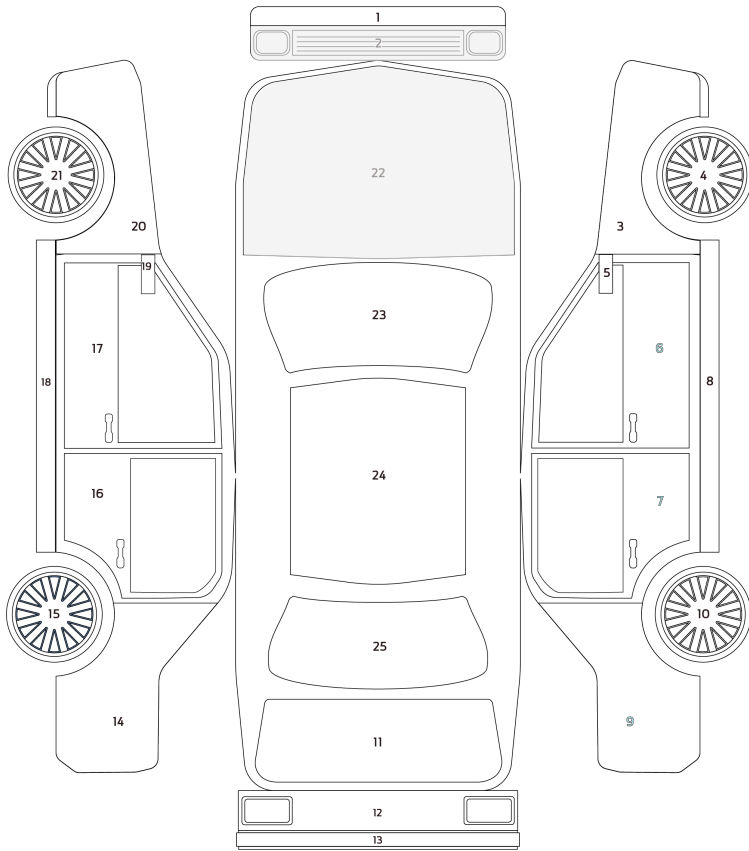
Exterior Inspection Points

1. Front Skirt	O	14. Left Skirt	O
2. Front Bumper	O (S2)	15. Left Wing Mirror	O
3. Front Right Fender	O	16. Front Windshield	O
4. Front Right Wheel	O	17. Roof	O
5. Front Left Fender	O	18. Rear Right Fender	O
6. Front Left Wheel	O	19. Rear Bonnet	O
7. Front bonnet	O	20. Back Right Wheel	O
8. Right Wing Mirror	O	21. Rear Bumper	O
9. Front Right Door	O	22. Rear Skirt	O
10. Rear Right Door	O	23. Rear Left Fender	O
11. Right Skirt	O	24. Back Left Wheel	O
12. Rear Left Door	O	25. Back Windshield	O
13. Front Left Door	O

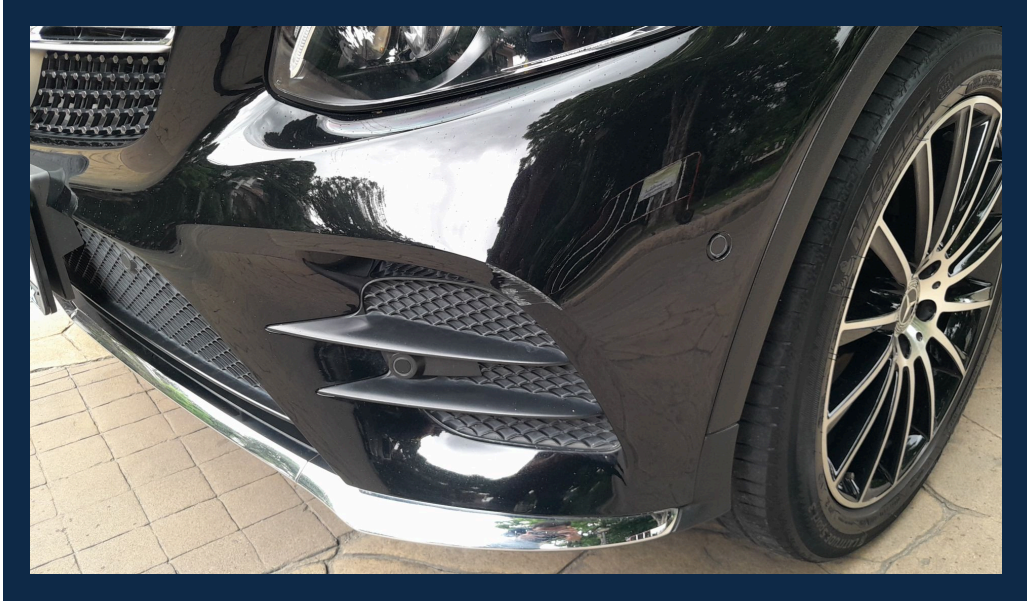
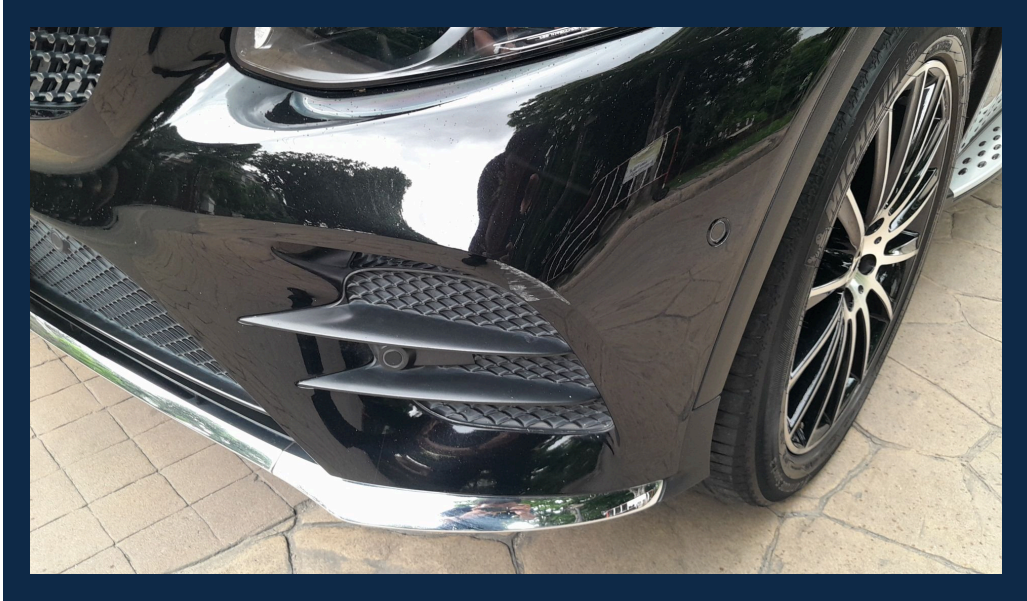
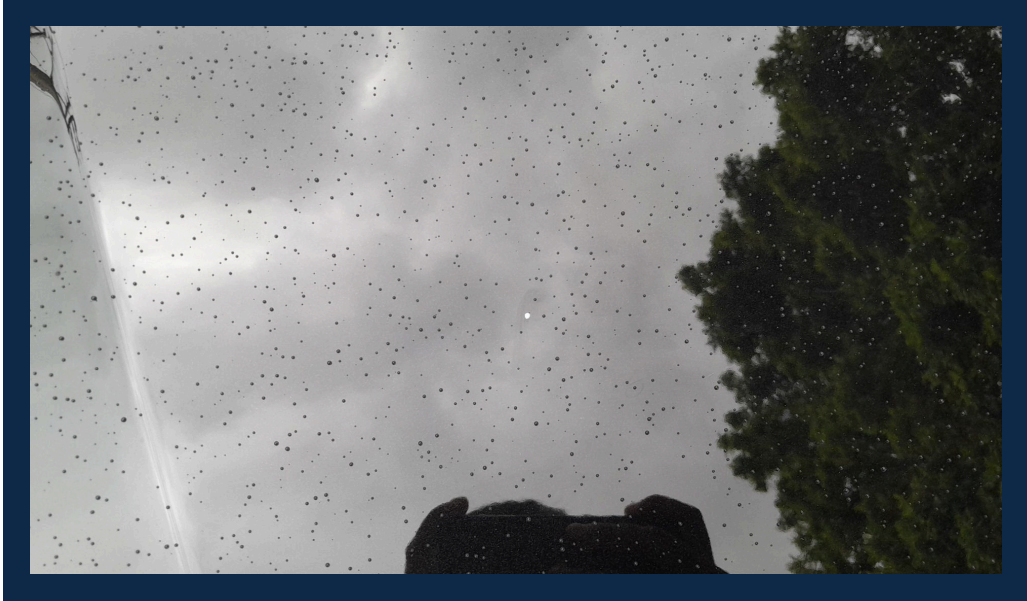
Vehicle Defect Notices

Inspector : ภายนอก(Exterior) : การตรวจสภาพภายนอกโดยรวมไม่พบหลักฐานการซ่อมแซมทำสี/กันชนหน้าถลอก/ฝากระโปรงหน้ามีรอยสะเก็ดหิน/ประตูหลังขวากะระเกาะ / สภาพยางปกติทั้ง4เส้น ปี22 ภายใน(Interior) : ภายในปกติ สะอาดเรียบร้อย , อุปกรณ์ไฟฟ้า แอร์ วิทยุFM ใช้งานได้สมบูรณ์ครบปกติ เครื่องยนต์(Engine) : เครื่องยนต์ทำงานได้ปกติ ,วิเคราะห์ปัญหาด้วยเครื่อง OBDII ไม่พบสิ่งผิดปกติ (ไม่ได้ทดสอบขับขี) โครงสร้าง(Frame) : อุบัติเหตุไม่มี ,โครงสร้างหลักปกติ ไม่มีการซ่อมแซมโครงสร้างหรือมีการชนถึงโครงสร้าง

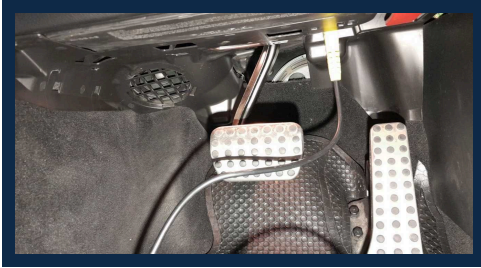
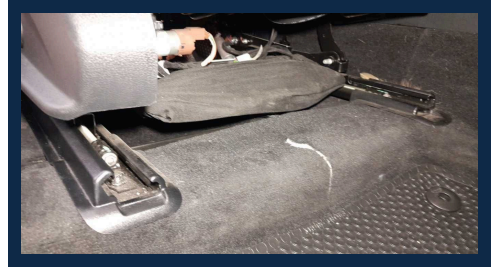
Flood Report

Evidence of Flood

No

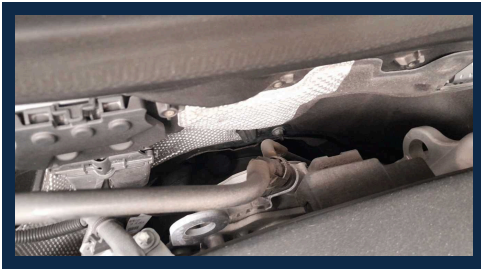
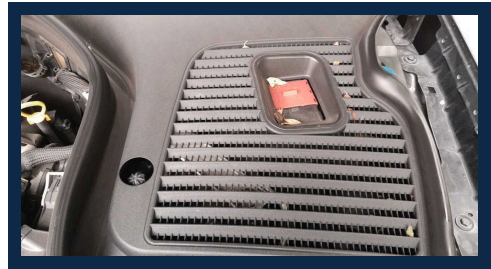
Fire Report

Evidence of Fire

No
